**ILLINOIS DEPARTMENT OF PUBLIC HEALTH  
AHERA THREE YEAR REINSPECTION  
ASBESTOS ABATEMENT PROGRAM  
SCHOOL INFORMATION FORM**

NAME OF SCHOOL DISTRICT: CHICAGO SCHOOL DIST 299  
SCHOOL ID NUMBER: 14-016-2990-2069  
SCHOOL NAME: Bass School  
ADDRESS OF SCHOOL: 1140 W. 66th  
CITY: Chicago, IL, 60621

DATE REINSPECTION COMPLETED: 4/1/2013 ENROLLMENT 333

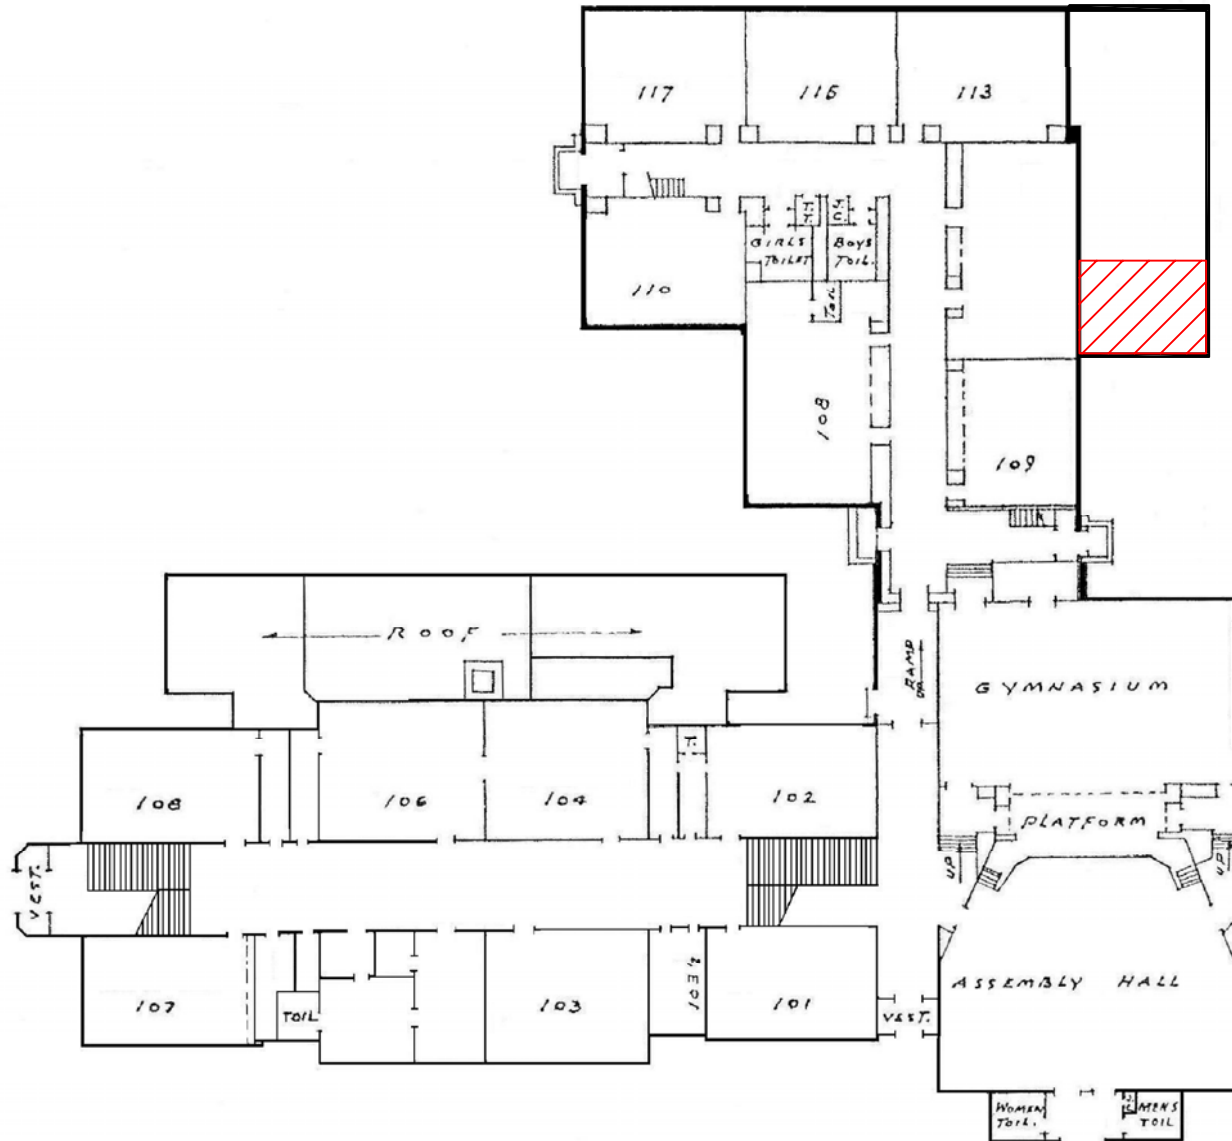
KCPSS 2011-2013 Three Year A-Cad Drawings\Region 5\Bass School\Bass School First Floor.dwg

**ASBESTOS REINSPECTION KEY NOTES:**

HOMOGENEOUS AREA: **CT1**  
MATERIAL DESCRIPTION: **2 X 4 Ceiling Tile**  
MATERIAL LOCATION: **Kitchen**  
MATERIAL QUANTITY: **800** MATERIAL UNITS: **SF**  
DAMAGE QUANTITY: **0** DAMAGE UNITS: **SF**

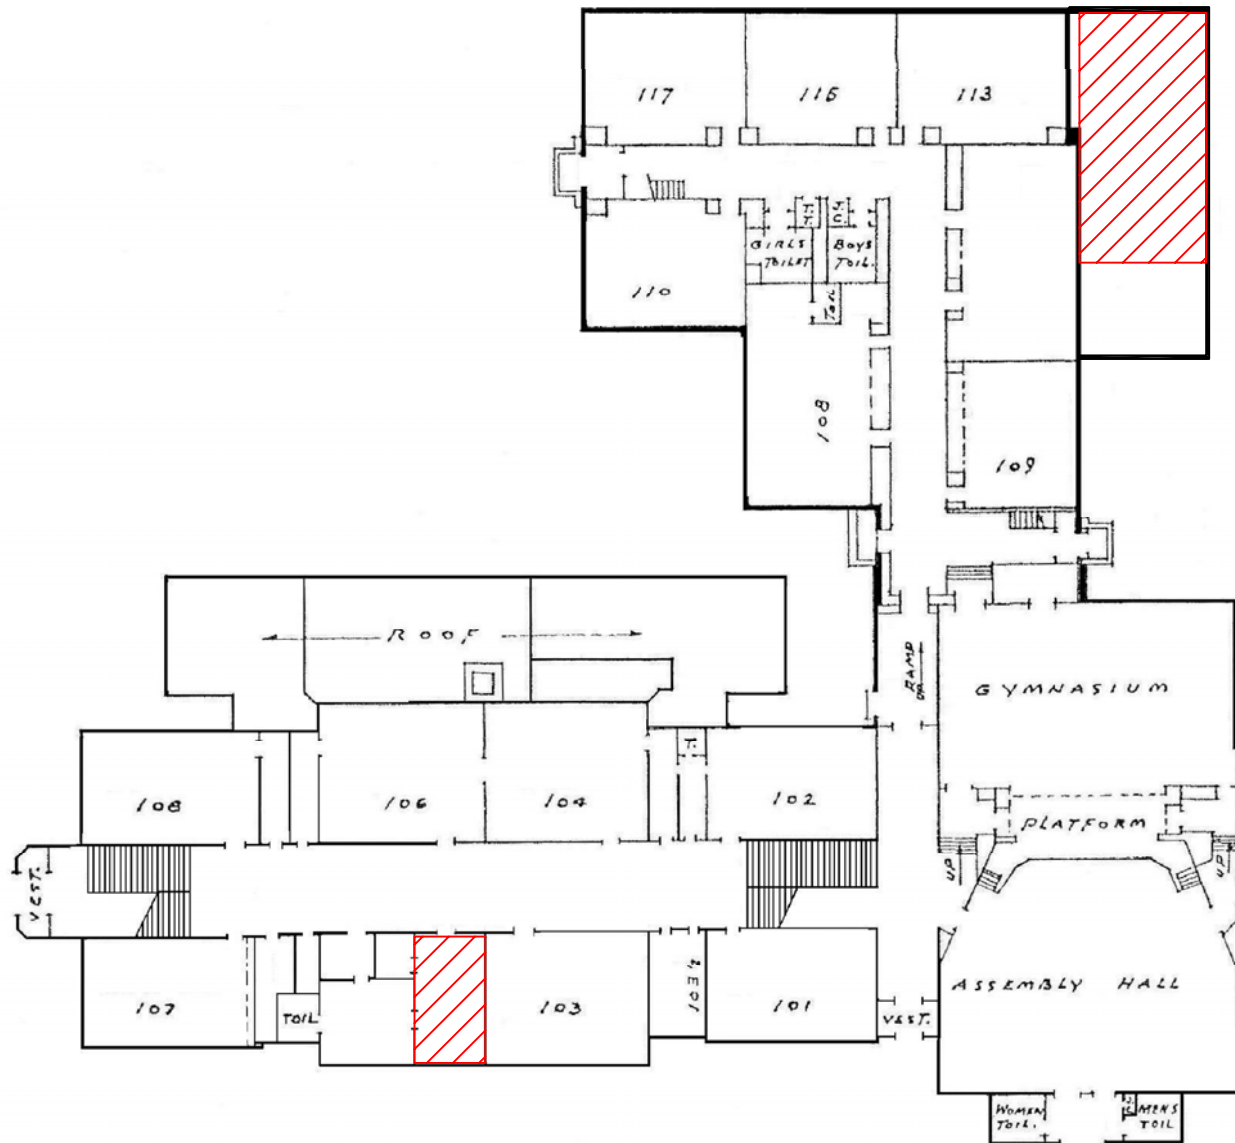
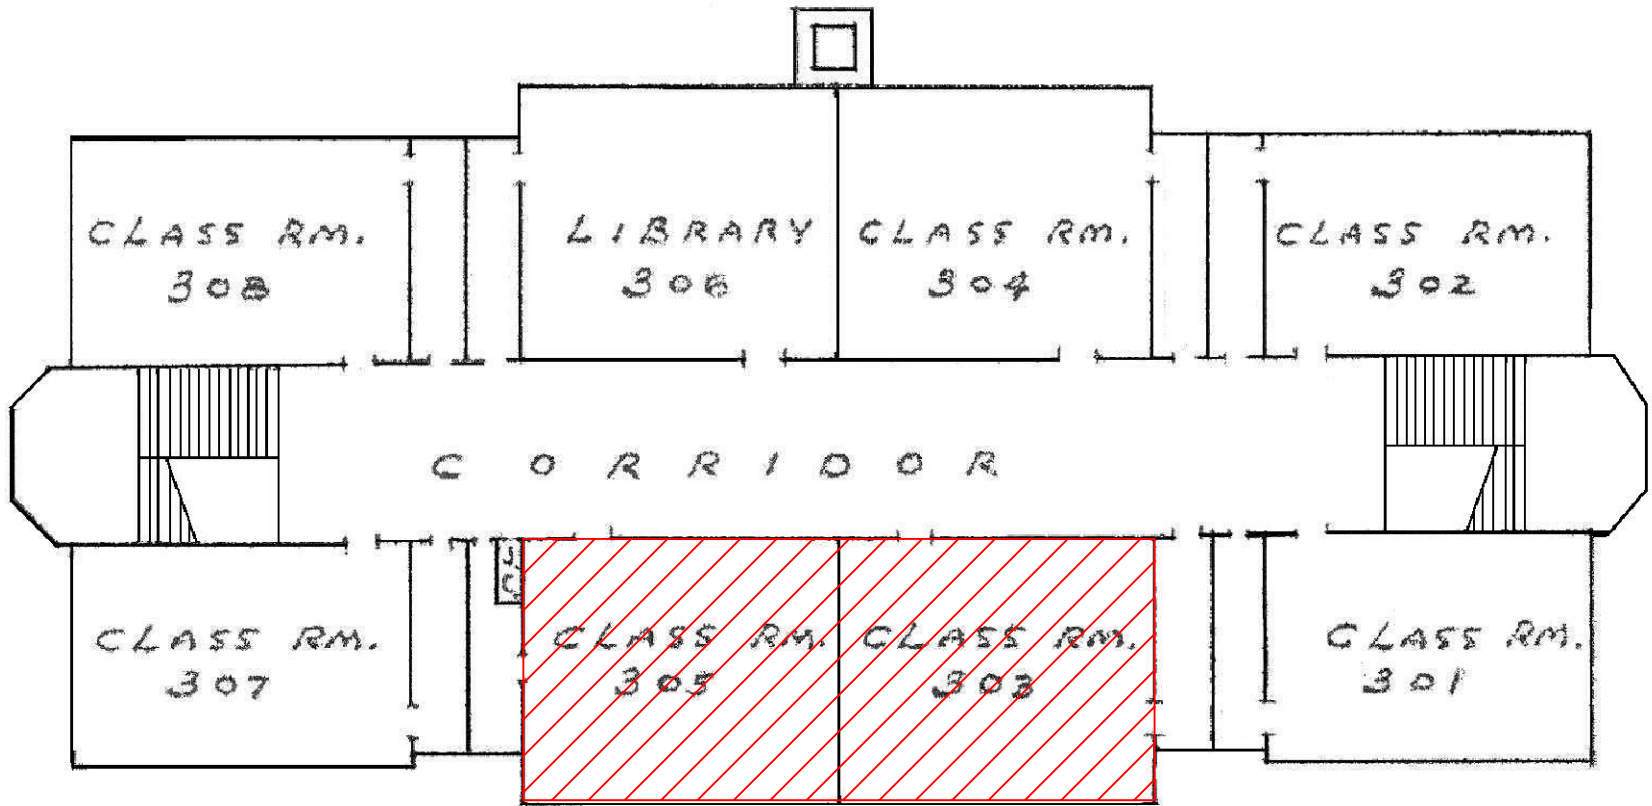
CCA PROJECT NUMBER  
A320130001-309  
DATE  
03/08/2013  
SHEET NUMBER  
**HA-CT2**

KCPSS 2011-2013 Three Year AHERA Region 533-Bass School/Bass School First Floor.dwg

**ASBESTOS REINSPECTION KEY NOTES:**

HA-CT2 2' x 4' Ceiling Tile Type 2

HOMOGENEOUS AREA: **CT2**  
MATERIAL DESCRIPTION: **2 X 4 Ceiling Tile**  
MATERIAL LOCATION: **Room 303, 305, Art Room, Principal Office, Lunchroom**  
MATERIAL QUANTITY: **2730**      MATERIAL UNITS: **SF**  
DAMAGE QUANTITY: **0**      DAMAGE UNITS: **SF**
