ILLINOIS DEPARTMENT OF PUBLIC HEALTH  
AHERA THREE YEAR REINSPECTION  
ASBESTOS ABATEMENT PROGRAM  
SCHOOL INFORMATION FORM

NAME OF SCHOOL DISTRICT: CHICAGO SCHOOL DIST 299  
SCHOOL ID NUMBER: 14-016-2990-2286  
SCHOOL NAME: Jefferson School  
ADDRESS OF SCHOOL: 1522 W. Fillmore  
CITY: Chicago, IL, 60607

DATE REINSPECTION COMPLETED: 4/8/2013 ENROLLMENT 0  
IDPH INSPECTOR LICENSE NUMBER: 100-11460  
IDPH LICENSED INSPECTOR NAME (Please Print): Marcus Tsilimos  
IDPH MP LICENSE NUMBER: 100-03613  
IDPH LICENSED MANAGEMENT PLANNER NAME (Please Print): Daniel Juneau

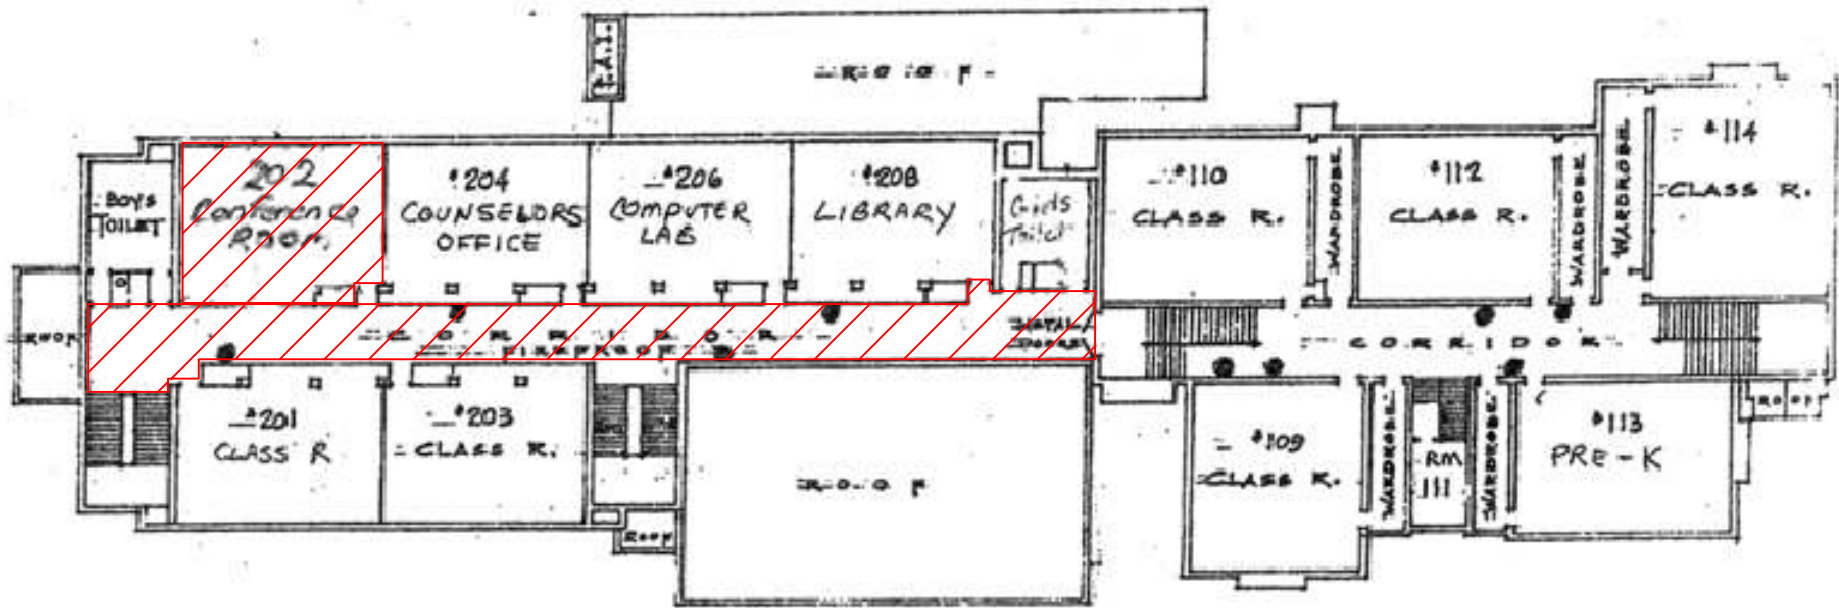
SECOND FLOOR PLAN  
SCALE: 1/32" = 1'-0"

CCA PROJECT NUMBER  
A320130001-53  
DATE  
March 15, 2013  
SHEET NUMBER  
**HA-79**

HOMOGENEOUS AREA: **79**  
MATERIAL DESCRIPTION: **12" X 12" lite Beige VFT Mastic**  
MATERIAL LOCATION: **Classroom 104 and Corridor**  
MATERIAL QUANTITY: **1600**      MATERIAL UNITS: **SF**  
MATERIAL CATEGORY: **MISC**      FRIABLE: **No**  
ASBESTOS TYPE: **Assumed**  
DISTURBANCE POTENTIAL: **LOW**      CONDITION:  
AHERA DAMAGE CATEGORY: **6 ACBM with the potential for damage**  
ACCESSIBILITY: **Not Reachable**      DAMAGE REASON:  
DAMAGE QUANTITY: **0**      DAMAGE REASON:  
DAMAGE UNITS: **SF**  
COMMENTS:

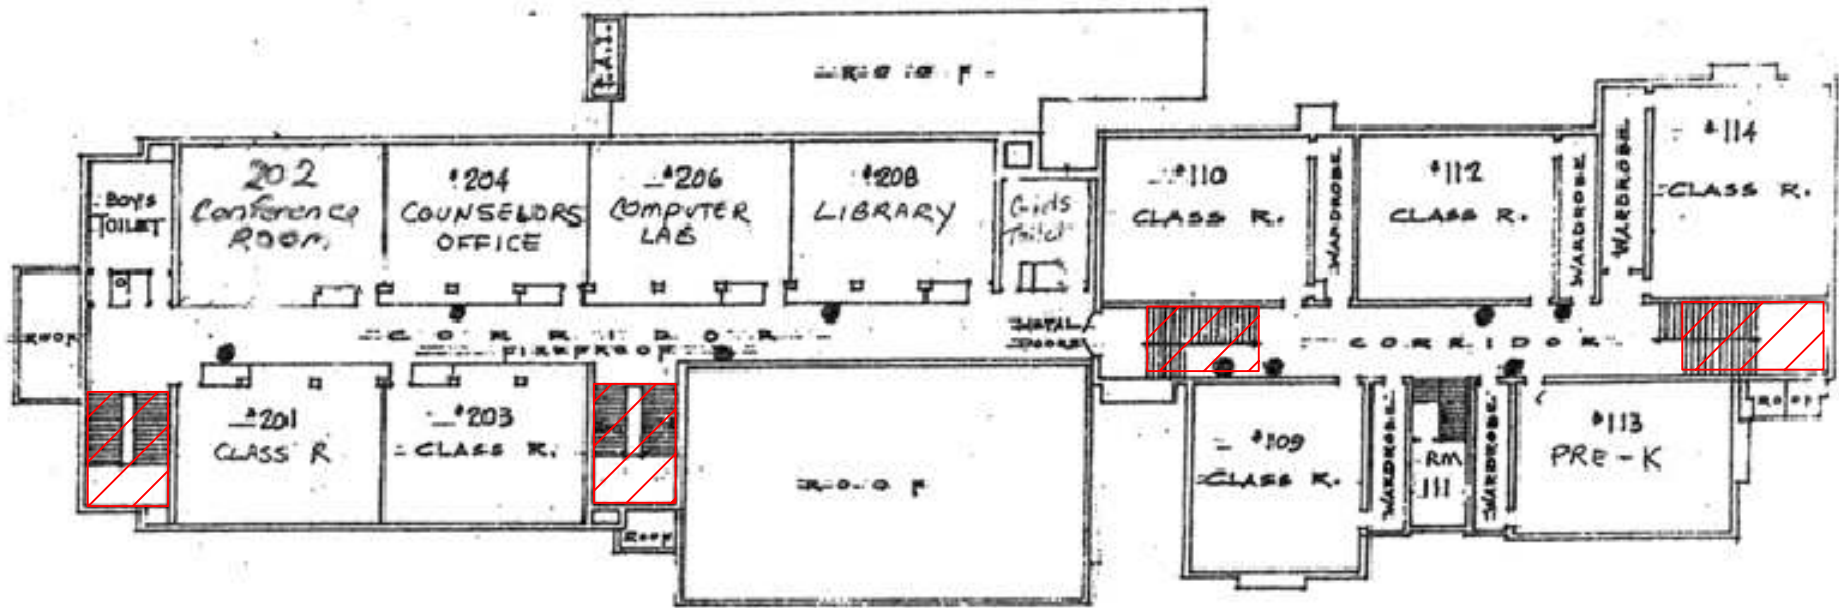
• SECOND FLOOR PLAN •  
 SCALE: 1/32" = 1'-0"

CCA PROJECT NUMBER  
 A320130001-53  
 DATE  
 March 15, 2013  
 SHEET NUMBER  
**HA-74**

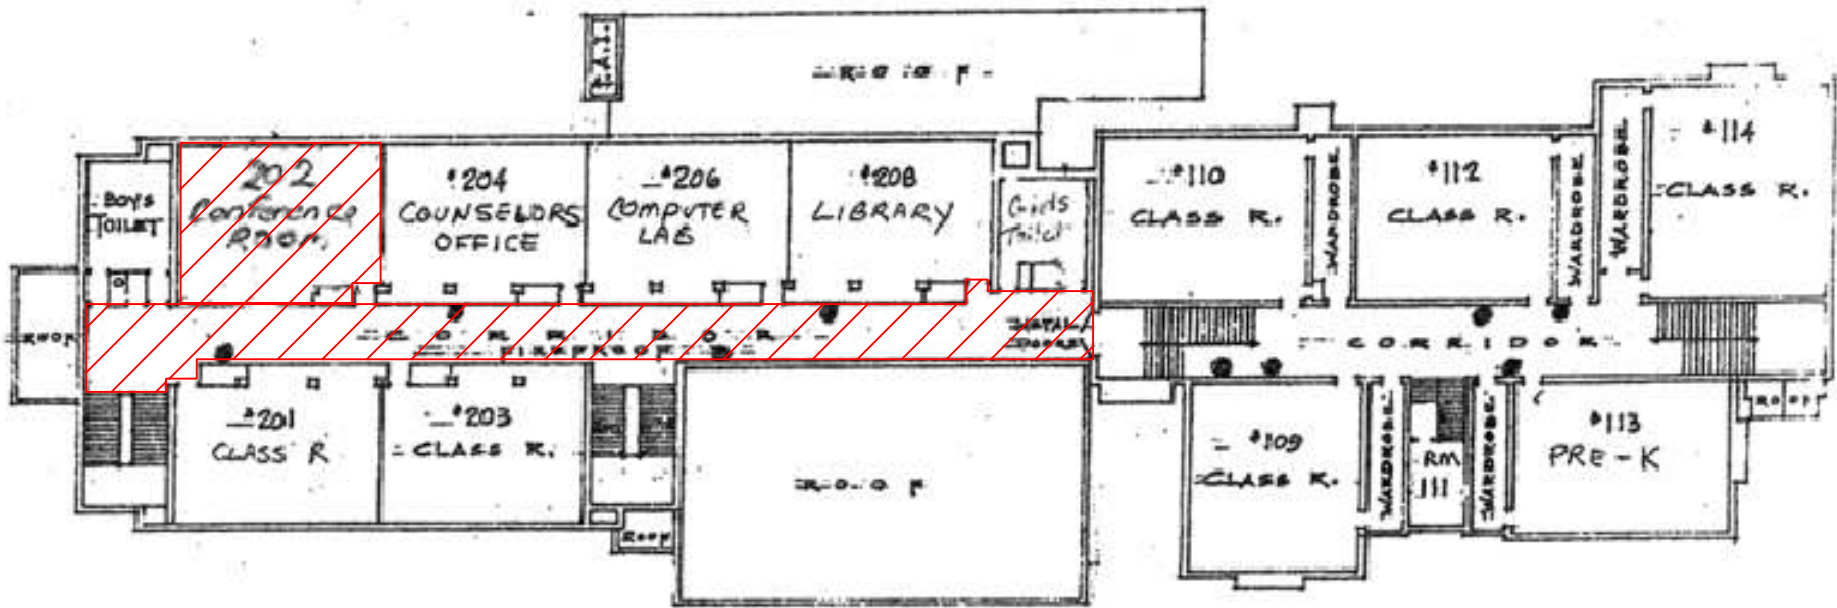
SECOND FLOOR PLAN  
SCALE: 1/32" = 1'-0"

**CARNOW CONIBEAR**  
CCA PROJECT NUMBER  
A320130001-53  
DATE  
March 15, 2013  
SHEET NUMBER  
**HA-78**
