**ILLINOIS DEPARTMENT OF PUBLIC HEALTH  
AHERA THREE YEAR REINSPECTION  
ASBESTOS ABATEMENT PROGRAM  
SCHOOL INFORMATION FORM**

NAME OF SCHOOL DISTRICT: CHICAGO SCHOOL DIST 299  
SCHOOL ID NUMBER: 14-016-2990-2252  
SCHOOL NAME: Hayt School  
ADDRESS OF SCHOOL: 1518 W Granville Avenue  
CITY: Chicago, IL, 60660

**THREE-YEAR REINSPECTION**

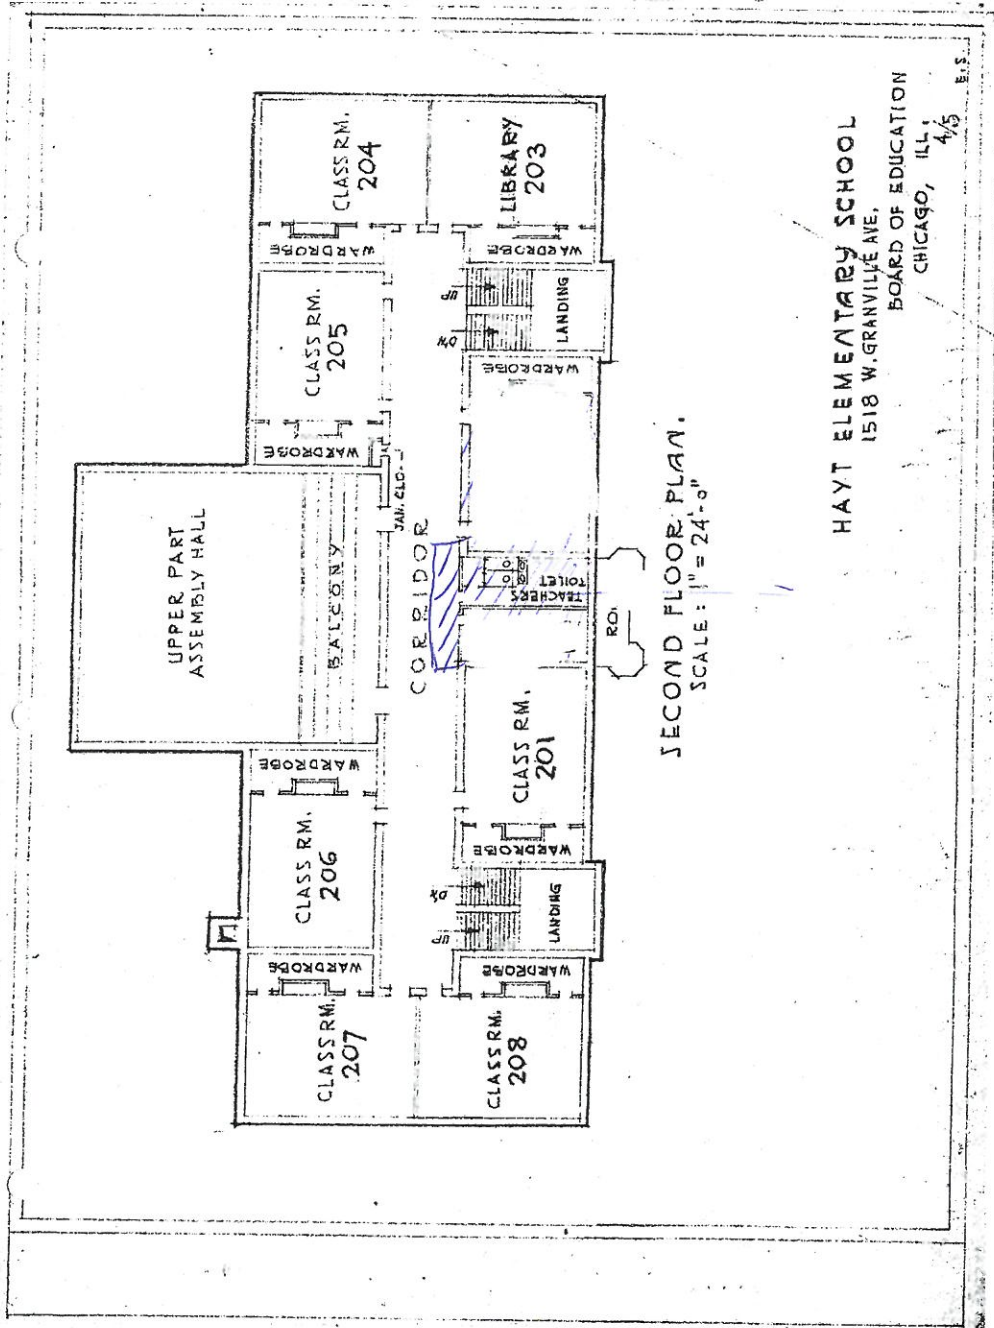
SECOND FLOOR PLAN.  
SCALE: 1" = 24'-0"

HA 75 375A

NET 10X8' Rod with Plastic

HOMOGENEOUS AREA: **75A**  
MATERIAL DESCRIPTION: **12"x12" red VFT MASTIC**  
MATERIAL LOCATION: **teacher's lounge 2nd fl, auditorium, rm 223**  
MATERIAL QUANTITY: **700**    MATERIAL UNITS: **SF**  
MATERIAL CATEGORY: **MISC**    FRIABLE: **No**  
ASBESTOS TYPE: **Assumed**  
DISTURBANCE POTENTIAL: **LOW**    CONDITION:  
AHERA DAMAGE CATEGORY: **6 ACBM with the potential for damage**  
ACCESSIBILITY: **Barely Reachable**    DAMAGE REASON:  
DAMAGE QUANTITY: **0**    DAMAGE REASON:  
DAMAGE UNITS: **SF**  
COMMENTS:

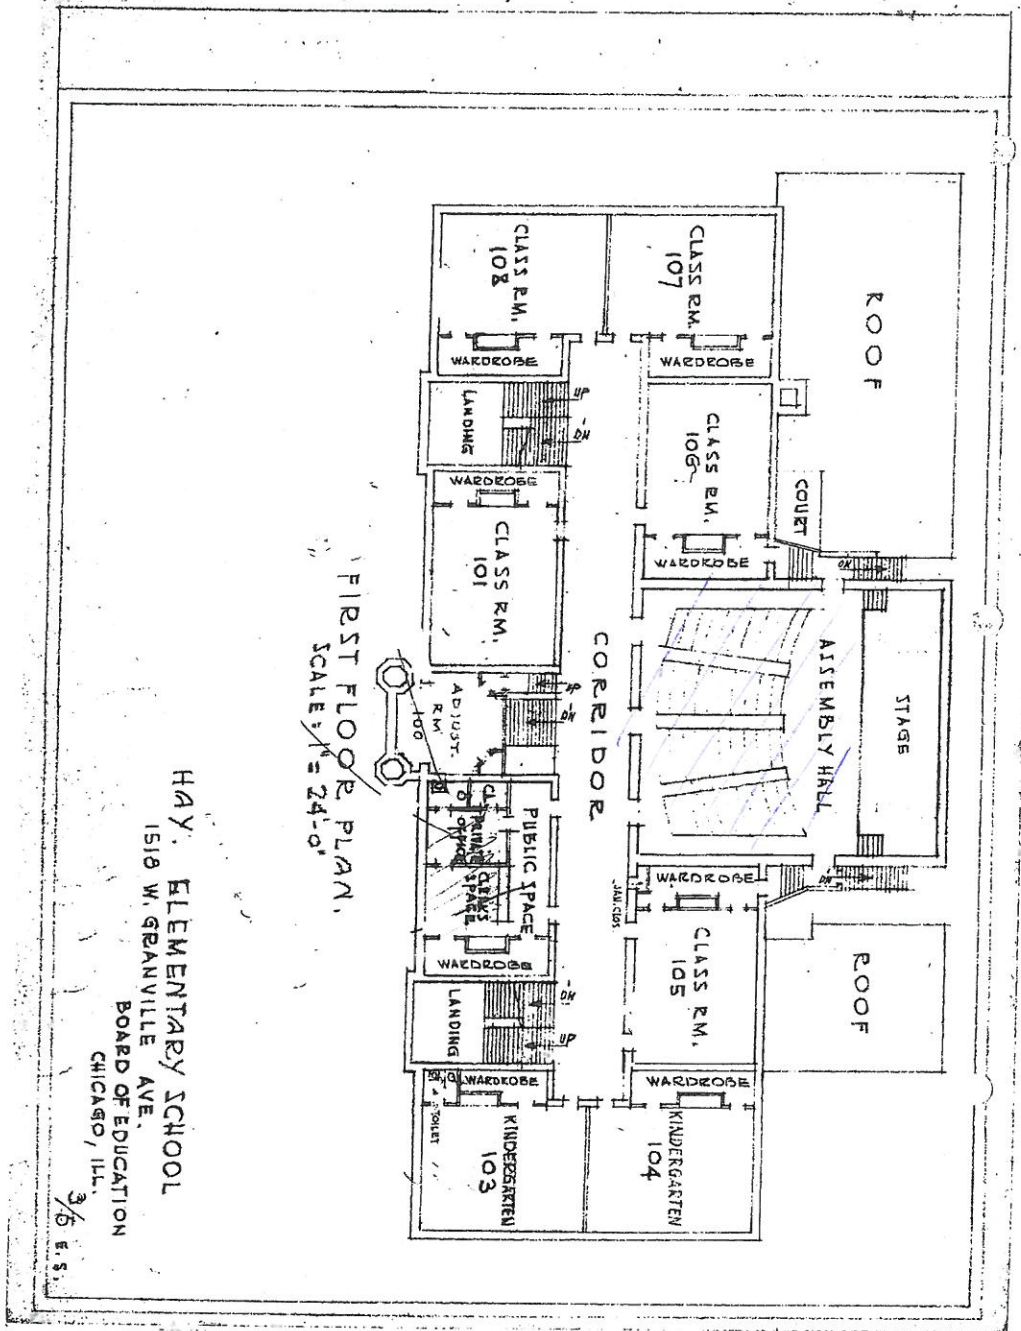
FIRST FLOOR PLAN,  
SCALE 1/8" = 2'-0"

HA 053 95A  
not in use, see with architect

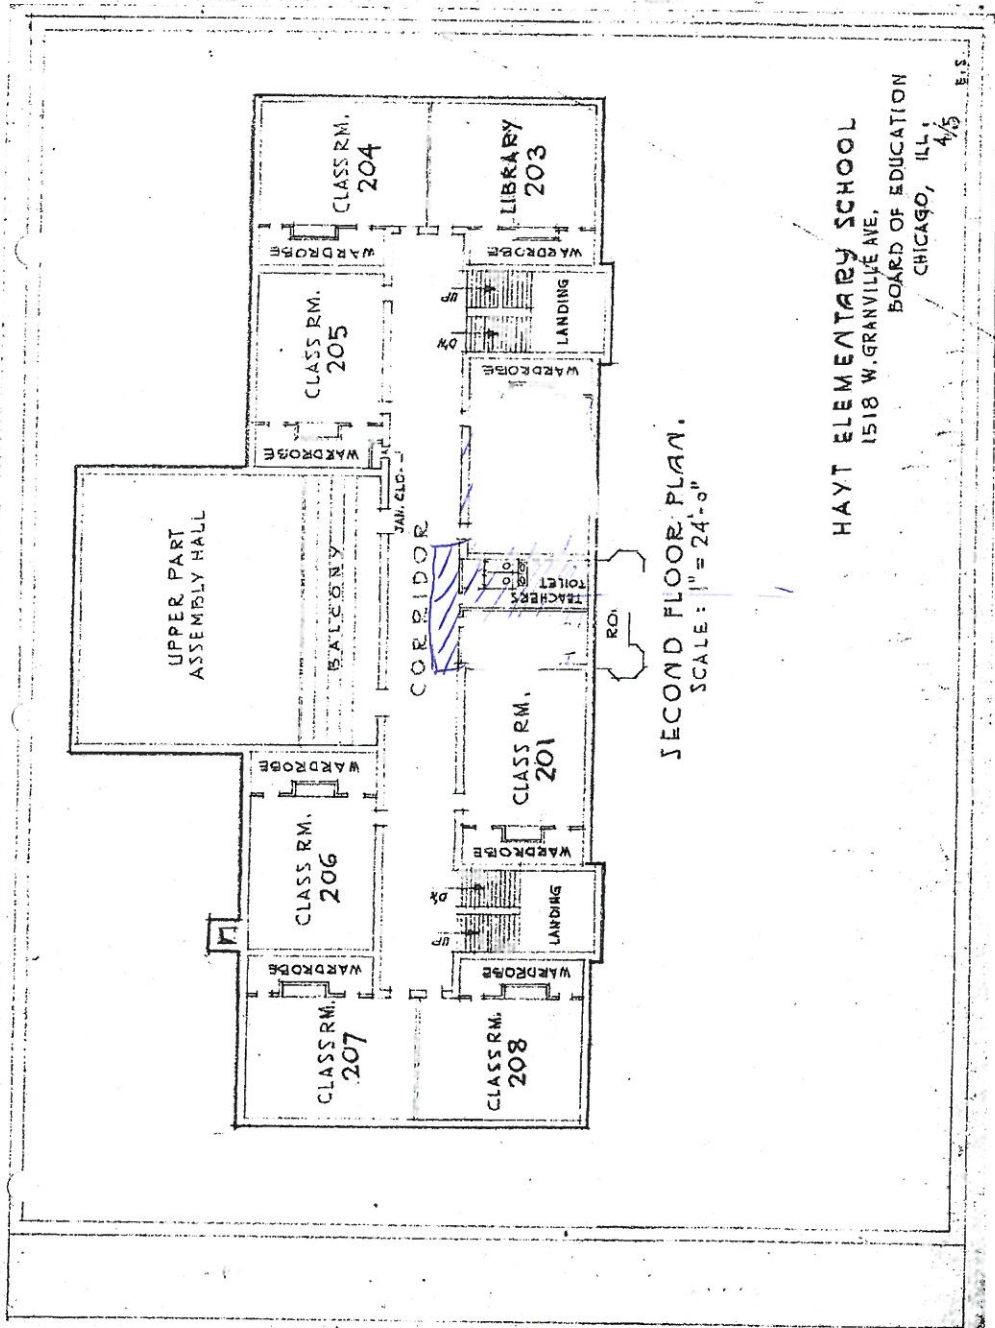
HA 75 375A

NET 10X9' Rod with Plastic

HOMOGENEOUS AREA: **74A**  
MATERIAL DESCRIPTION: **12"x12" gold VFT MASTIC**  
MATERIAL LOCATION: **room 002, auditorium, teacher's lounge 2nd fl, room 223, 3rd floor elevator lobby**  
MATERIAL QUANTITY: **2000** MATERIAL UNITS: **SF**  
MATERIAL CATEGORY: **MISC** FRIABLE: **No**  
ASBESTOS TYPE: **Assumed**  
DISTURBANCE POTENTIAL: **LOW** CONDITION:  
AHERA DAMAGE CATEGORY: **6 ACBM with the potential for damage**  
ACCESSIBILITY: **Barely Reachable** DAMAGE REASON:  
DAMAGE QUANTITY: **0** DAMAGE REASON:  
DAMAGE UNITS: **SF**  
COMMENTS:

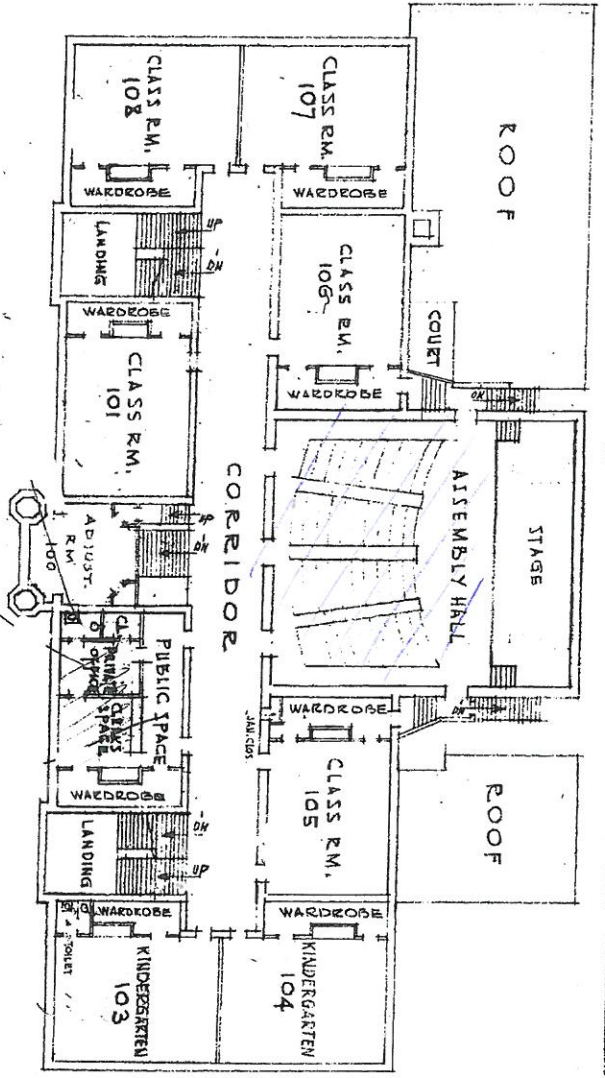
FIRST FLOOR PLAN,  
SCALE 1/8" = 2'-0"

HA 053 95A  
not in use, see with architect

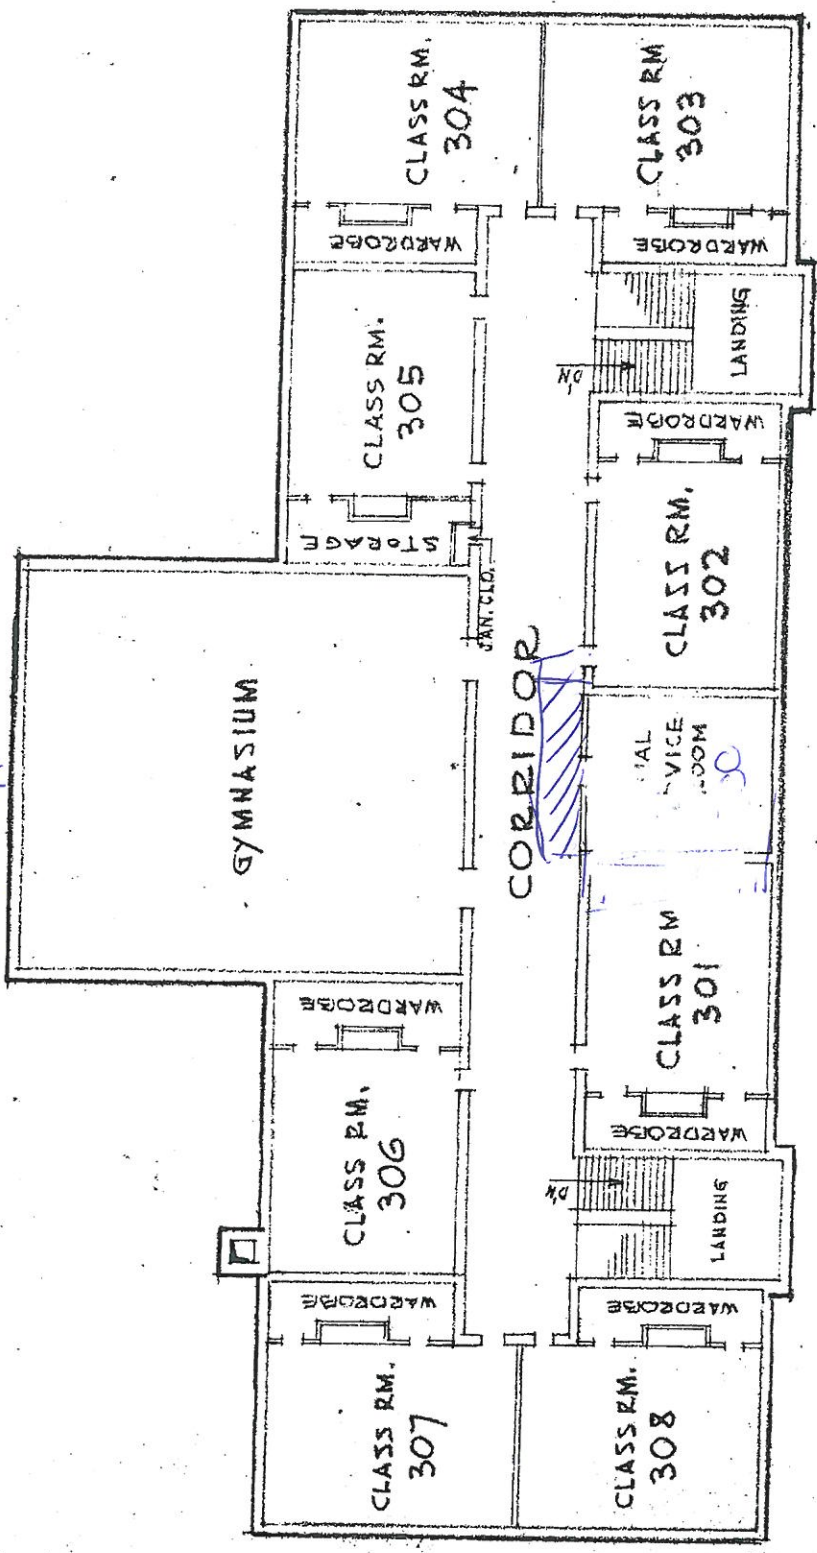
THIRD FLOOR PLAN.  
SCALE: 1" = 24'-0"

11-11-1918 yellow in the sketch

H.A. THANA

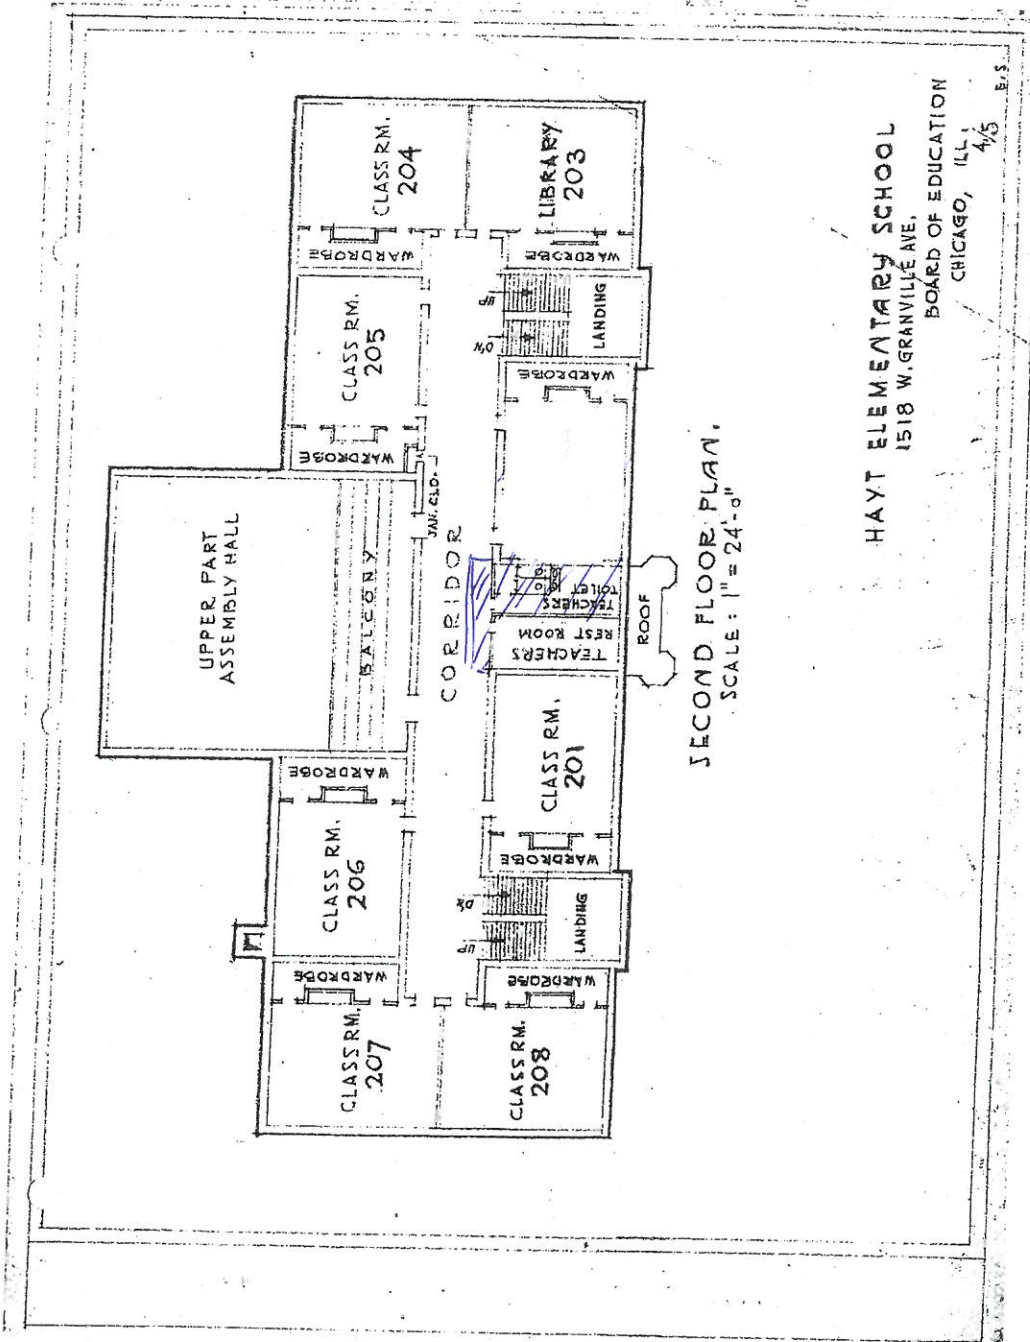
SECOND FLOOR PLAN.  
 SCALE: 1" = 24'-0"

FLA 204 570A  
 12' x 19" 60' w/ finish

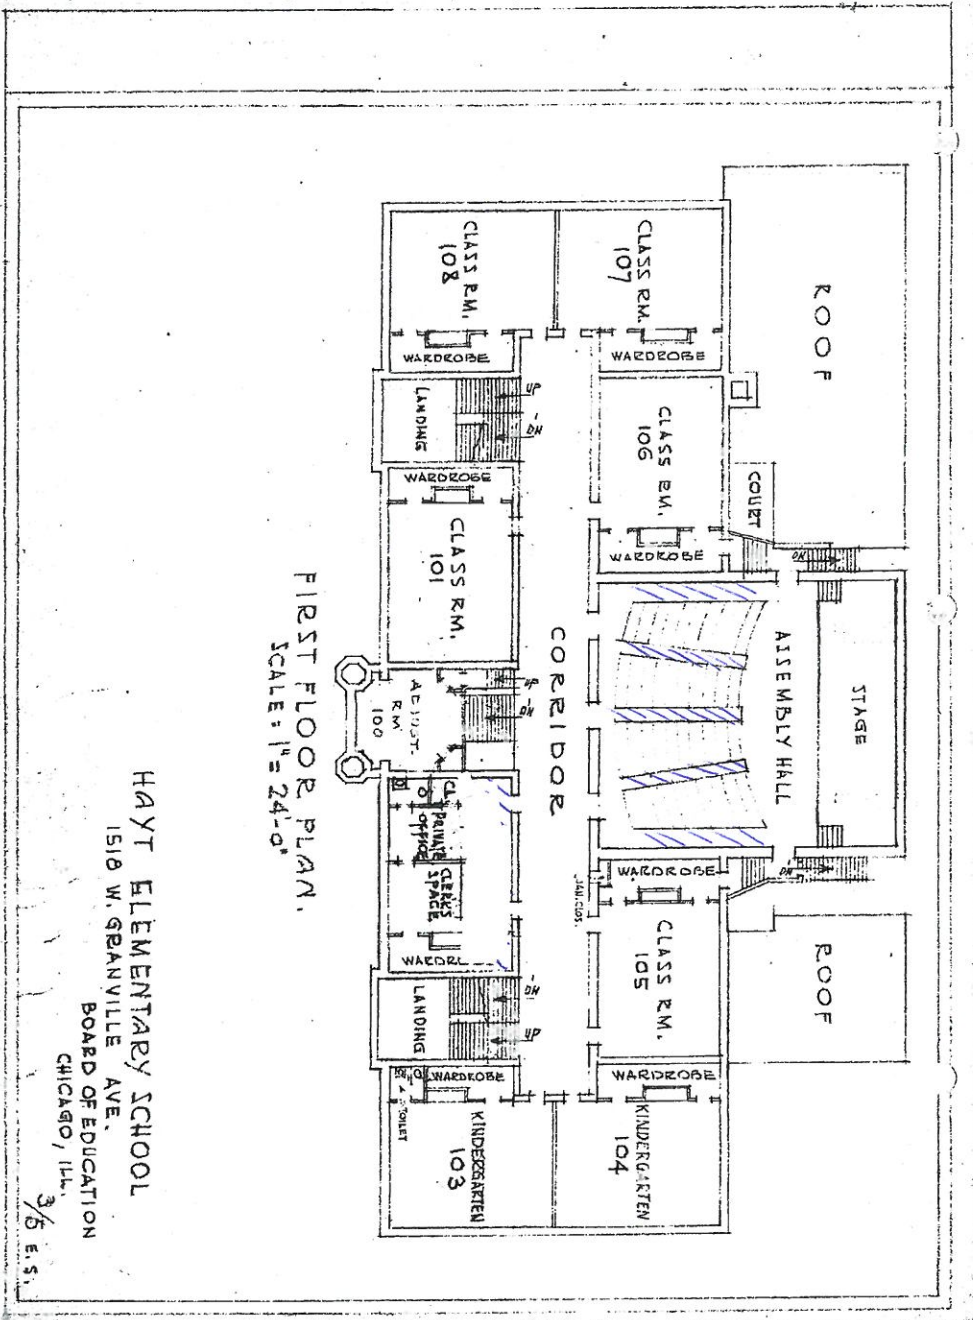
FIRST FLOOR PLAN.  
SCALE: 1" = 24'-0"

1112 92 372A  
- VET 12x12 TARM/W/ GALE JOIS 3/5/51 C

HOMOGENEOUS AREA: **72**  
MATERIAL DESCRIPTION: **12"x12" tan w/ black dots VFT**  
MATERIAL LOCATION: **auditorium aisles**  
MATERIAL QUANTITY: **400**    MATERIAL UNITS: **SF**  
MATERIAL CATEGORY: **MISC**    FRIABLE: **No**  
ASBESTOS TYPE: **Assumed**  
DISTURBANCE POTENTIAL: **LOW**    CONDITION:  
AHERA DAMAGE CATEGORY: **6 ACBM with the potential for damage**  
ACCESSIBILITY: **Within Reach**    DAMAGE REASON:  
DAMAGE QUANTITY: **0**    DAMAGE REASON:  
DAMAGE UNITS: **SF**  
COMMENTS:

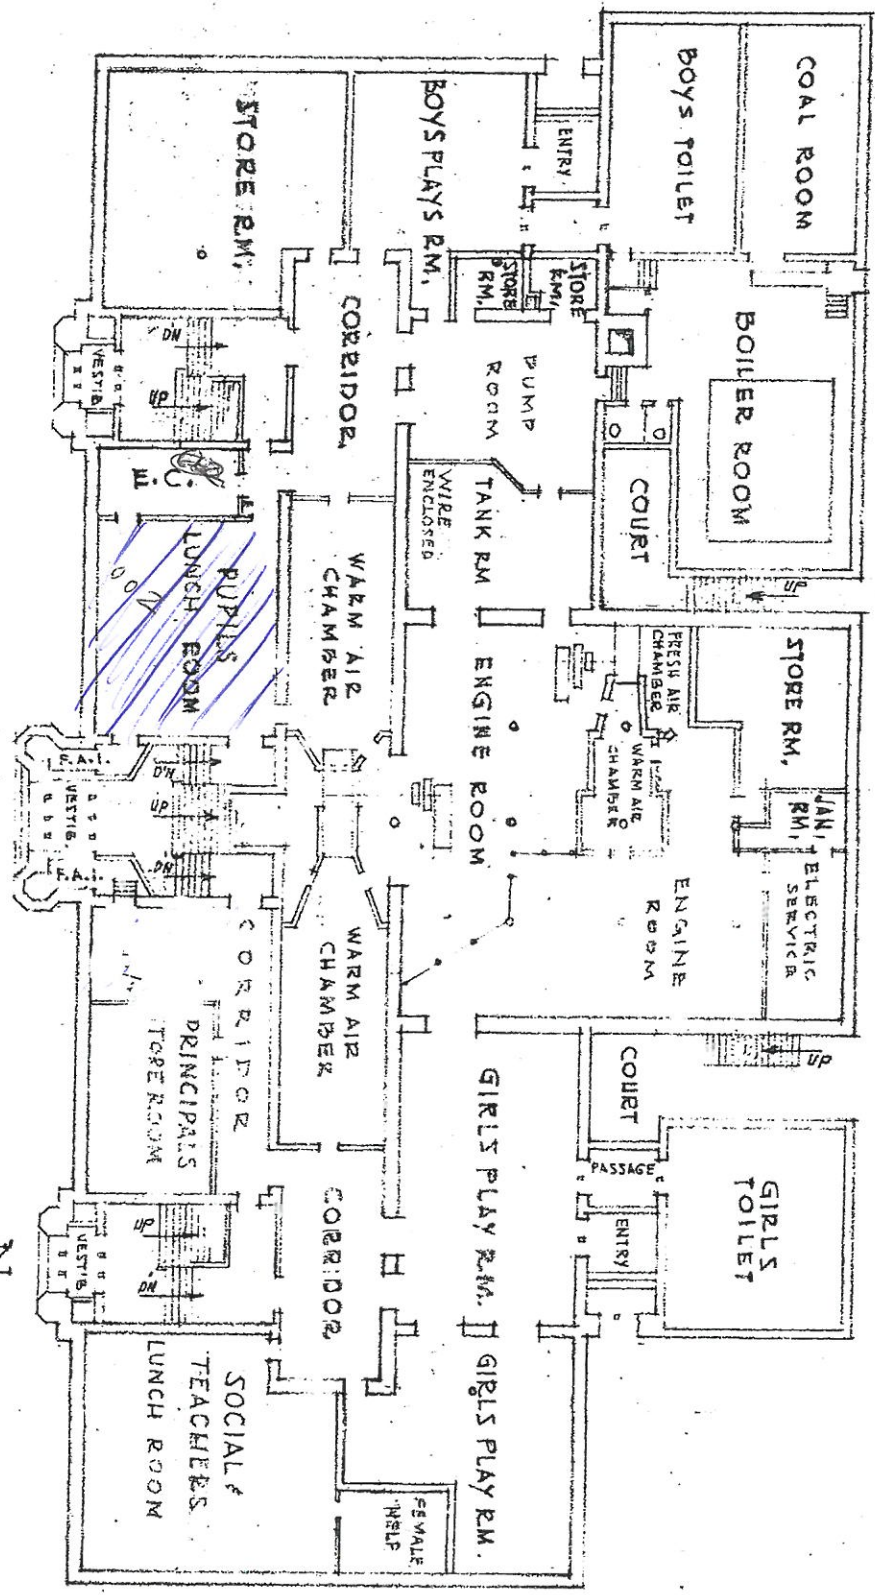
BASEMENT PLAN  
SCALE: 1" = 24'-0"

HA 94 374A  
12' x 12' yellow with Meshic

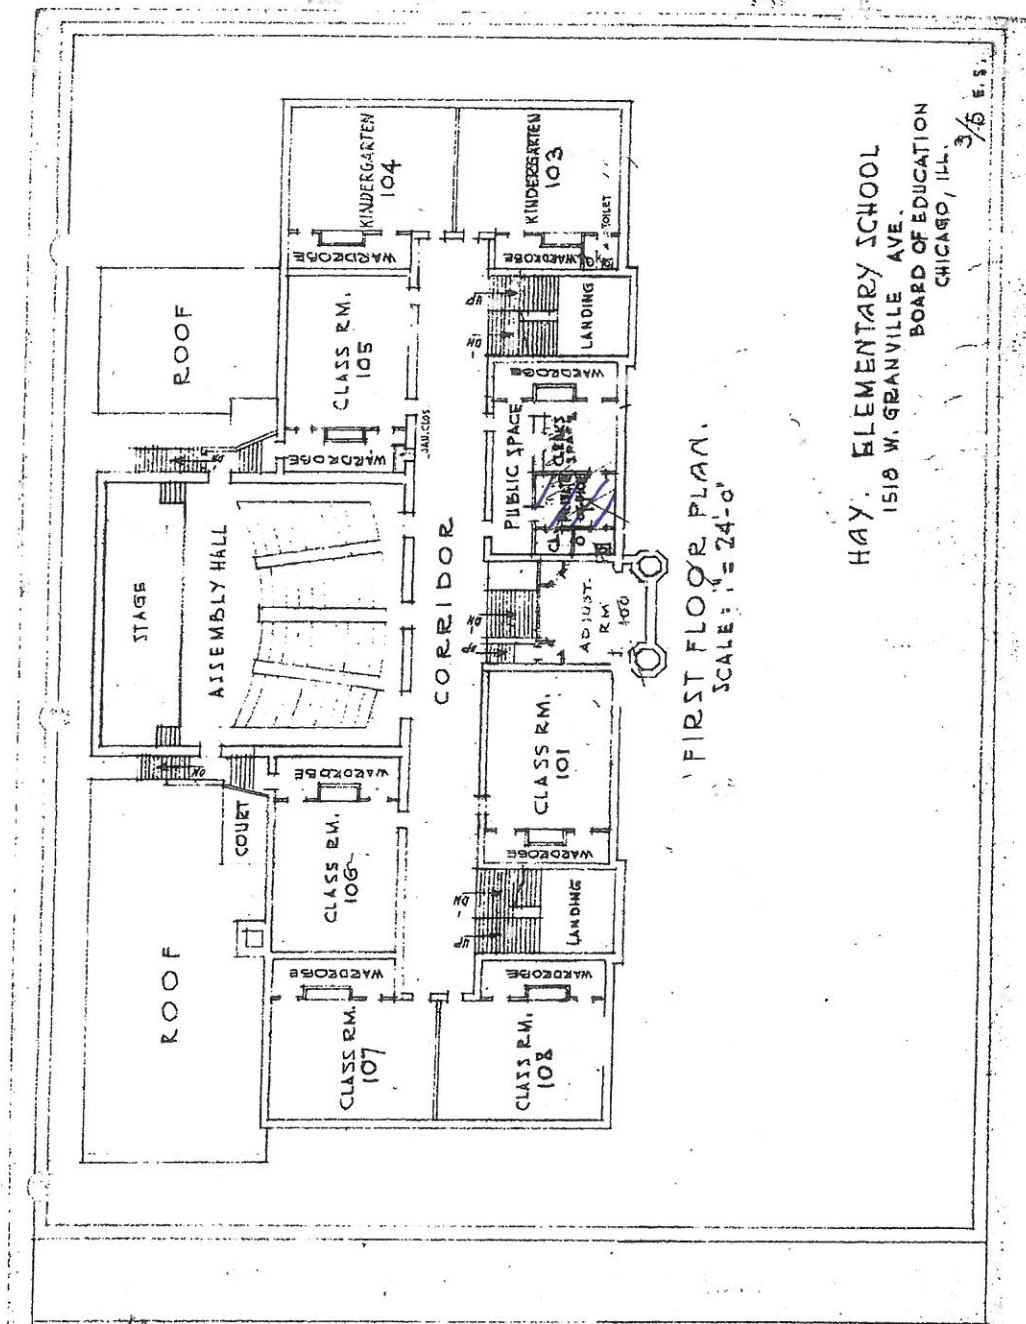
FIRST FLOOR PLAN.  
SCALE: 1" = 24'-0"

HA-15  
-Carpet Marked
