ILLINOIS DEPARTMENT OF PUBLIC HEALTH
AHERA THREE YEAR REINSPECTION
ASBESTOS ABATEMENT PROGRAM
SCHOOL INFORMATION FORM

NAME OF SCHOOL DISTRICT: CHICAGO SCHOOL DIST 299
SCHOOL ID NUMBER: 14-016-2990-2783
SCHOOL NAME: Cardenas School
ADDRESS OF SCHOOL: 2345 S. Millard
CITY: Chicago, IL, 60623

DATE REINSPECTION COMPLETED: 4/17/2013 ENROLLMENT 433
IDPH INSPECTOR LICENSE NUMBER: 100-07839
IDPH LICENSED INSPECTOR NAME (Please Print): Lisa Laney
IDPH MP LICENSE NUMBER: 100-05171
IDPH LICENSED MANAGEMENT PLANNER NAME (Please Print): Stephen Diblik

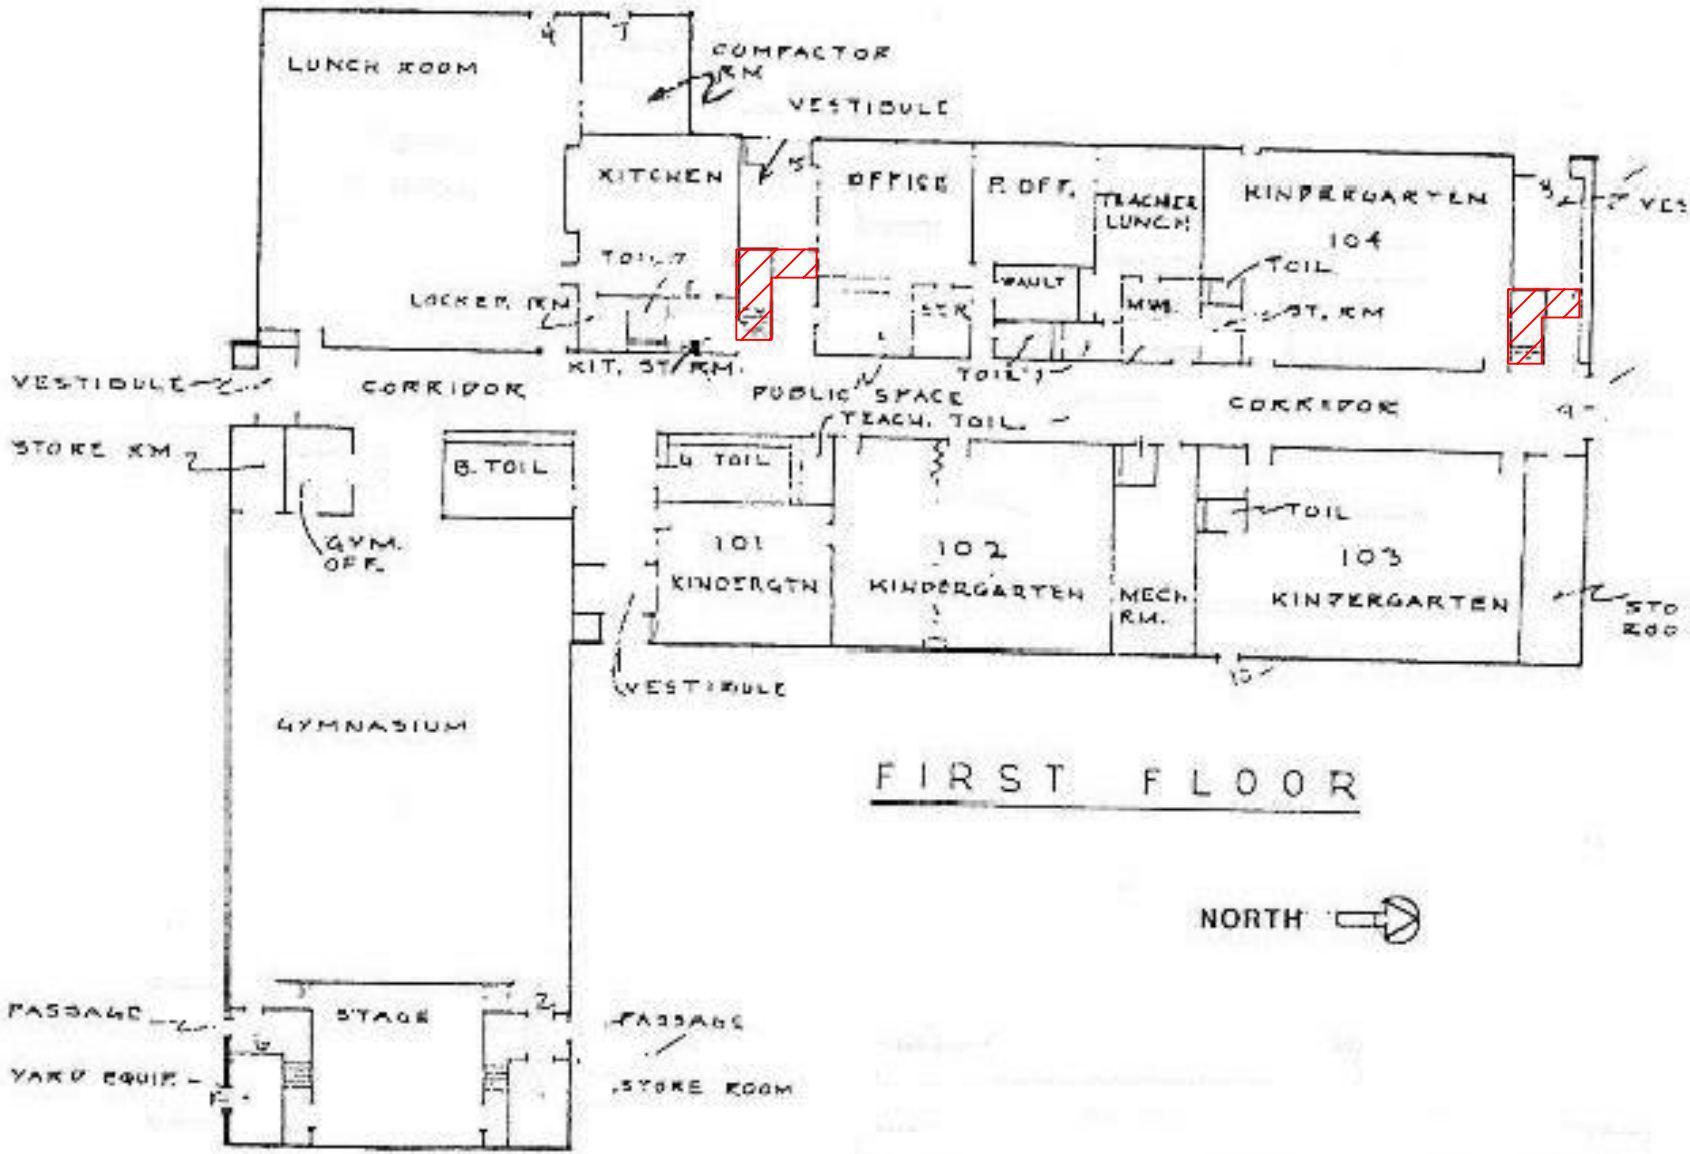
CCA PROJECT NUMBER
A320130001-153
DATE
3/25/2013
SHEET NUMBER
HA-022

FIRST FLOOR

K:\CPSS\2011\2013 Three Year AHERA Reinspection\Region 40\Cardenas School\Cardenas School First Floor.dwg

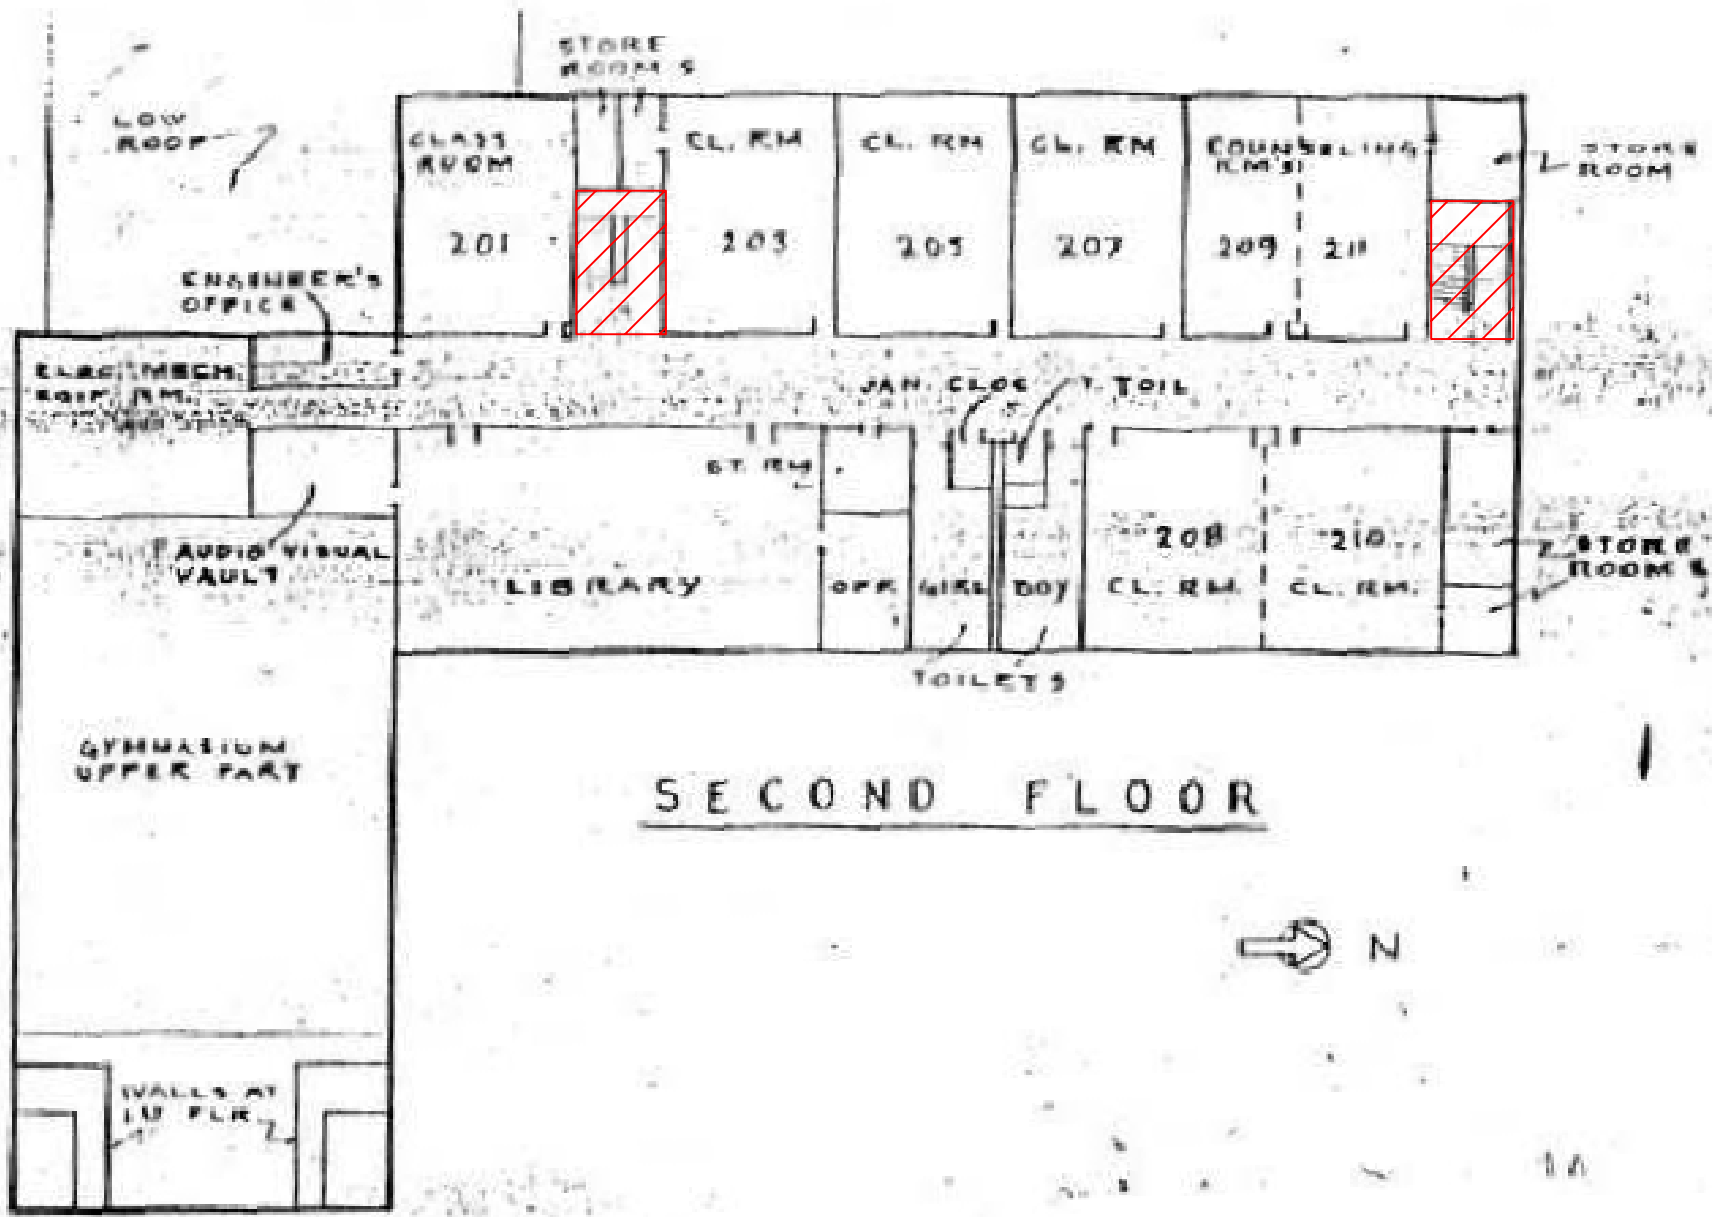
SECOND FLOOR

ASBESTOS REINSPECTION KEY NOTES:

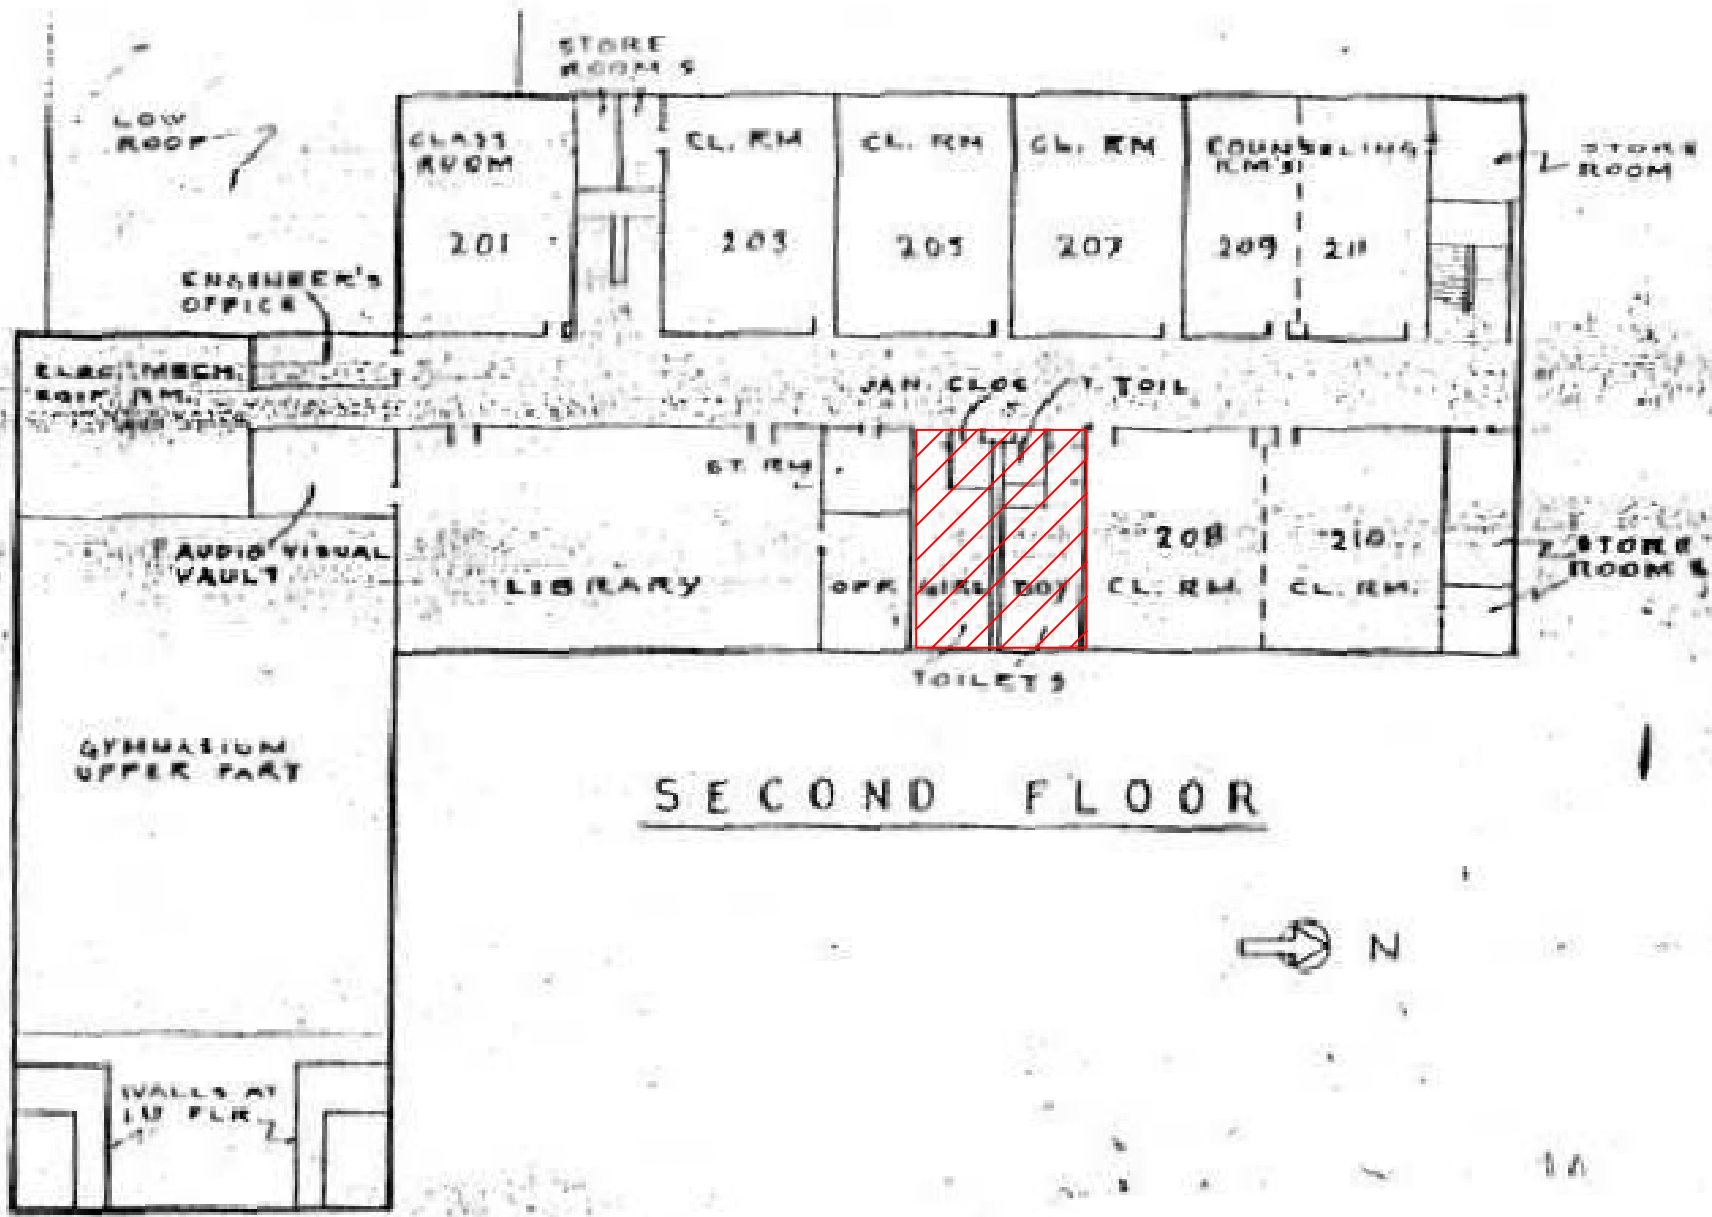
CCA PROJECT NUMBER
A320130001-153
DATE
3/25/2013
SHEET NUMBER
HA-021

SECOND FLOOR

ASBESTOS REINSPECTION KEY NOTES:

KCPSS 2011/2013 Three Year/Full Drawings/Reports - JGC/Cardeas School/Cardeas School Second Floor.dwg
