ILLINOIS DEPARTMENT OF PUBLIC HEALTH
AHERA THREE YEAR REINSPECTION
ASBESTOS ABATEMENT PROGRAM
SCHOOL INFORMATION FORM

NAME OF SCHOOL DISTRICT: CHICAGO SCHOOL DIST 299
SCHOOL ID NUMBER: 14-016-2990-
SCHOOL NAME: Ruiz School
ADDRESS OF SCHOOL: 2410 S.Leavitt
CITY: Chicago, IL, 60608

PLEASE COMPLETE THE FOLLOWING FOR YOUR THREE YEAR REINSPECTION:

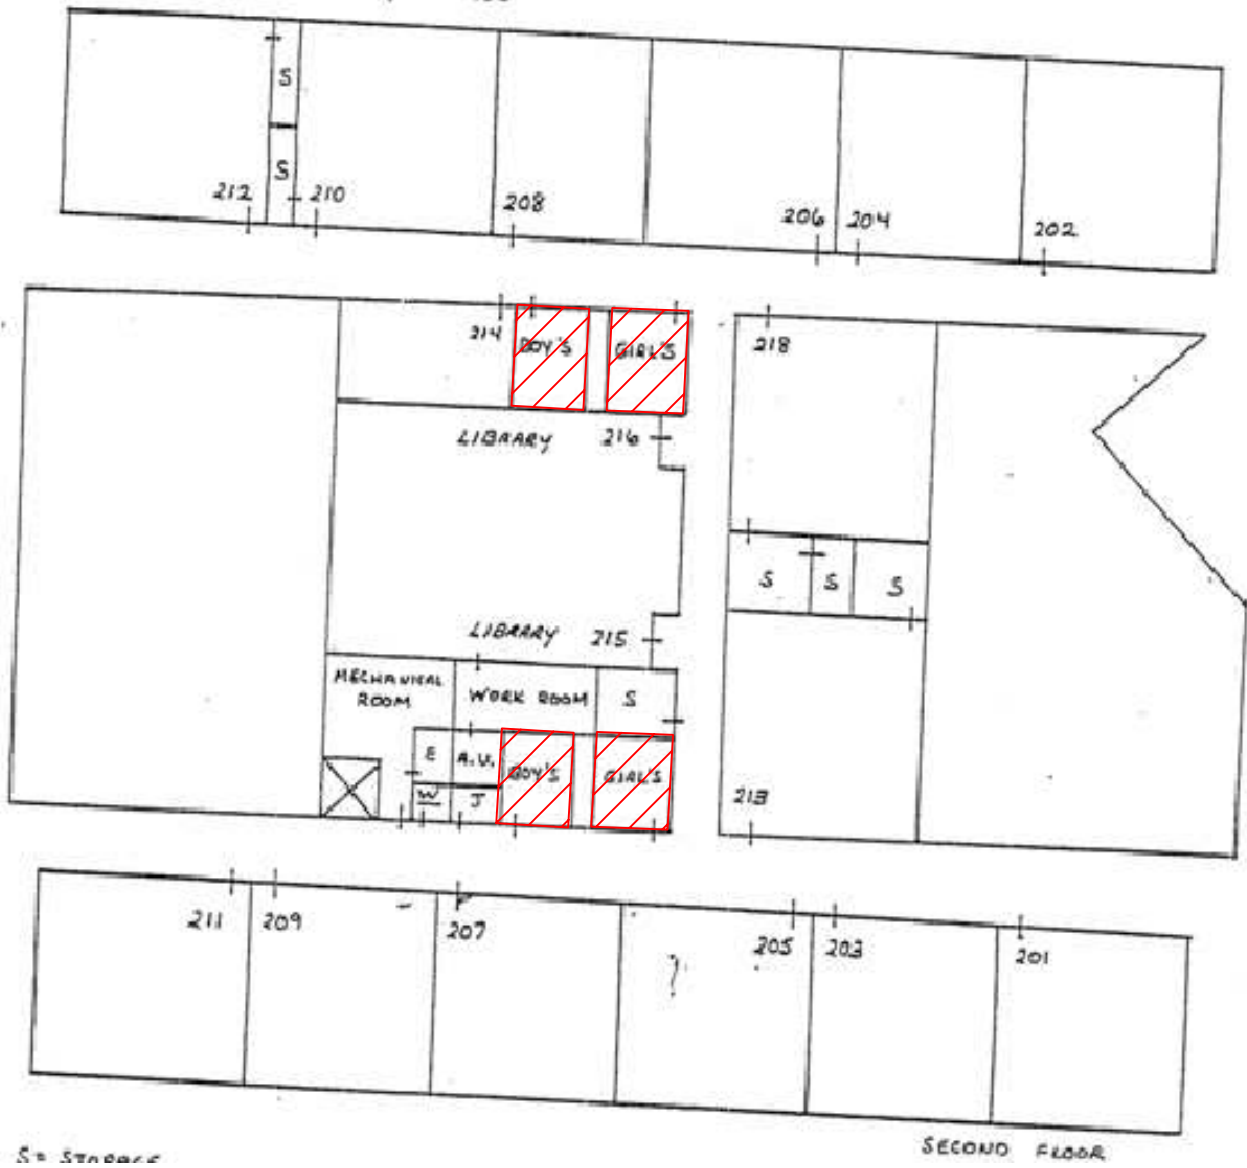
SECOND FLOOR

Key: HA-59 Tan Ceramic Grout
