ILLINOIS DEPARTMENT OF PUBLIC HEALTH
AHERA THREE YEAR REINSPECTION
ASBESTOS ABATEMENT PROGRAM
SCHOOL INFORMATION FORM

NAME OF SCHOOL DISTRICT: CHICAGO SCHOOL DIST 299
SCHOOL ID NUMBER: 14-016-2990-2417
SCHOOL NAME: Ray School
ADDRESS OF SCHOOL: 5631 S. Kimbark
CITY: Chicago, IL, 60637

Ray School Basement
 2013 ASBESTOS REINSPECTION

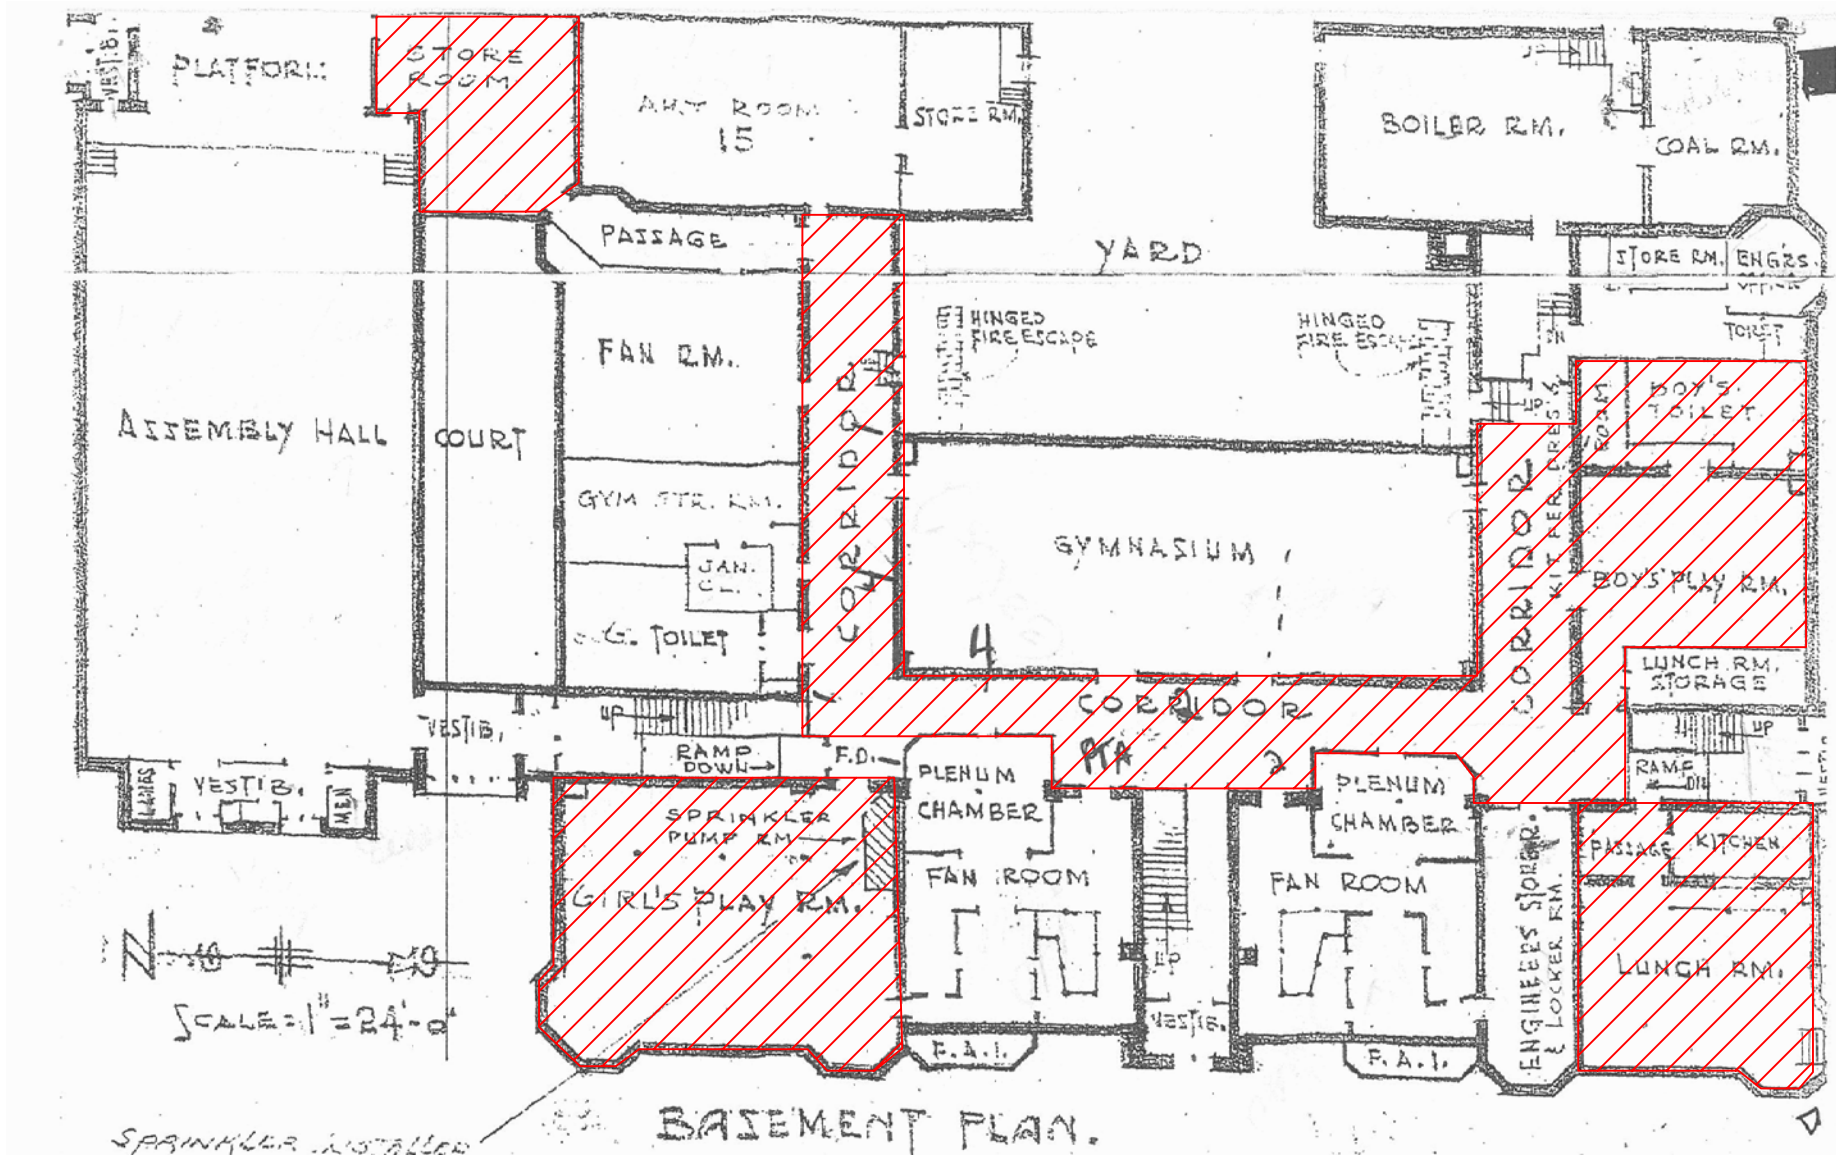
SHEET NUMBER
HA-22

KCPSS 2013/03/13 These Notes are to be used in conjunction with the drawings for the 2013 ASBESTOS REINSPECTION of the Ray School Basement.

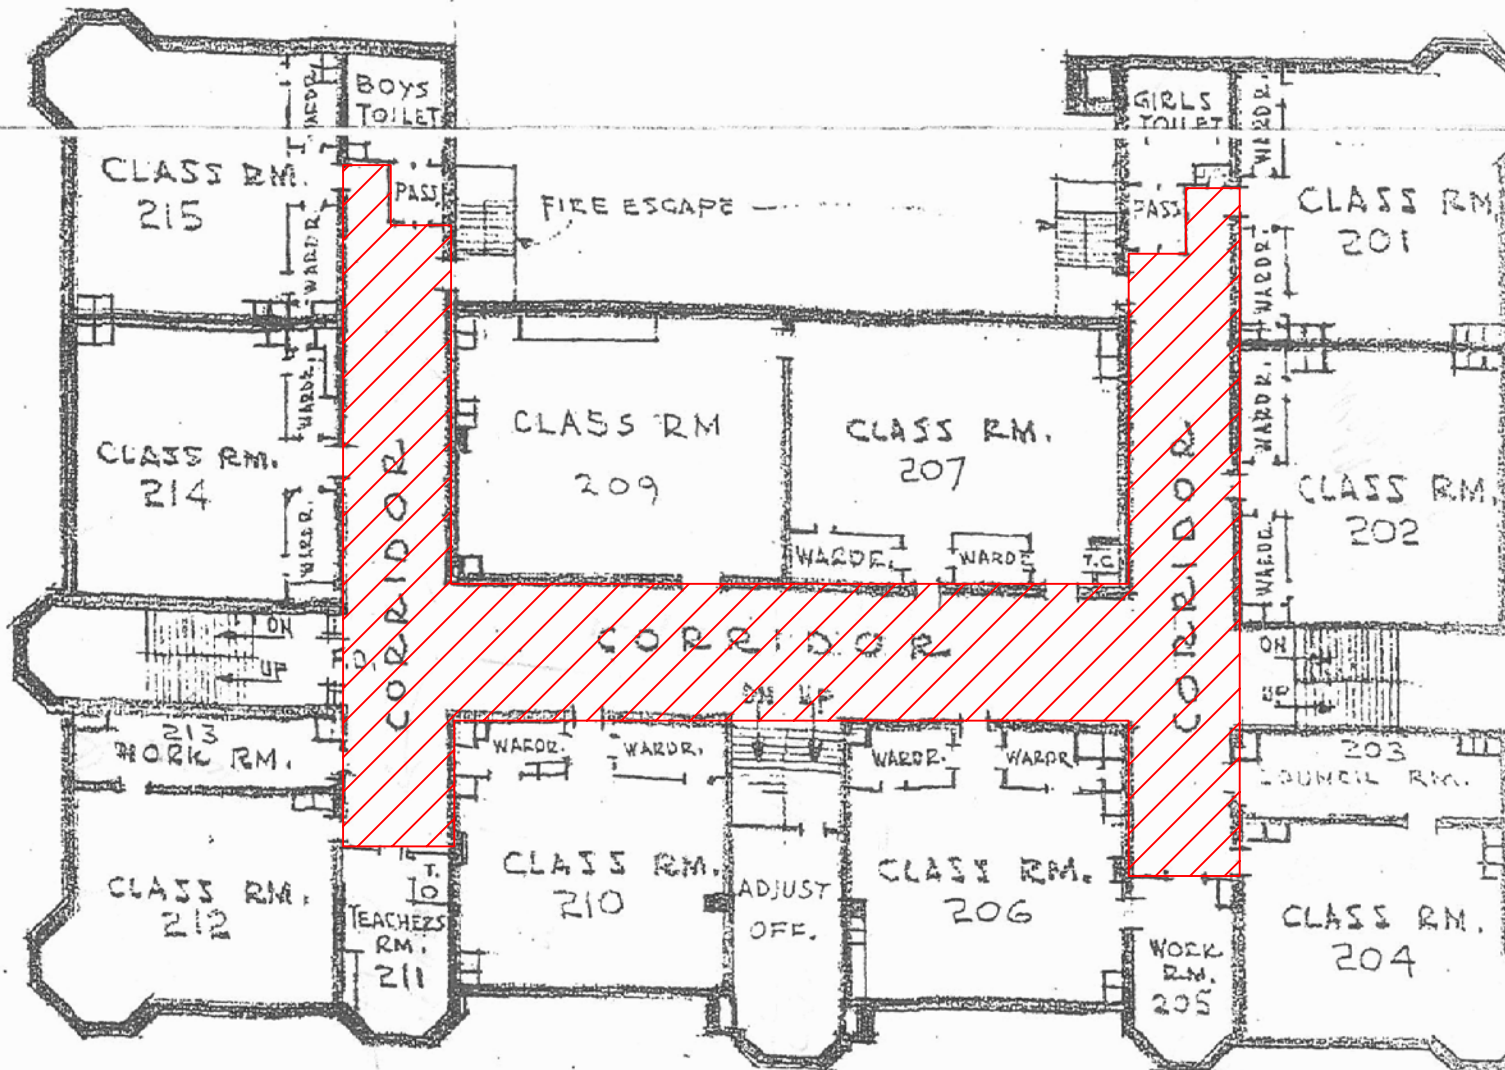
SHEET NUMBER
HA-22

SECOND FLOOR PLAN,
WILLIAM H. RAY SCHOOL

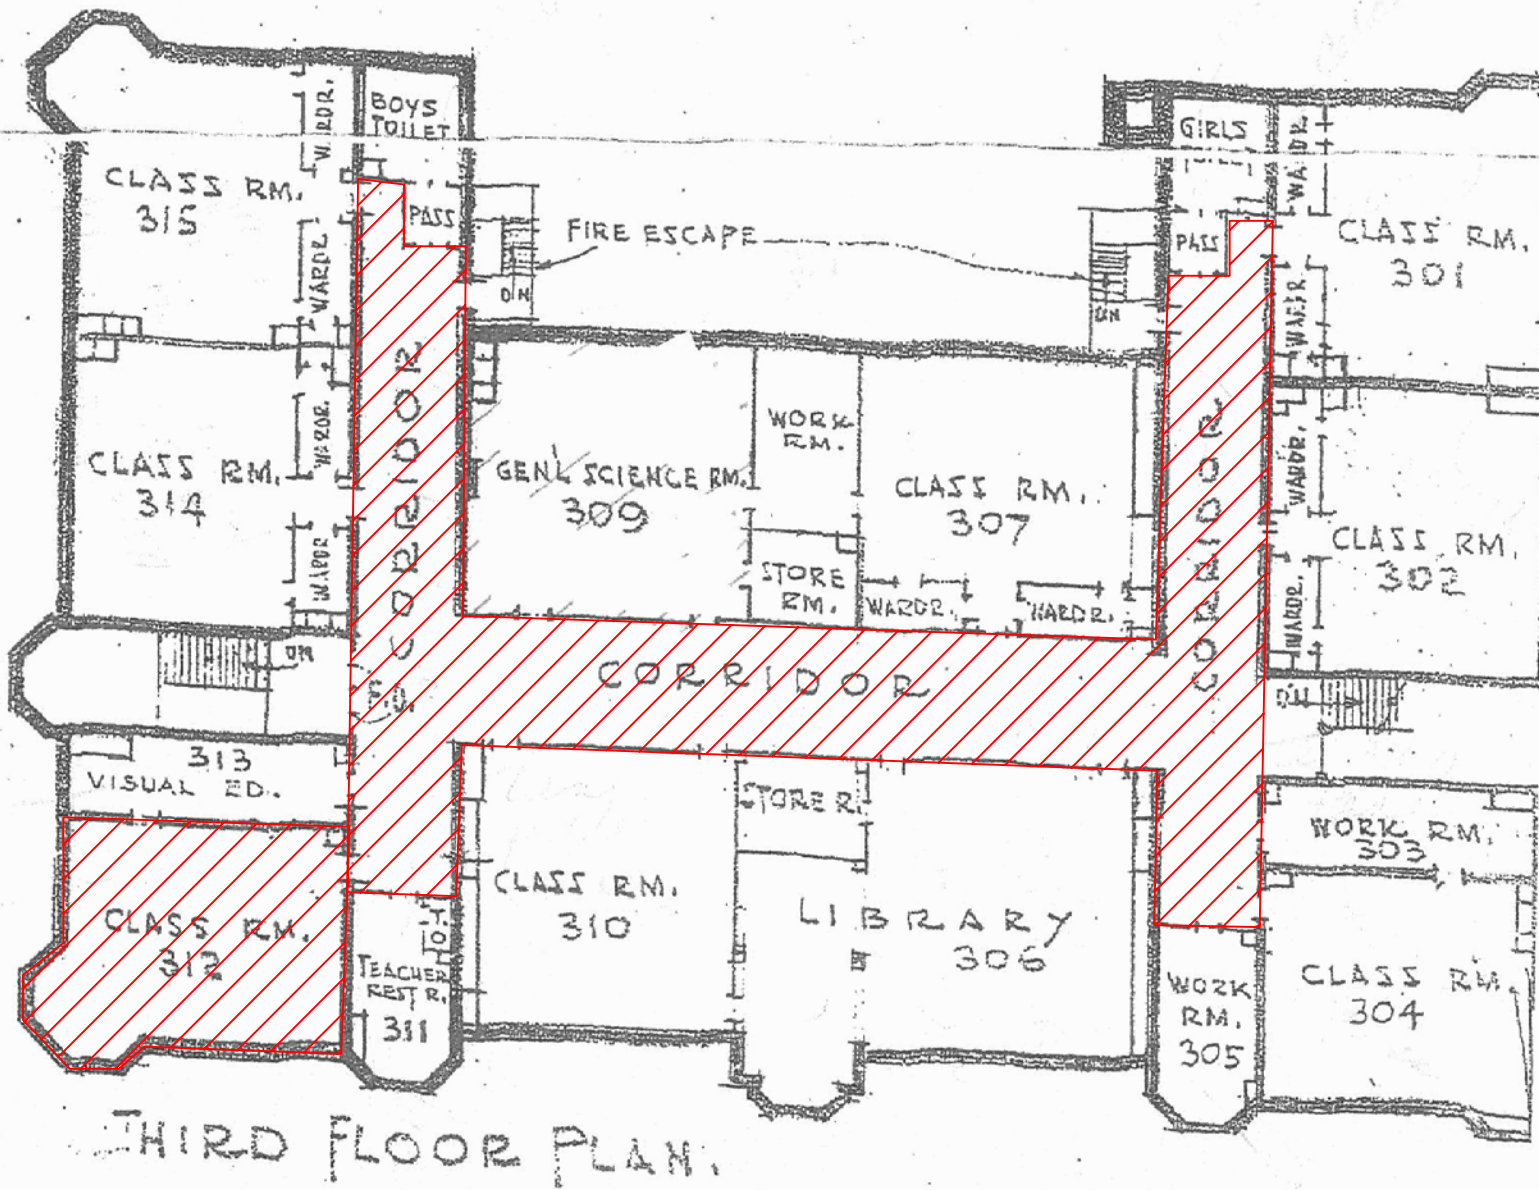
HOMOGENEOUS AREA: **23**
MATERIAL DESCRIPTION: **12"x12" Light Blue VFT Mastic**
MATERIAL LOCATION: **Basement Storage, Boys Restroom, Lunchroom, Corridor, Girls Playroom, Room 312,**
MATERIAL QUANTITY: **6700** MATERIAL UNITS: **SF**
MATERIAL CATEGORY: **MISC** FRIABLE: **No**
ASBESTOS TYPE: **Assumed**
DISTURBANCE POTENTIAL: **LOW** CONDITION:
AHERA DAMAGE CATEGORY: **6 ACBM with the potential for damage**
ACCESSIBILITY: **Not Reachable** DAMAGE REASON:
DAMAGE QUANTITY: **0** DAMAGE REASON:
DAMAGE UNITS: **SF**
COMMENTS:

HOMOGENEOUS AREA: **23**
MATERIAL DESCRIPTION: **12"x12" Light Blue VFT Mastic**
MATERIAL LOCATION: **Basement Storage, Boys Restroom, Lunchroom, Corridor, Girls Playroom, Room 312,**
MATERIAL QUANTITY: **6700** MATERIAL UNITS: **SF**
DAMAGE QUANTITY: **0** DAMAGE UNITS: **SF**

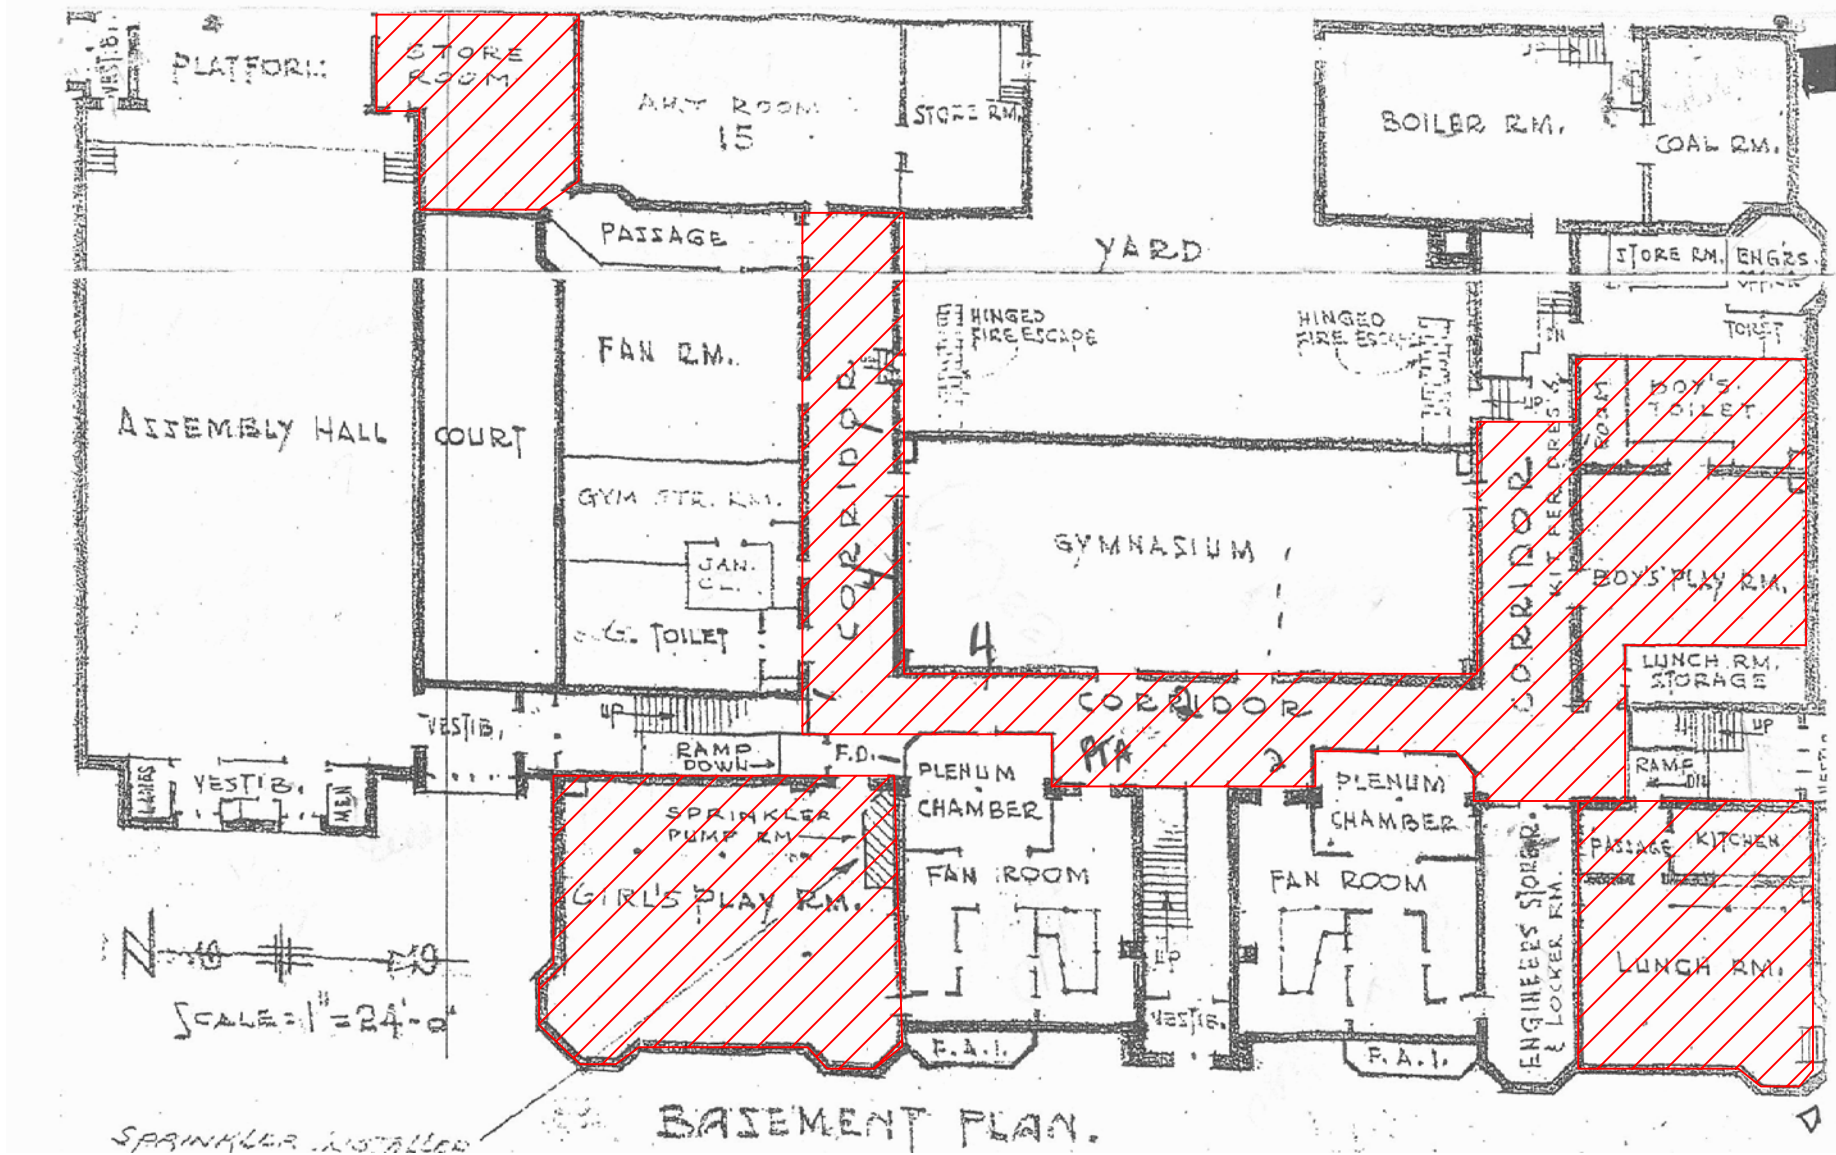
HOMOGENEOUS AREA: **24**
MATERIAL DESCRIPTION: **12"x12" Dark Blue VFT**
MATERIAL LOCATION: **Basement,1st,2nd,3rd Floor Corridors, Adjust. Office,**
MATERIAL QUANTITY: **2400** MATERIAL UNITS: **SF**
MATERIAL CATEGORY: **MISC** FRIABLE: **No**
ASBESTOS TYPE: **Assumed**
DISTURBANCE POTENTIAL: **HIGH** CONDITION:
AHERA DAMAGE CATEGORY: **6 ACBM with the potential for damage**
ACCESSIBILITY: **Within Reach** DAMAGE REASON:
DAMAGE QUANTITY: **0** DAMAGE REASON:
DAMAGE UNITS: **SF**
COMMENTS:

HOMOGENEOUS AREA: **24**
MATERIAL DESCRIPTION: **12"x12" Dark Blue VFT**
MATERIAL LOCATION: **Basement,1st,2nd,3rd Floor Corridors, Adjust. Office,**
MATERIAL QUANTITY: **2400** MATERIAL UNITS: **SF**
DAMAGE QUANTITY: **0** DAMAGE UNITS: **SF**

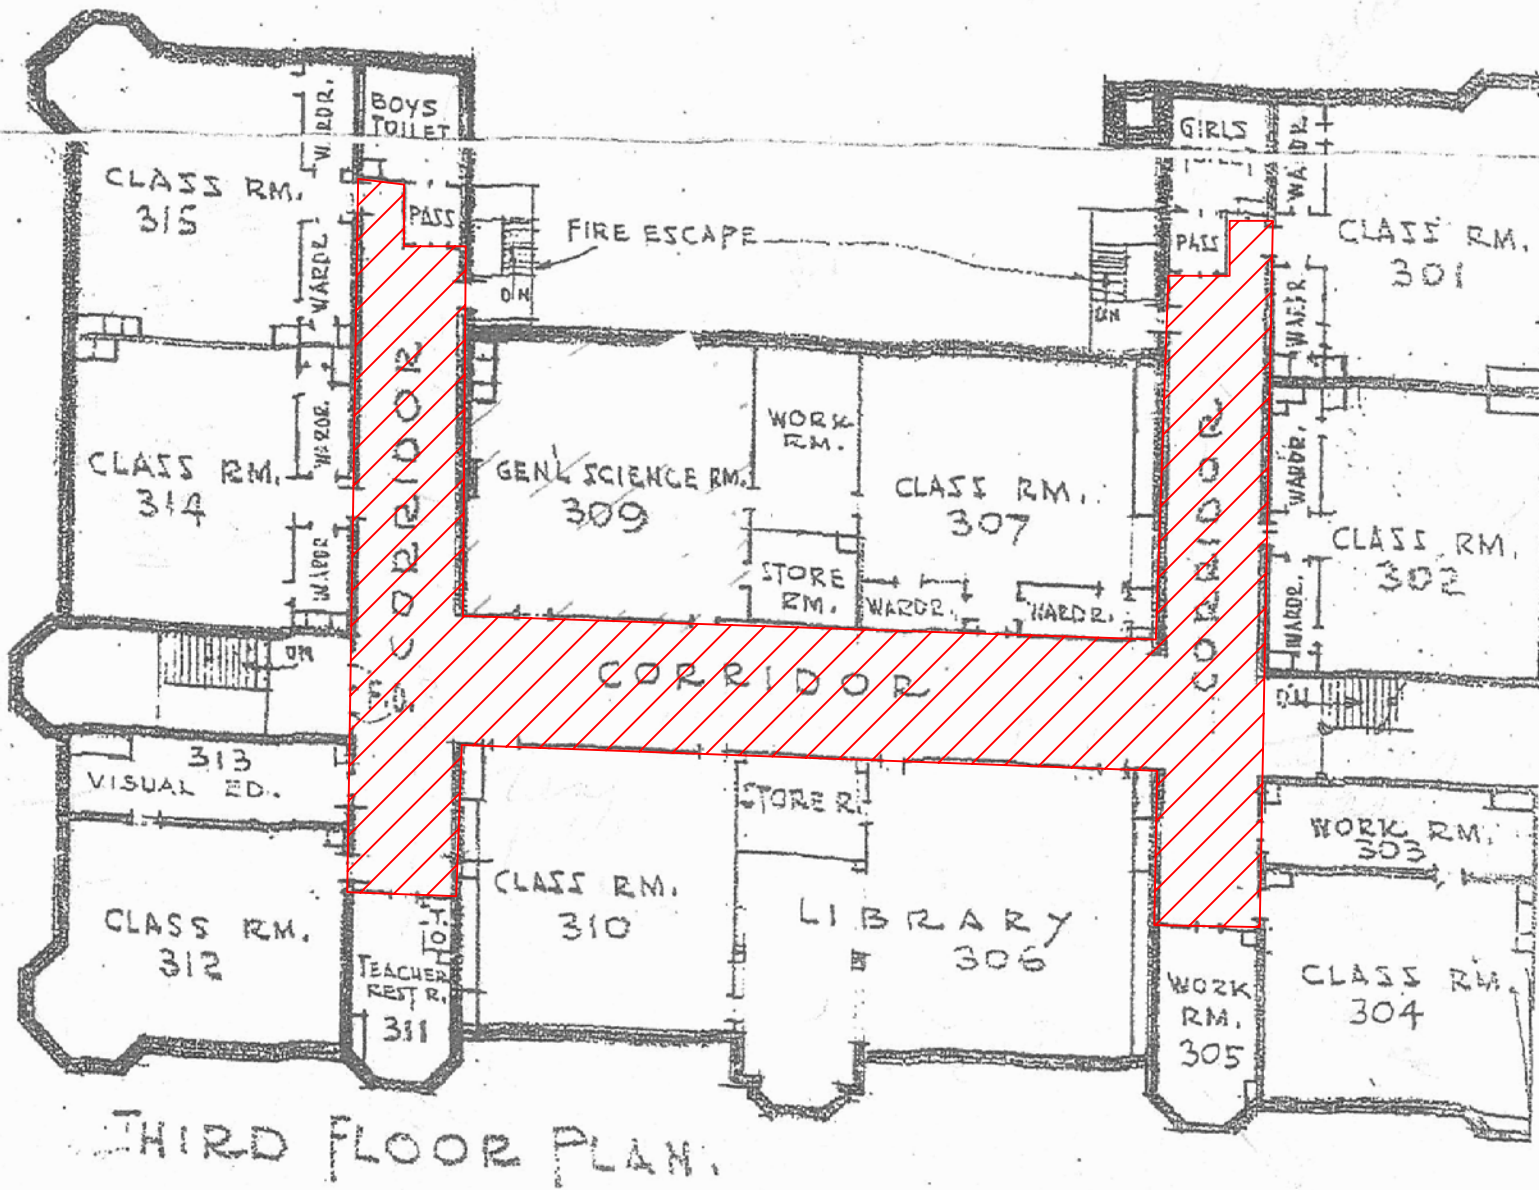
HOMOGENEOUS AREA: **27**
MATERIAL DESCRIPTION: **12"x12" Light Green VFT**
MATERIAL LOCATION: **1st Floor Corridor, Storage Room, Principles Office.**
MATERIAL QUANTITY: **3200** MATERIAL UNITS: **SF**
MATERIAL CATEGORY: **MISC** FRIABLE: **No**
ASBESTOS TYPE: **Assumed**
DISTURBANCE POTENTIAL: **HIGH** CONDITION:
AHERA DAMAGE CATEGORY: **6 ACBM with the potential for damage**
ACCESSIBILITY: **Within Reach** DAMAGE REASON:
DAMAGE QUANTITY: **0** DAMAGE REASON:
DAMAGE UNITS: **SF**
COMMENTS:

HOMOGENEOUS AREA: **27**
MATERIAL DESCRIPTION: **12"x12" Light Green VFT**
MATERIAL LOCATION: **1st Floor Corridor, Storage Room, Principles Office.**
MATERIAL QUANTITY: **3200** MATERIAL UNITS: **SF**
DAMAGE QUANTITY: **0** DAMAGE UNITS: **SF**

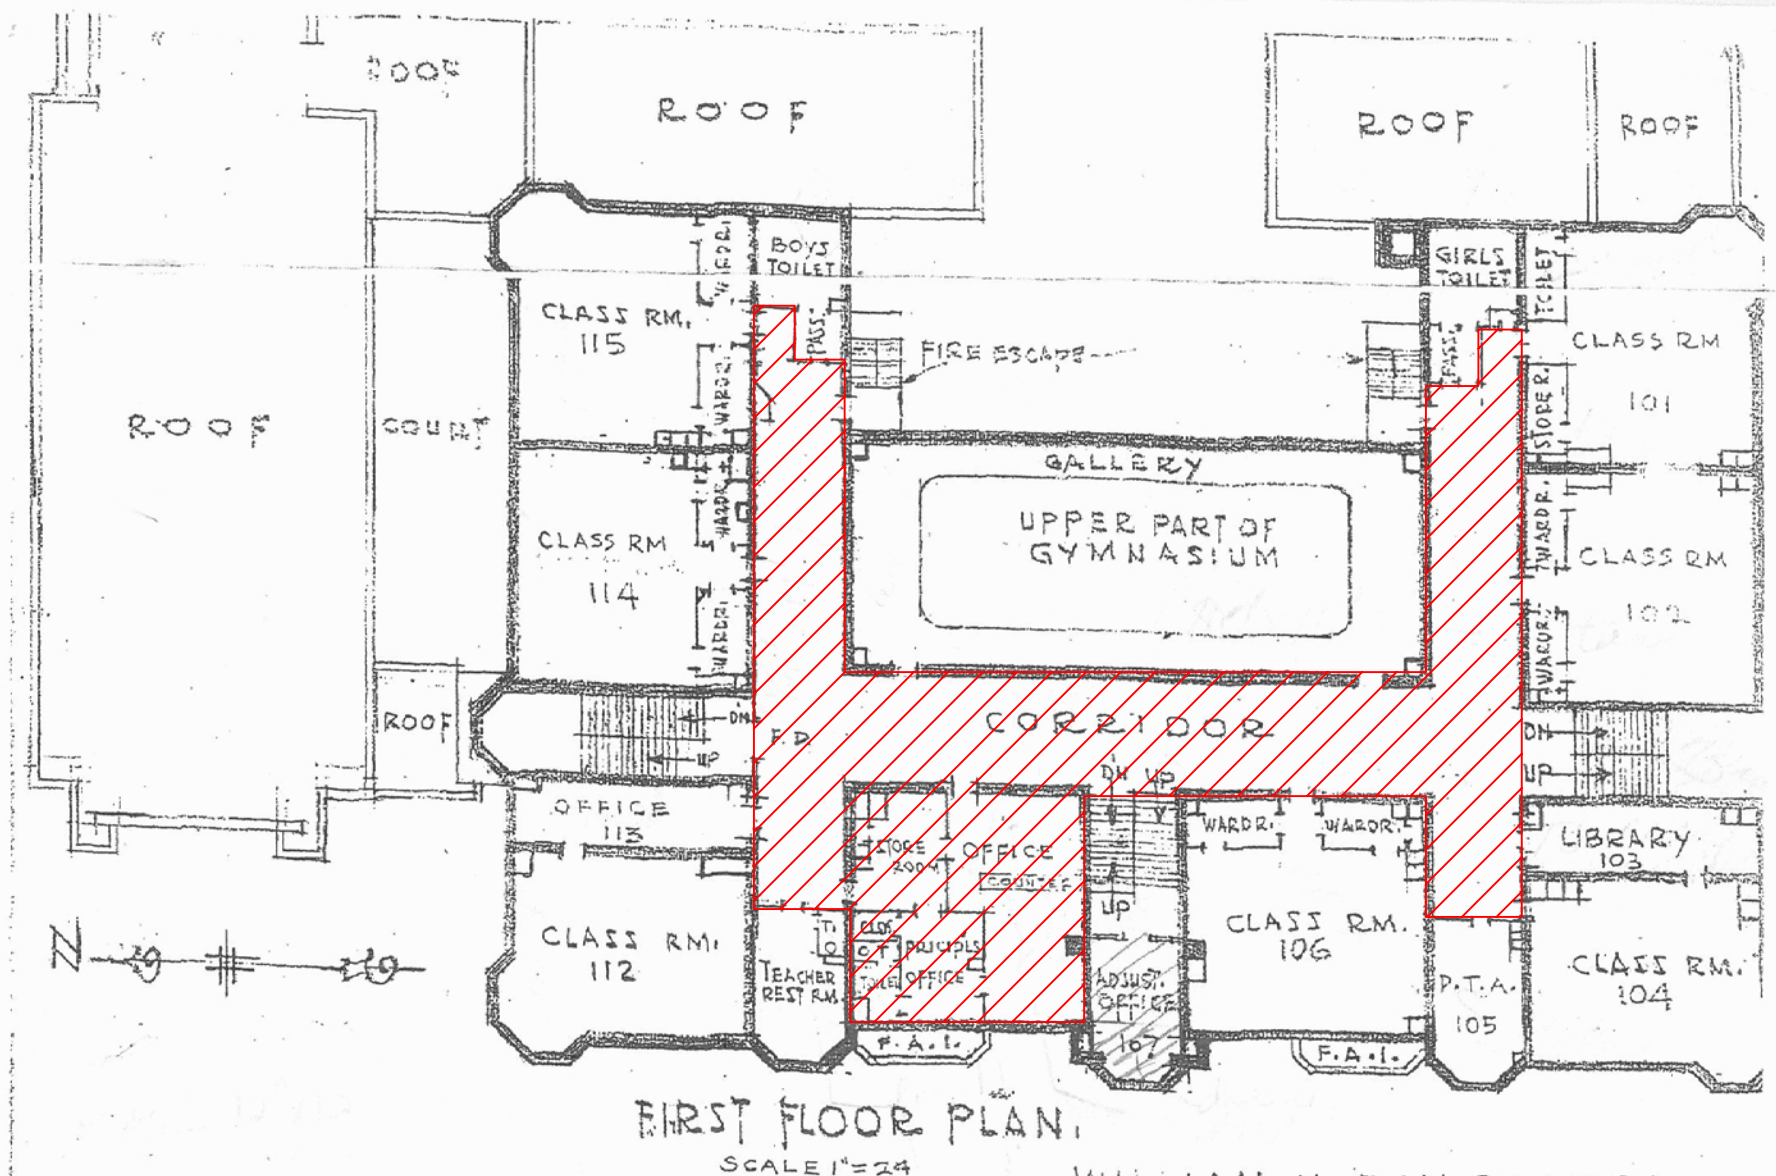
HOMOGENEOUS AREA: **28**
MATERIAL DESCRIPTION: **12"x12" Light Green VFT Mastic**
MATERIAL LOCATION: **1st Floor Corridor, Storage Room, Principles Office.**
MATERIAL QUANTITY: **3200** MATERIAL UNITS: **SF**
DAMAGE QUANTITY: **0** DAMAGE UNITS: **SF**
