**ILLINOIS DEPARTMENT OF PUBLIC HEALTH
AHERA THREE YEAR REINSPECTION
ASBESTOS ABATEMENT PROGRAM
SCHOOL INFORMATION FORM**

NAME OF SCHOOL DISTRICT: CHICAGO SCHOOL DIST 299
SCHOOL ID NUMBER: 14-016-2990-2426
SCHOOL NAME: Rogers School
ADDRESS OF SCHOOL: 7345 N Washtenaw Avenue
CITY: Chicago, IL, 60645

GSG Consultants, Inc.
2013 AHERA REINSPECTION

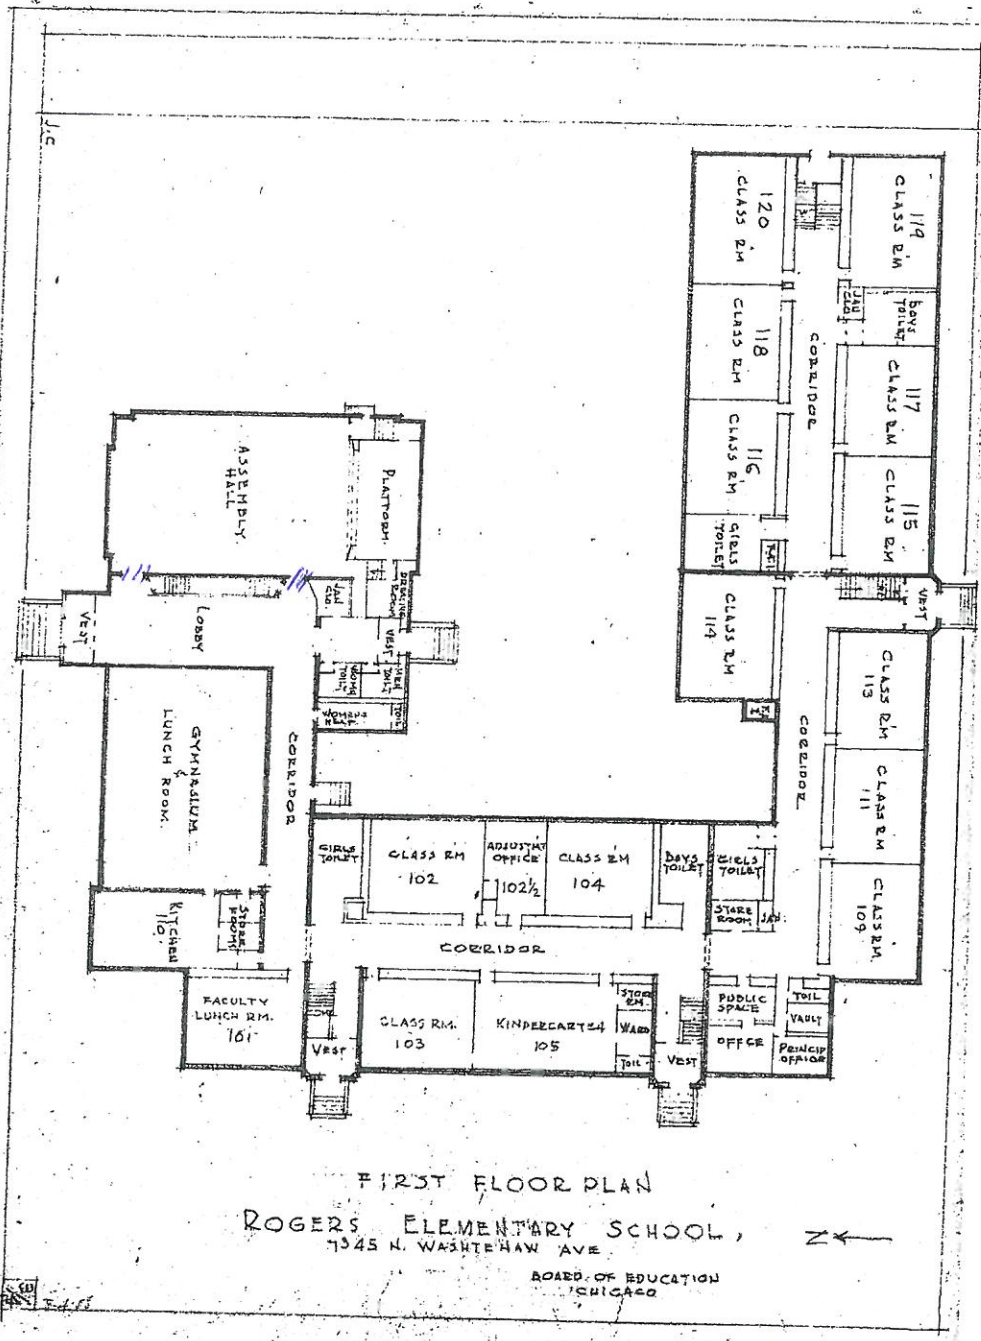
FIRST FLOOR PLAN
 ROGERS ELEMENTARY SCHOOL,
 7345 N. WASHINGTON AVE.
 BOARD OF EDUCATION
 CHICAGO

HOMOGENEOUS AREA: **43A**
MATERIAL DESCRIPTION: **12" X 12' blue, Mastic**
MATERIAL LOCATION: **Corridor leading to Assembly Hall, next to Gym-seams where addition 1952 meets original school bldg in both the 1st and 2nd floors. Corridor exiting to south exit of 1952 bldg**
MATERIAL QUANTITY: **995** MATERIAL UNITS: **SF**
MATERIAL CATEGORY: **MISC** FRIABLE: **No**
ASBESTOS TYPE: **Assumed**
DISTURBANCE POTENTIAL: **LOW** CONDITION:
AHERA DAMAGE CATEGORY: **6 ACBM with the potential for damage**
ACCESSIBILITY: **Within Reach** DAMAGE REASON:
DAMAGE QUANTITY: **0** DAMAGE REASON:
DAMAGE UNITS: **SF**
COMMENTS:

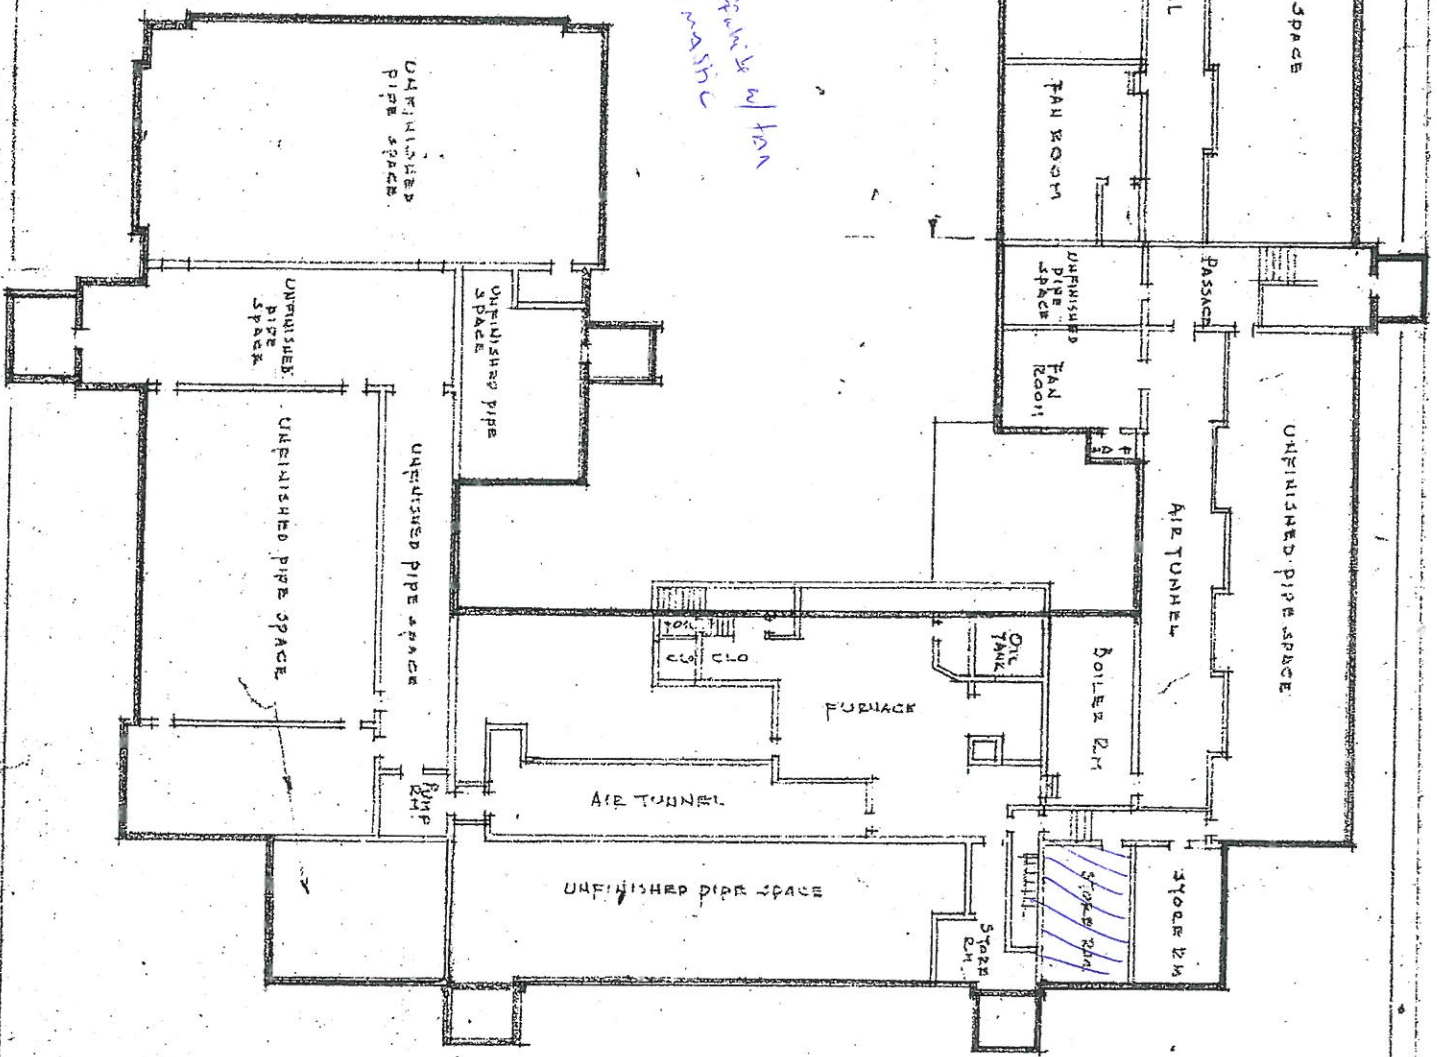
BASEMENT PLAN

HIA 38

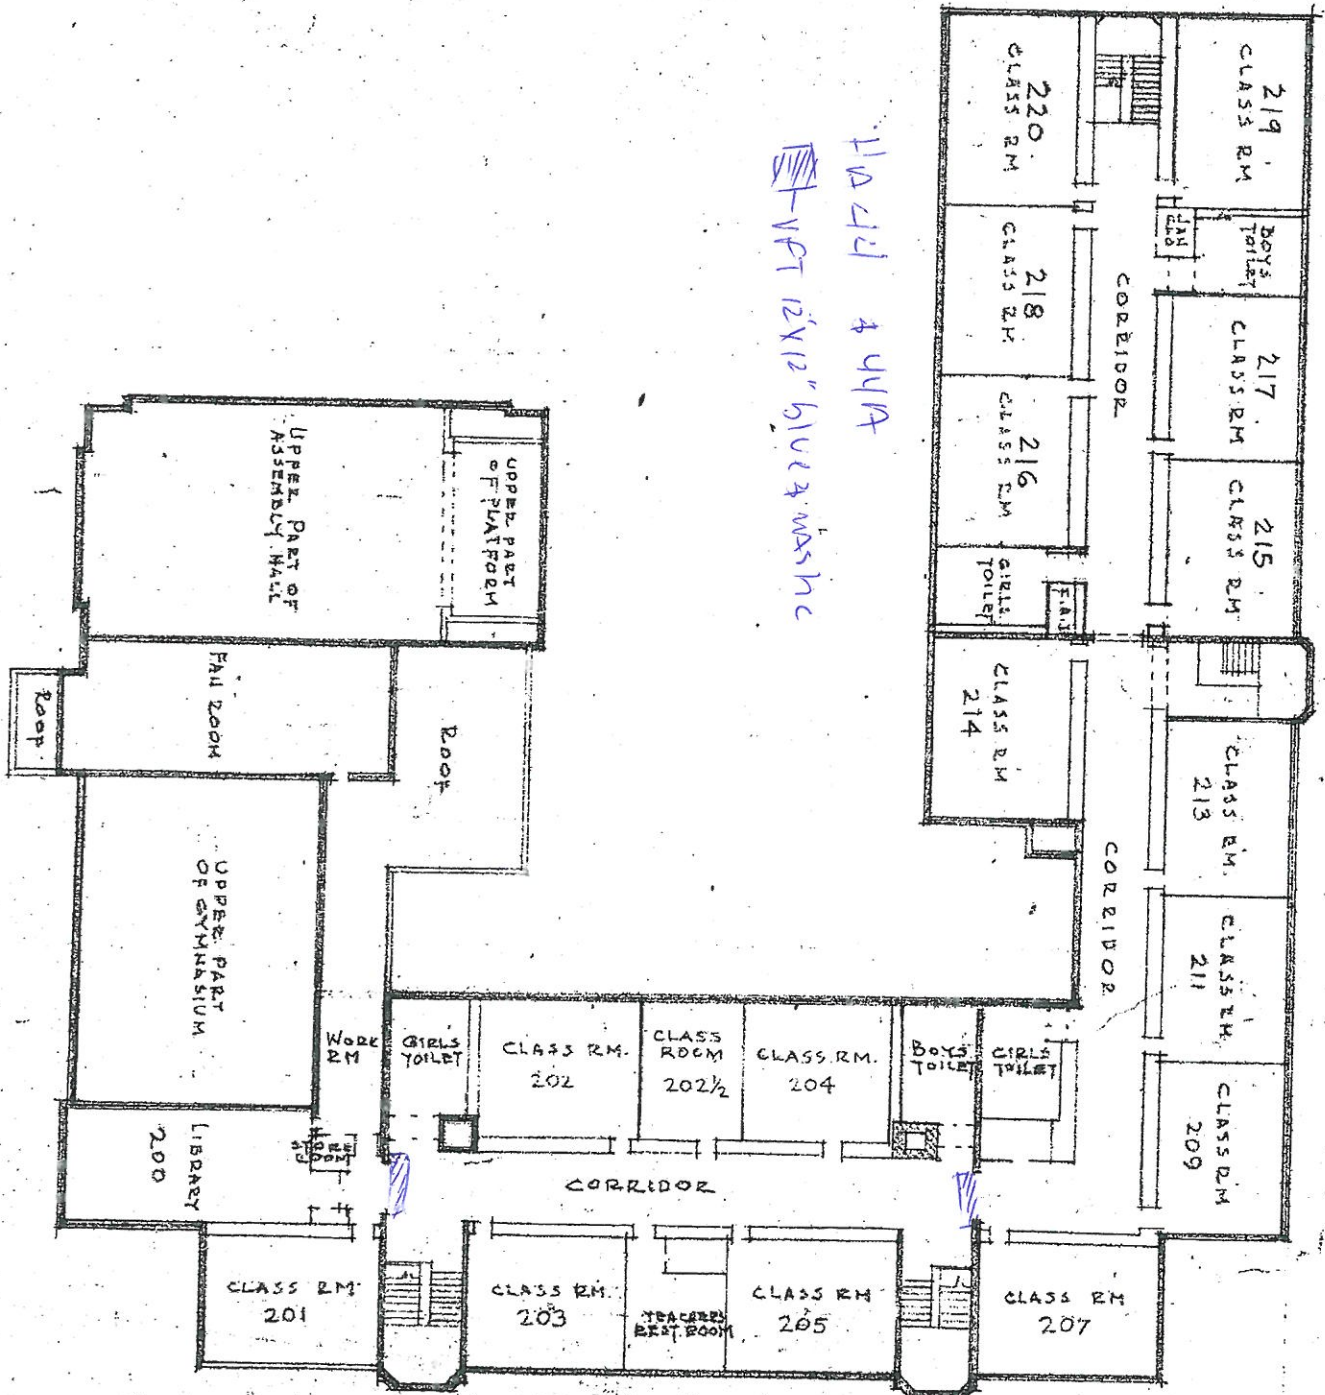
SECOND FLOOR PLAN

11A 44 3 44A
EST-VFT 12'x12" RIVER 3 WASH C

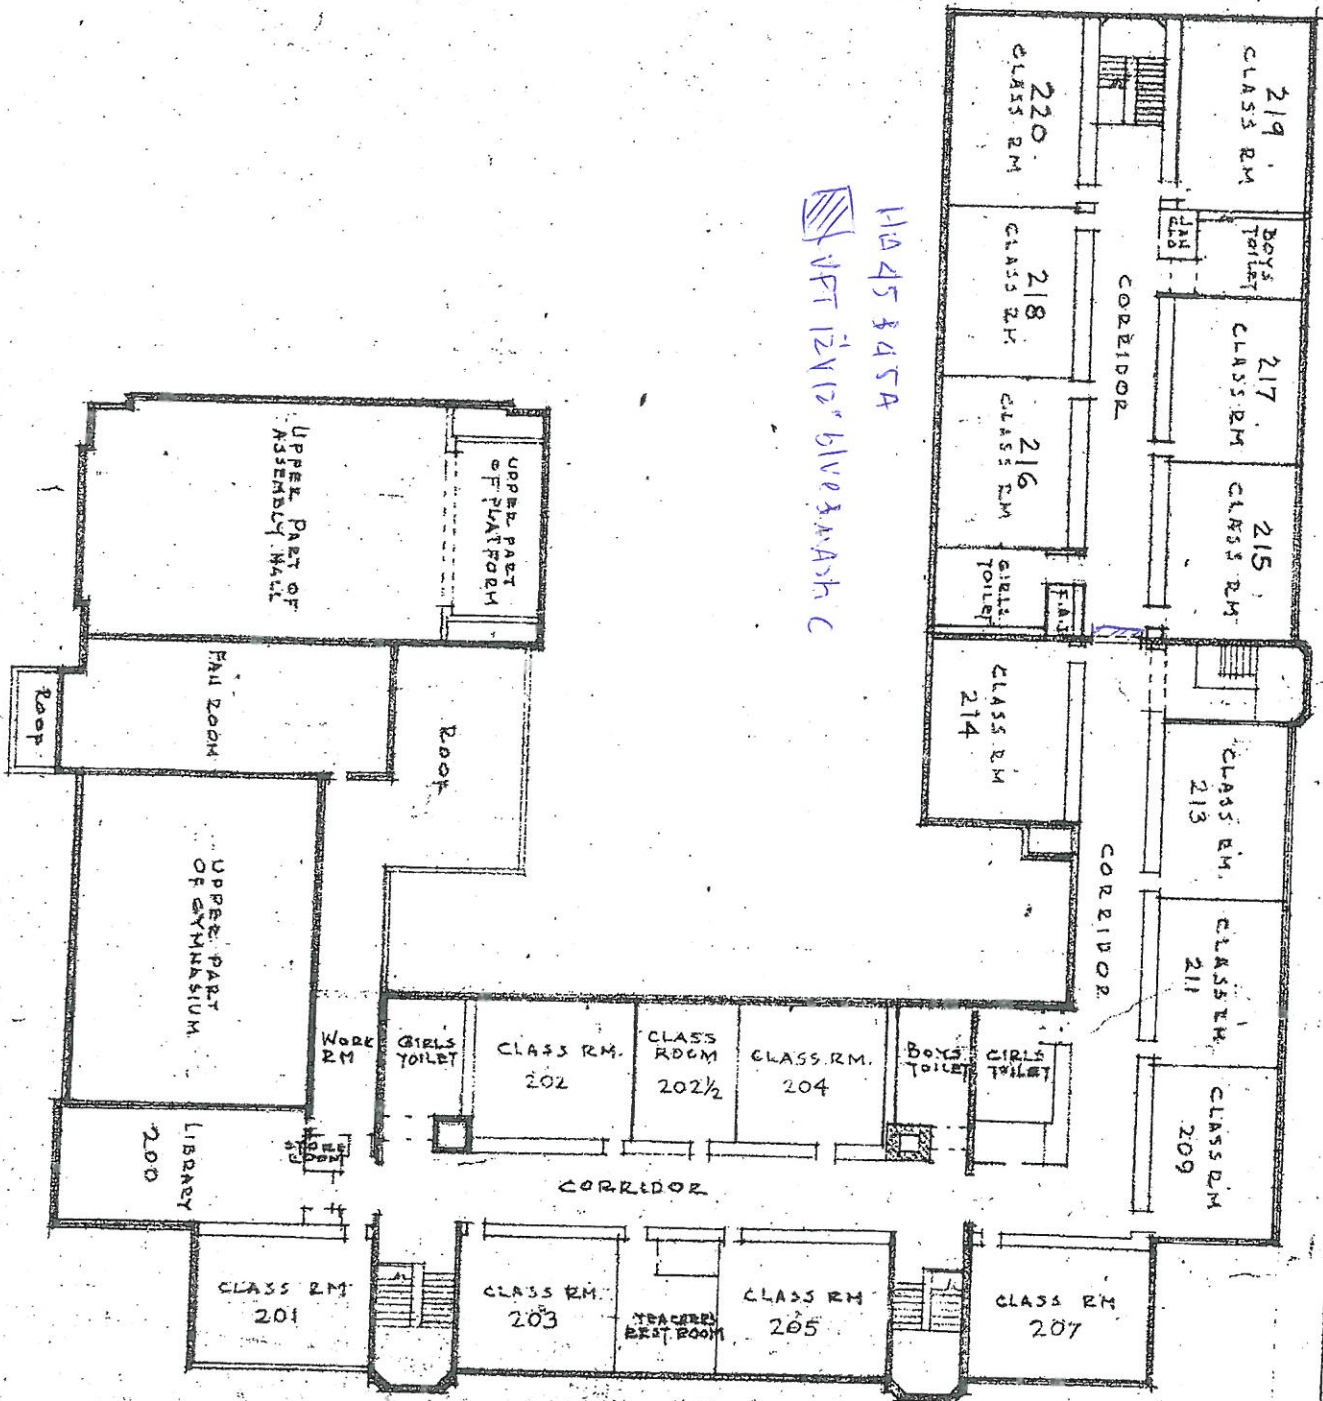
SECOND FLOOR PLAN

H1045 & 457A
 VFT 12/12/12 BIVE & MASH C

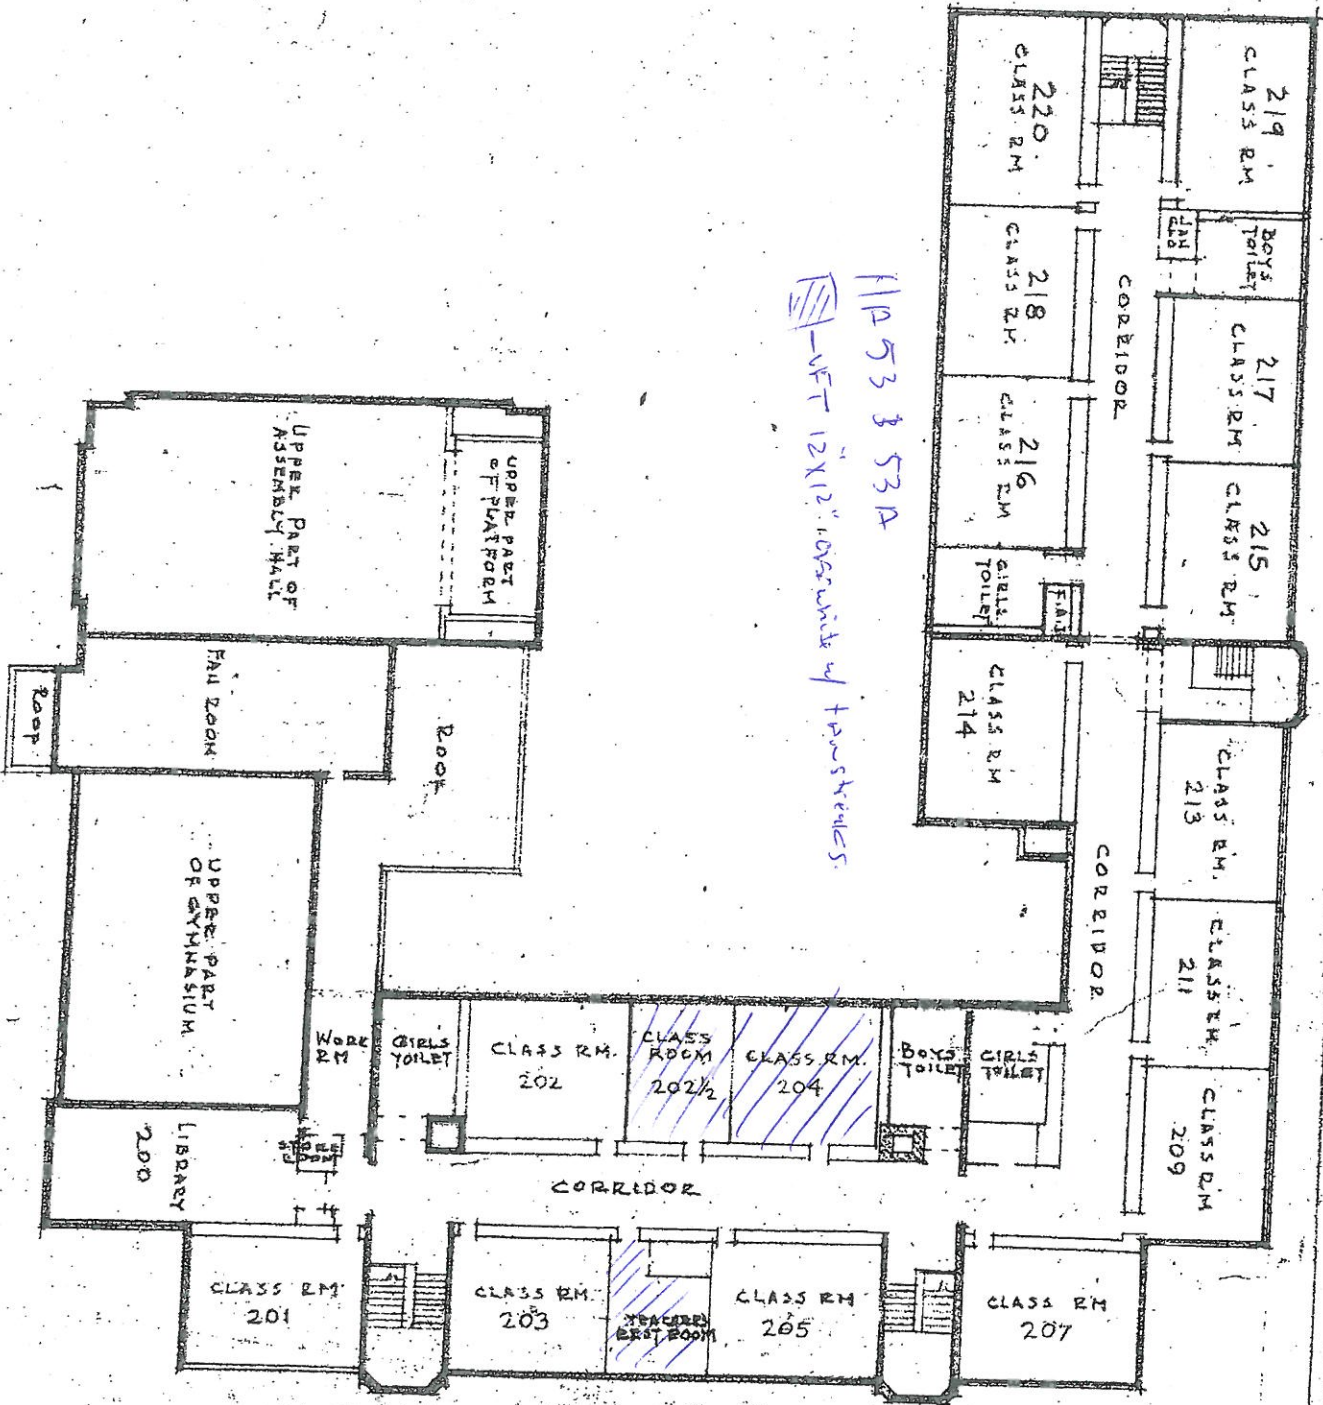
SECOND FLOOR PLAN

11A 53 & 53A
 - VET 12x12' 1055 units of floor stickers

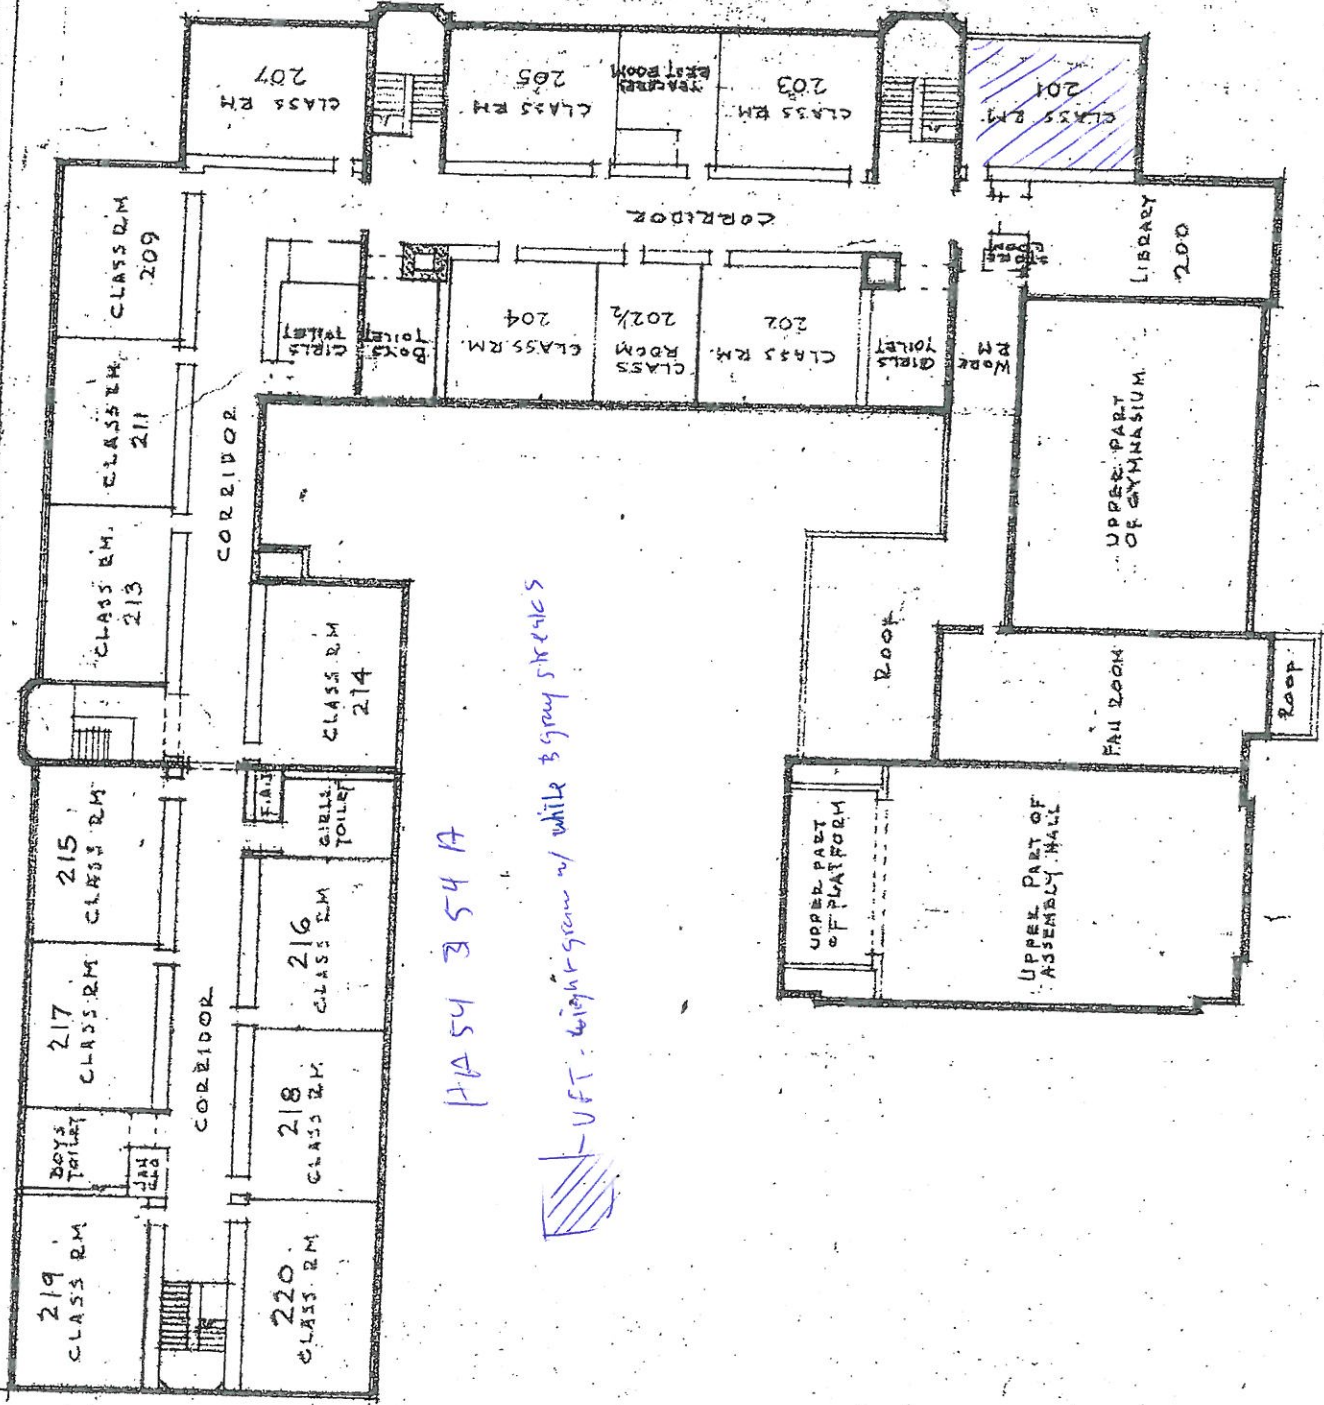
ROGEDS ELEMENTARY SCHOOL
 7345 N. WASHINGTON AVE.
 BOARD OF EDUCATION
 CHICAGO
 SCALE 1" = 30'
 SECOND FLOOR PLAN

HA 54 354 A
 UFT - light green w/ white & grey streaks

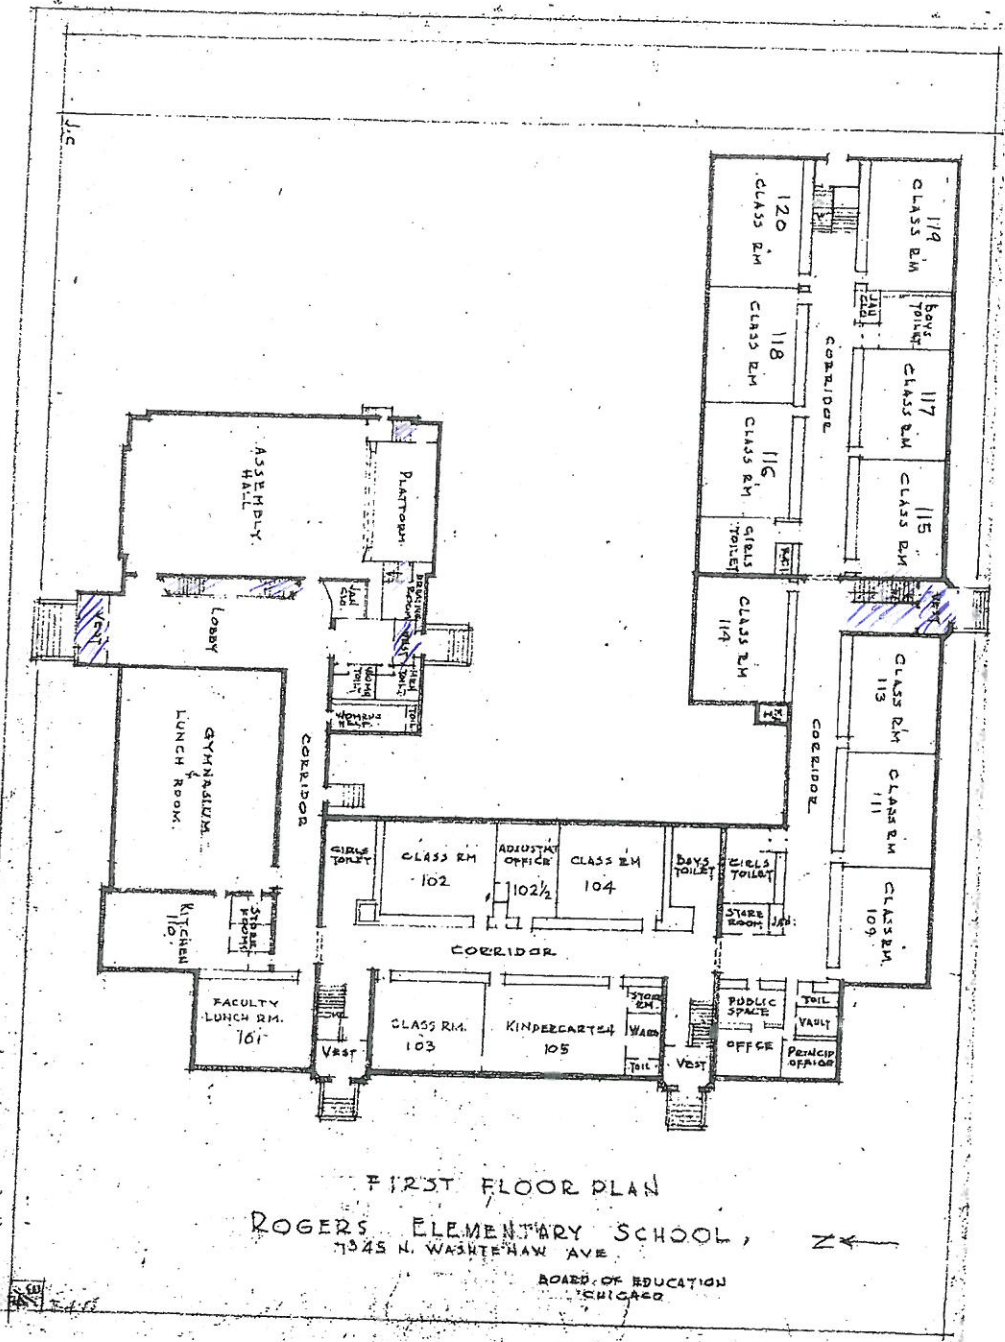
FIRST FLOOR PLAN
 ROGERS ELEMENTARY SCHOOL,
 1345 N. WASHINGTON AVE.
 BOARD OF EDUCATION
 CHICAGO

LA 39
 7-11-20 Springfield, IL

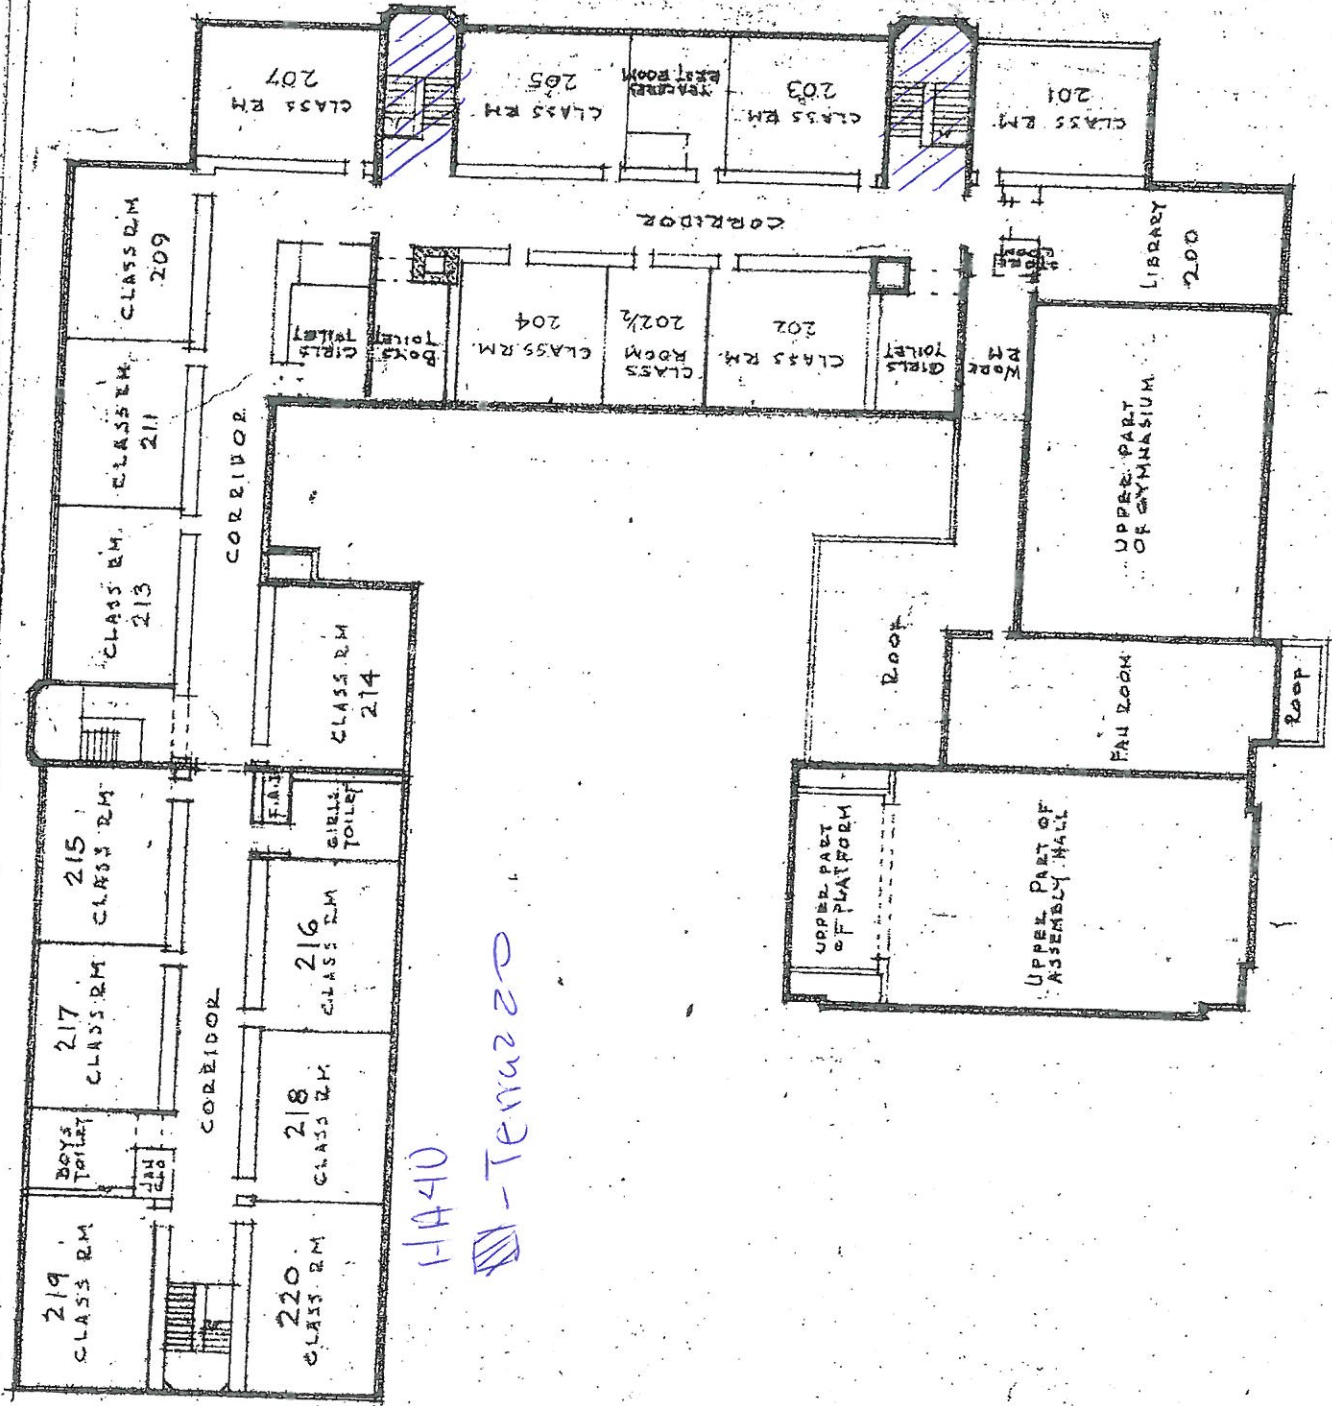
HA410
 -Tenuzzo

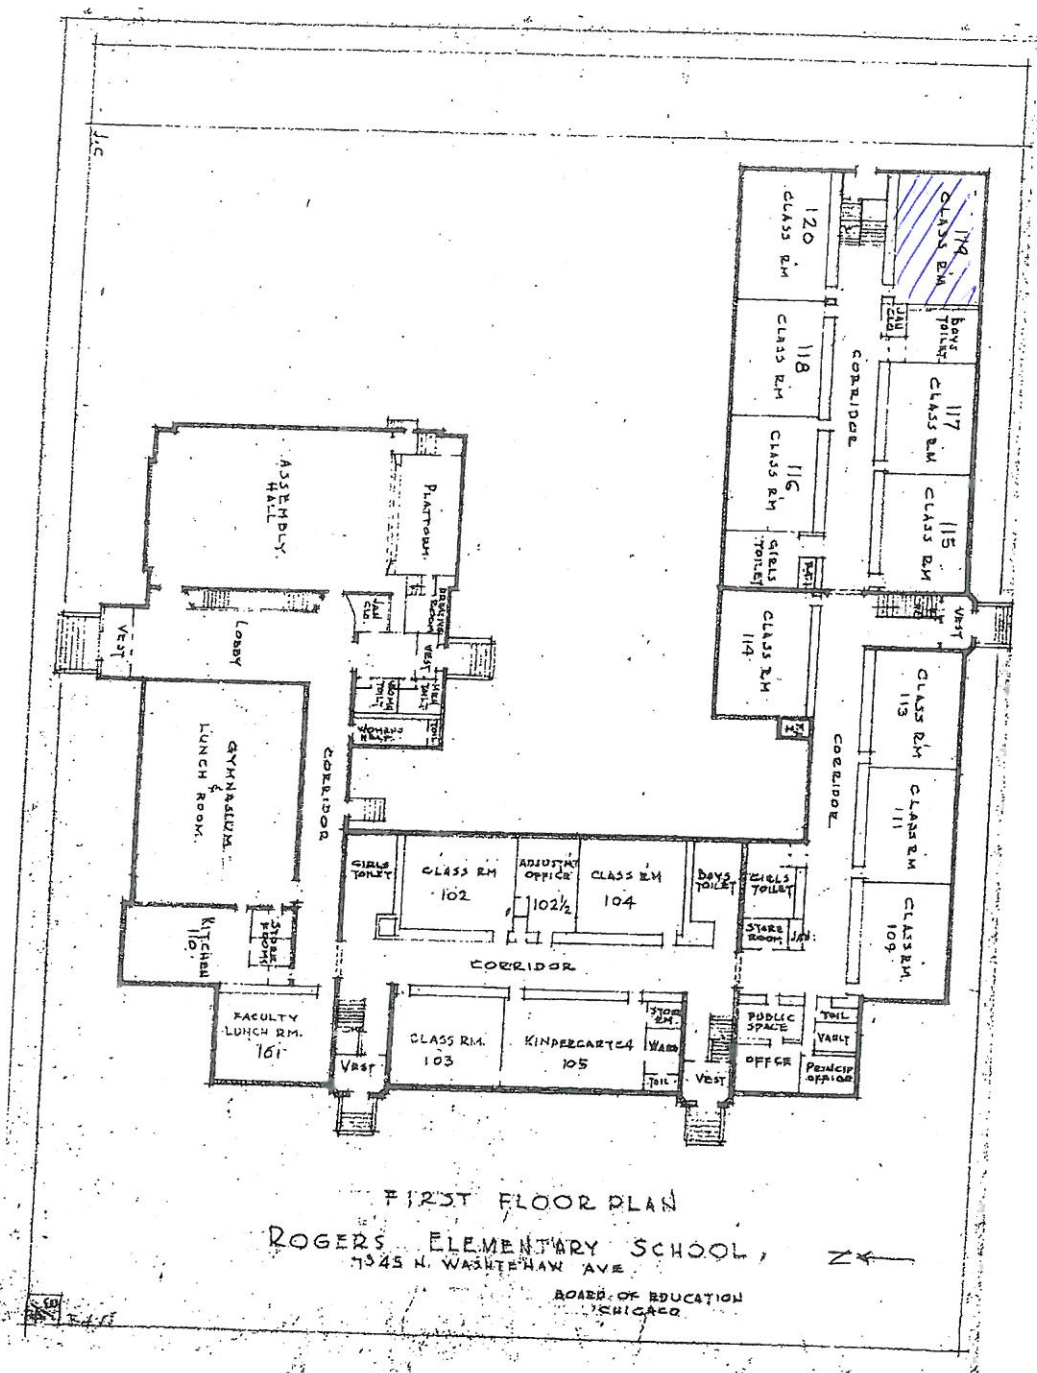
FIRST FLOOR PLAN
ROGERS ELEMENTARY SCHOOL,
7345 N. WASHINGTON AVE
BOARD OF EDUCATION
CHICAGO

H049E49A

12'11" gray w/ light gray & white stripes & wash C.

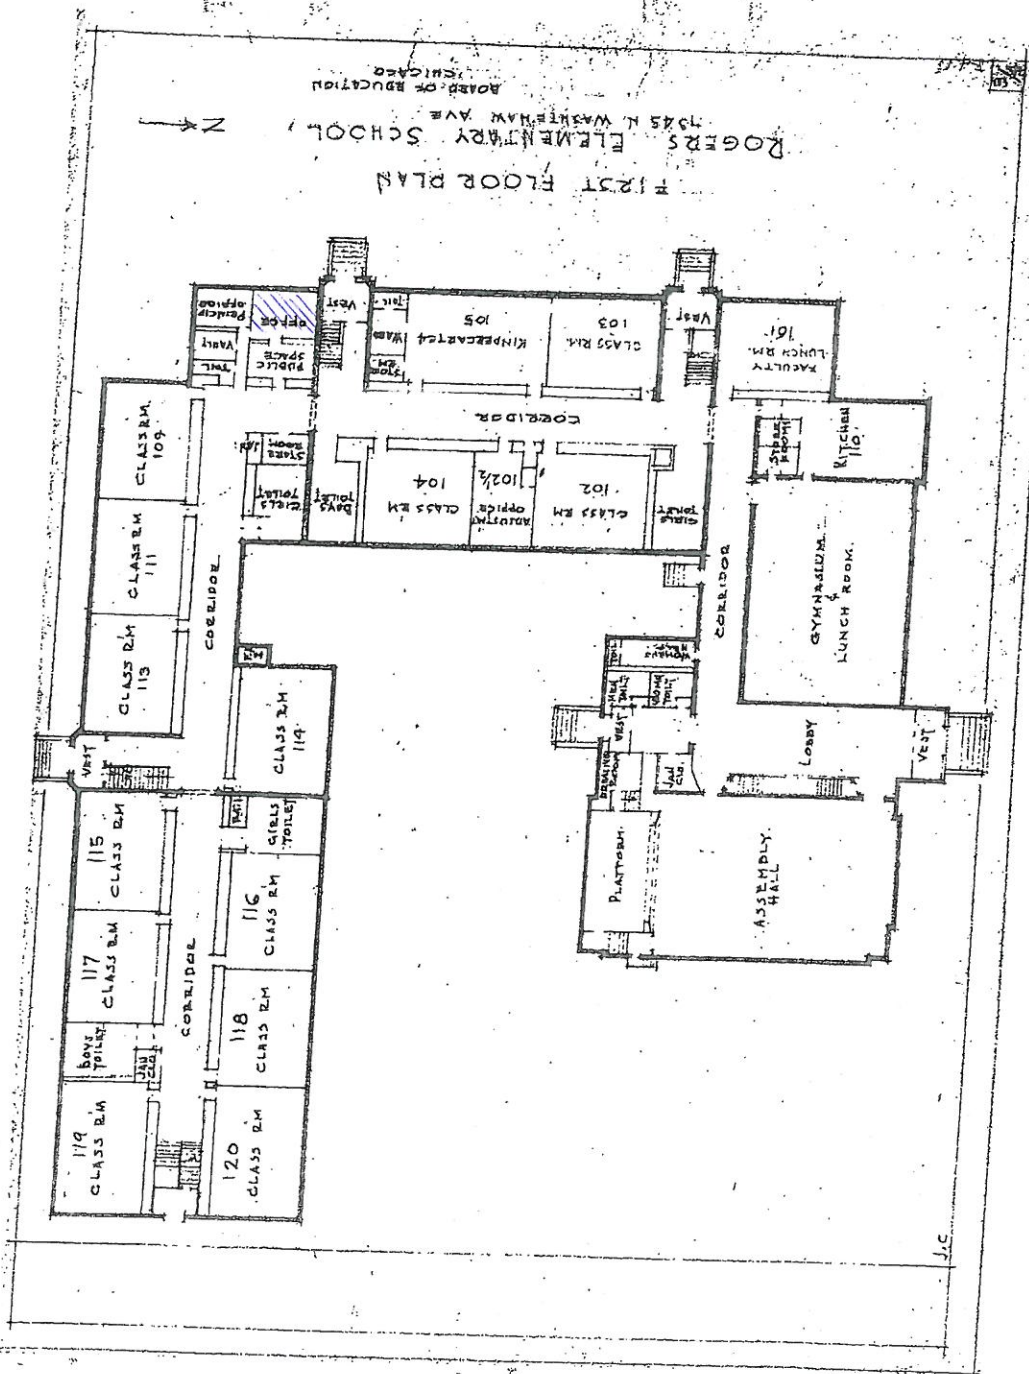
HA 50

117 - Carpet MASH C

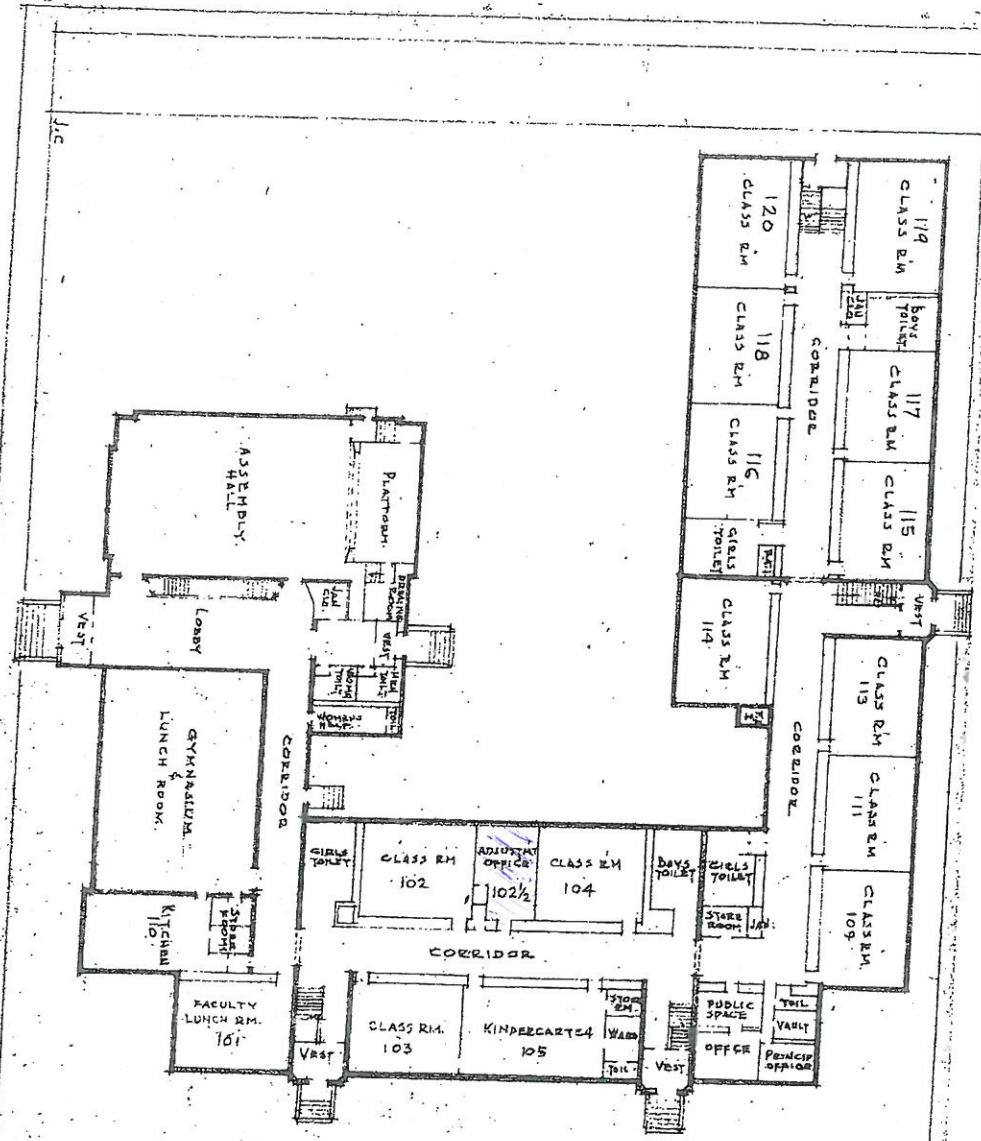
FIRST FLOOR PLAN
ROGERS ELEMENTARY SCHOOL,
7345 N. WASHINGTON AVE.
BOARD OF EDUCATION
CHICAGO

HP 48
Carpet Mastic
