ILLINOIS DEPARTMENT OF PUBLIC HEALTH
AHERA THREE YEAR REINSPECTION
ASBESTOS ABATEMENT PROGRAM
SCHOOL INFORMATION FORM

NAME OF SCHOOL DISTRICT: CHICAGO SCHOOL DIST 299
SCHOOL ID NUMBER: 14-016-2990-2438
SCHOOL NAME: Scammon School
ADDRESS OF SCHOOL: 4201 W Henderson Street
CITY: Chicago, IL, 60641

DATE REINSPECTION COMPLETED: 5/3/2013 ENROLLMENT 886
IDPH INSPECTOR LICENSE NUMBER: 100-11089
IDPH LICENSED INSPECTOR NAME (Please Print): Panfilo Carrazco
IDPH MP LICENSE NUMBER: 100-07342
IDPH LICENSED MANAGEMENT PLANNER NAME (Please Print): Jigar Shah

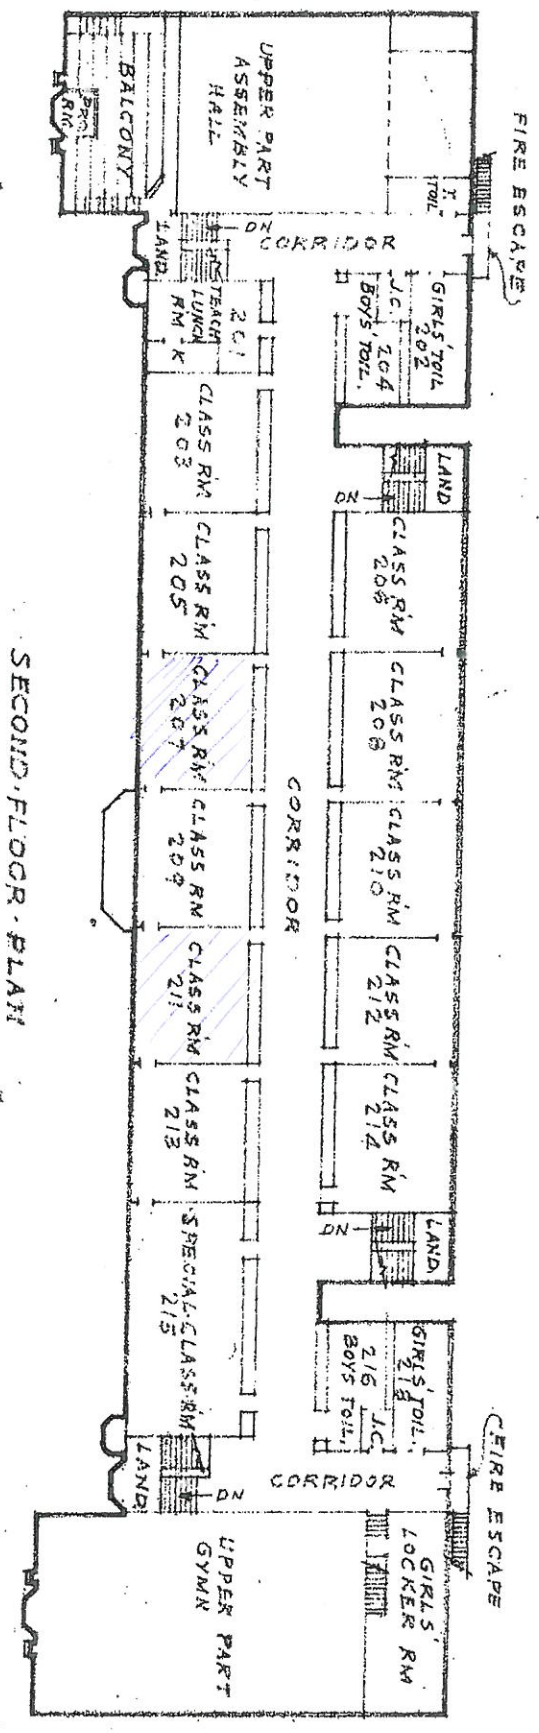
SECOND FLOOR PLAN

SCAMMON ELEMENTARY SCHOOL
4201 W. HENDERSON STREET,
CHICAGO

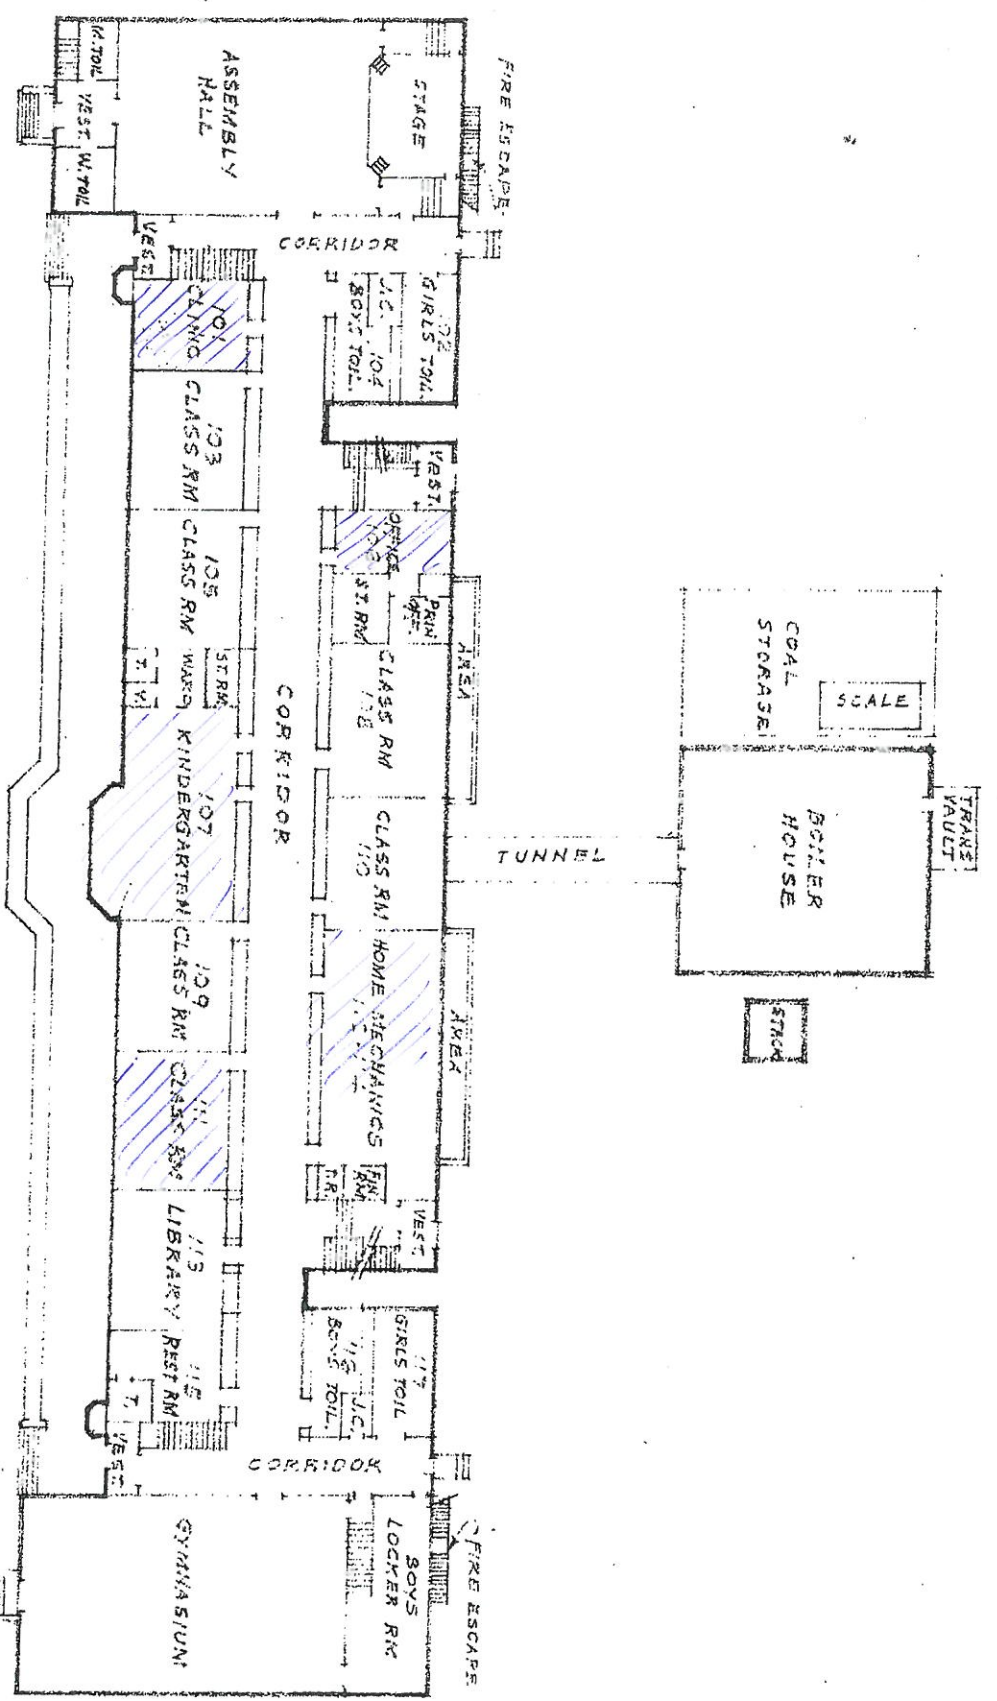
FIRST FLOOR PLAN
 SECOND FLOOR PLAN

ASS: SCHOOL
 INSTRUCTION: FIREPROOF
 ORIES: 2
 EIGHT: 30'6"

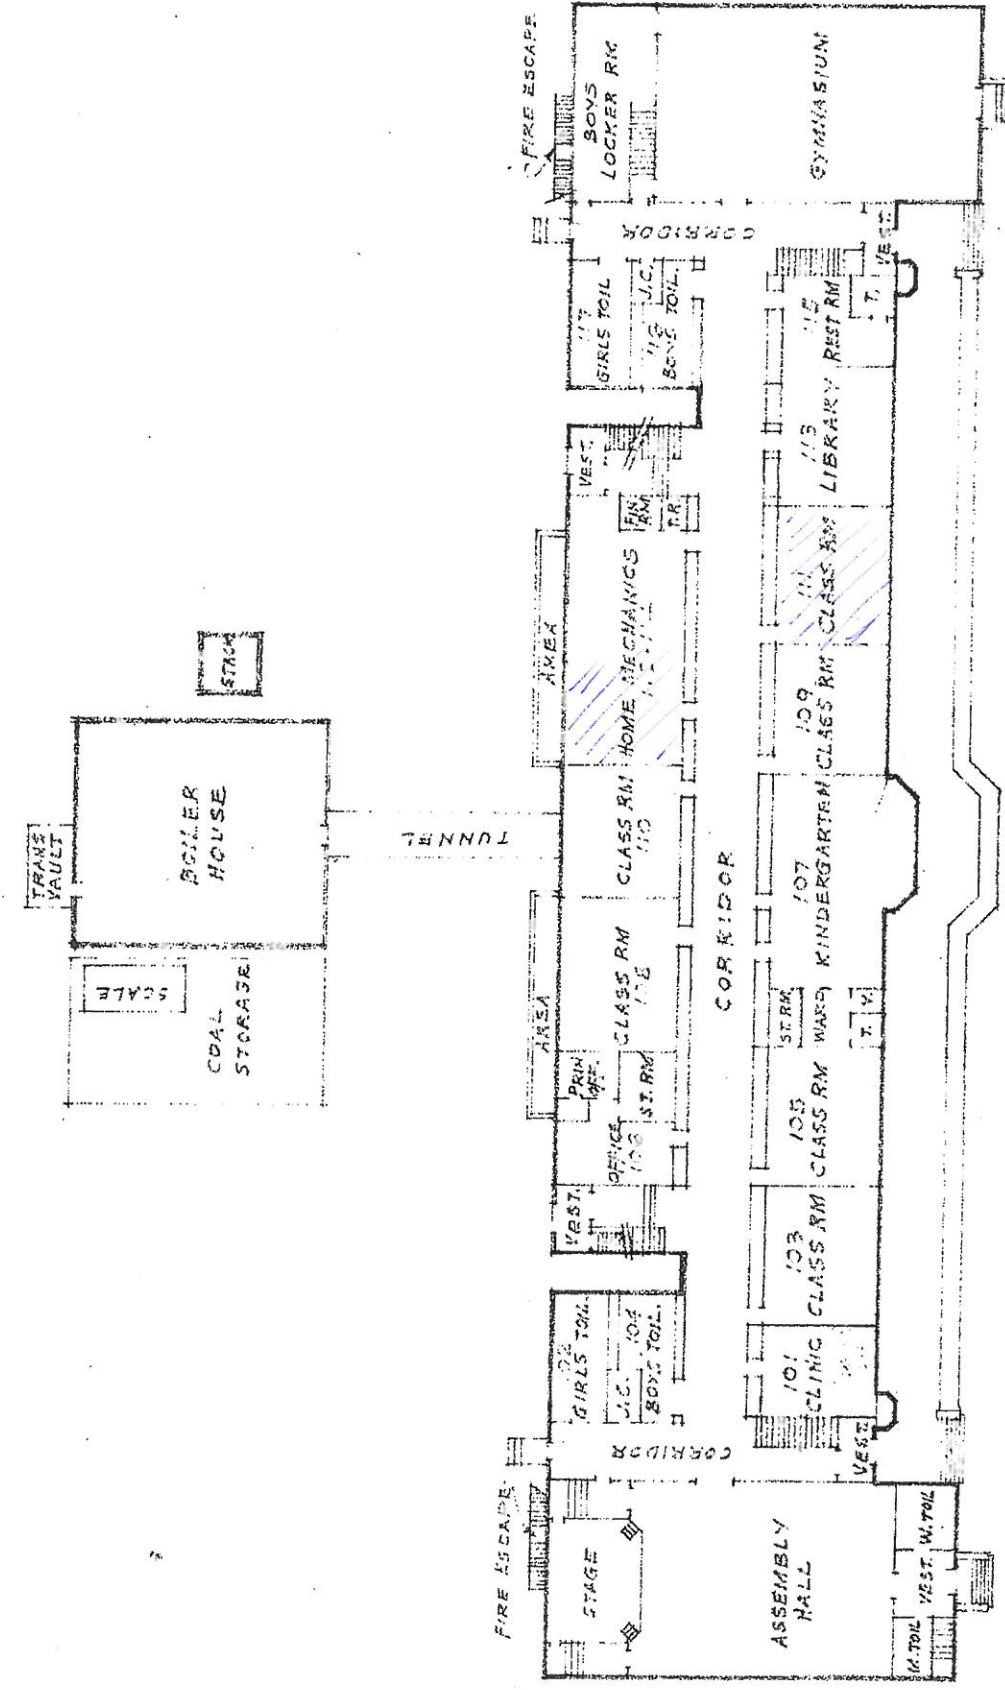
FIRST FLOOR PLAN
SECOND FLOOR SIMILAR

11-24-1918' 20' 31/2" x 110' 0" w/ boys 33' x 110' 0" in main area etc
