**ILLINOIS DEPARTMENT OF PUBLIC HEALTH
AHERA THREE YEAR REINSPECTION
ASBESTOS ABATEMENT PROGRAM
SCHOOL INFORMATION FORM**

NAME OF SCHOOL DISTRICT: CHICAGO SCHOOL DIST 299
SCHOOL ID NUMBER: 14-016-2990-3725
SCHOOL NAME: Christopher School
ADDRESS OF SCHOOL: 5042 S. Artesian
CITY: Chicago, IL, 60632

DATE REINSPECTION COMPLETED: 4/18/2013 ENROLLMENT 313
IDPH INSPECTOR LICENSE NUMBER: 100-11170
IDPH LICENSED INSPECTOR NAME (Please Print): Jesus Delgado
IDPH MP LICENSE NUMBER: 100-09870
IDPH LICENSED MANAGEMENT PLANNER NAME (Please Print): Todd Huffer

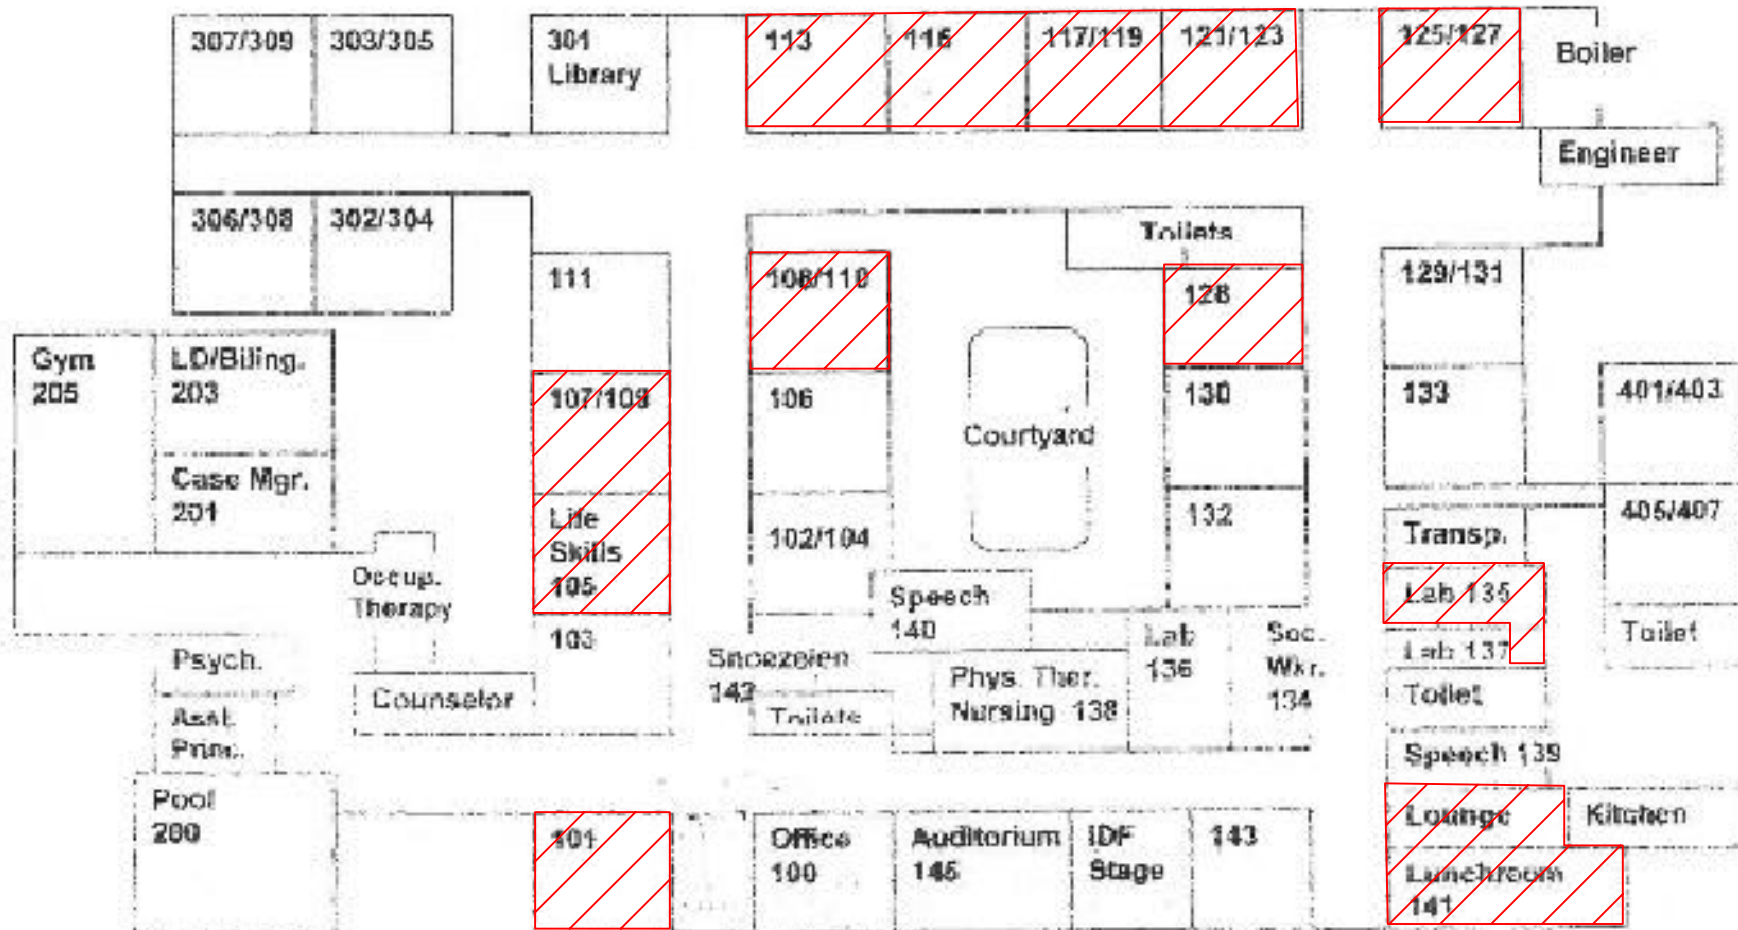
Walter S. Christopher School Floor Plan

HOMOGENEOUS AREA: **108**
MATERIAL DESCRIPTION: **12"X12" Blue W/Gray White Streaks VFT**
MATERIAL LOCATION: **Room 113,116,117/119,121/123,143,101,105,107,109,125, 127,128,137,141, cafeteria lounge**
MATERIAL QUANTITY: **11000** MATERIAL UNITS: **SF**
DAMAGE QUANTITY: **0** DAMAGE UNITS: **SF**
