**ILLINOIS DEPARTMENT OF PUBLIC HEALTH  
AHERA THREE YEAR REINSPECTION  
ASBESTOS ABATEMENT PROGRAM  
SCHOOL INFORMATION FORM**

NAME OF SCHOOL DISTRICT: CHICAGO SCHOOL DIST 299  
SCHOOL ID NUMBER: 14-016-2990-2804  
SCHOOL NAME: Metcalfe Academy  
ADDRESS OF SCHOOL: 12339 S Normal Avenue  
CITY: Chicago, IL, 60628

**THREE-YEAR REINSPECTION**

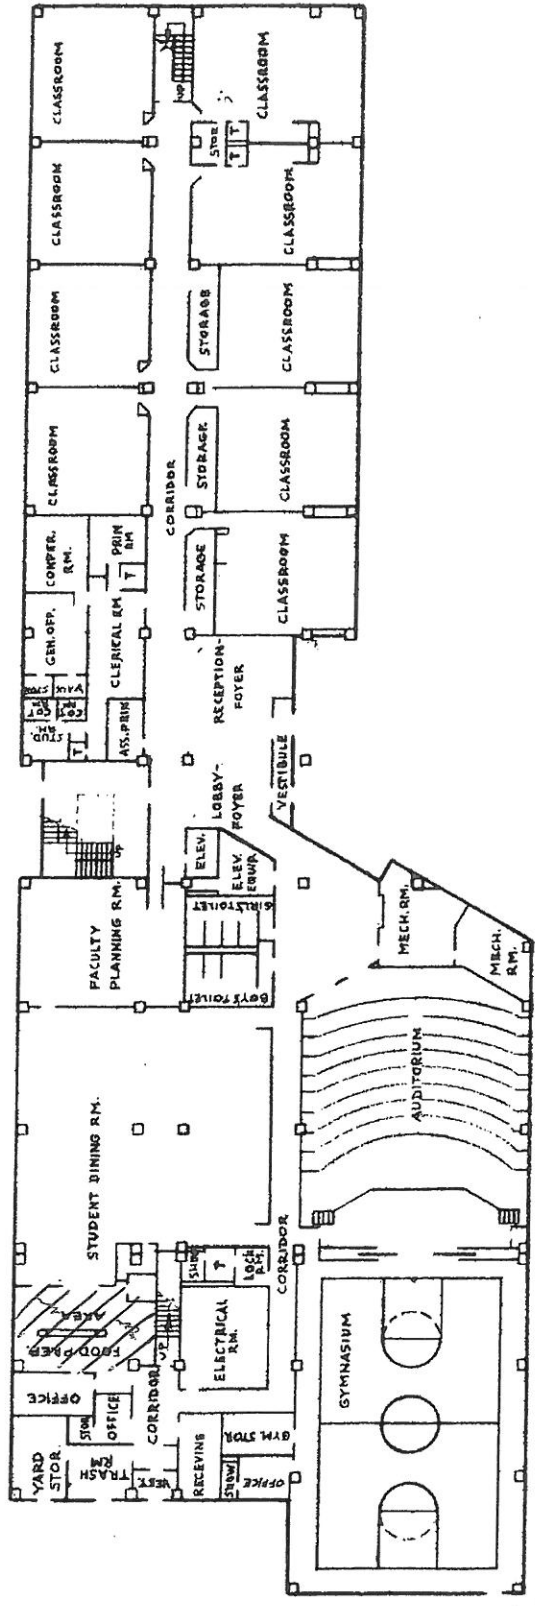
**FIRST FLOOR PLAN**  
 SCALE 1" = 40'

**RALPH H. METCALFE ELEMENTARY SCHOOL**  
 12339 S. NORMAL  
 CHICAGO, ILL
