**ILLINOIS DEPARTMENT OF PUBLIC HEALTH
AHERA THREE YEAR REINSPECTION
ASBESTOS ABATEMENT PROGRAM
SCHOOL INFORMATION FORM**

NAME OF SCHOOL DISTRICT: CHICAGO SCHOOL DIST 299
SCHOOL ID NUMBER: 14-016-2990-0039
SCHOOL NAME: King High School
ADDRESS OF SCHOOL: 4445 S. Drexel
CITY: Chicago, IL, 60653

DATE REINSPECTION COMPLETED: 4/18/2013 ENROLLMENT 849
IDPH INSPECTOR LICENSE NUMBER: 100-18099
IDPH LICENSED INSPECTOR NAME (Please Print): Rondell Adams
IDPH MP LICENSE NUMBER: 100-09870
IDPH LICENSED MANAGEMENT PLANNER NAME (Please Print): Todd Huffer

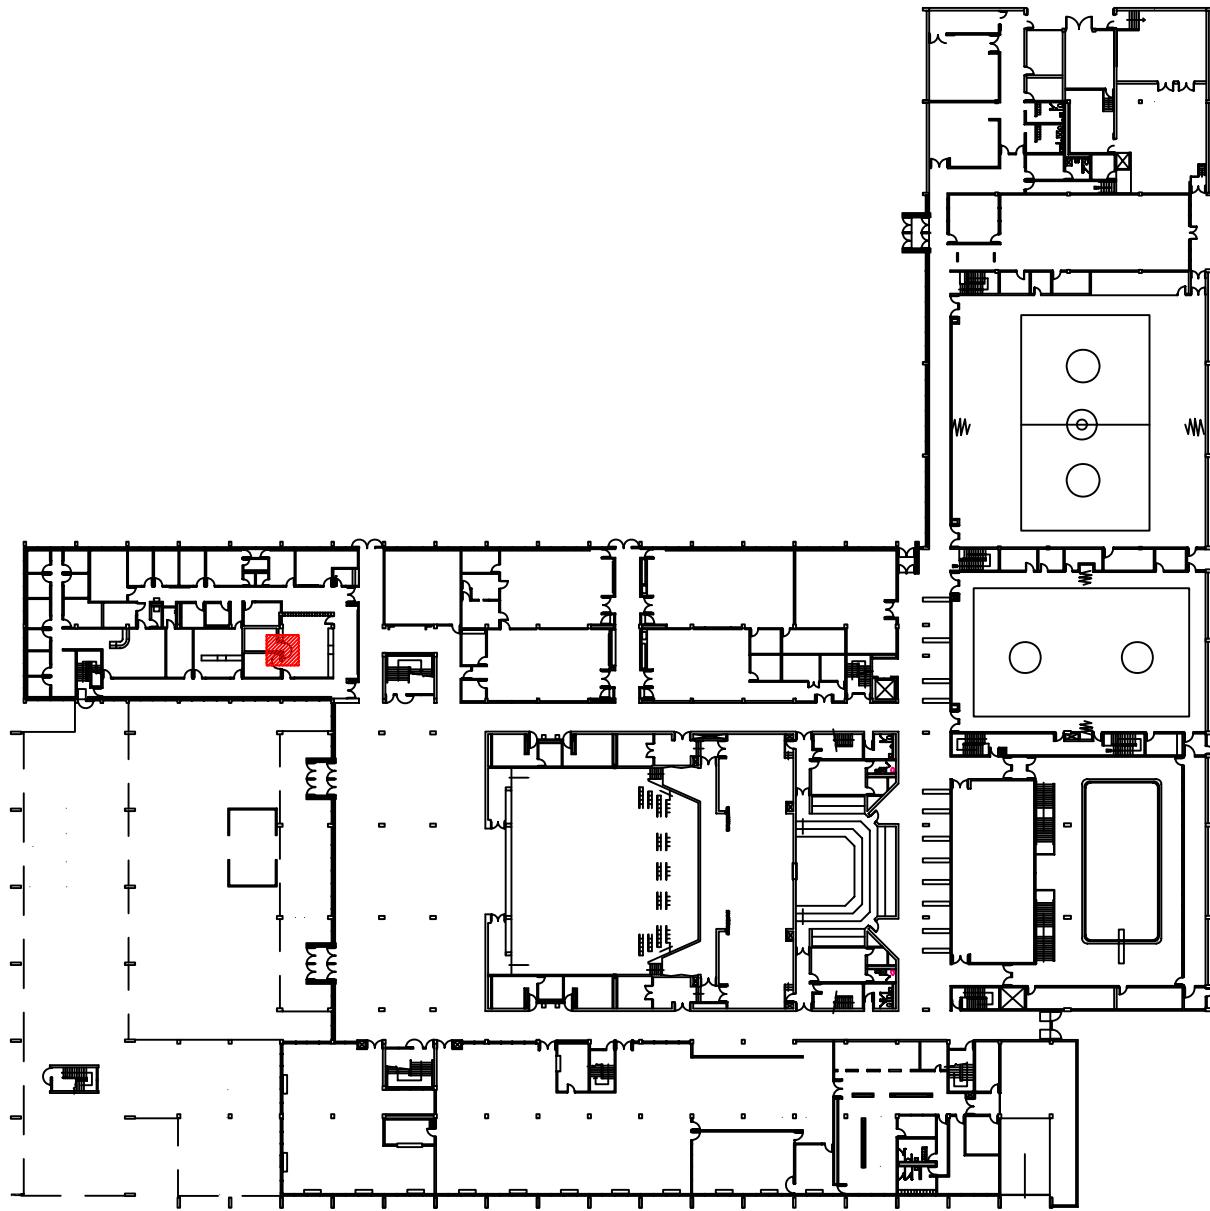
K:\CPS 2011\2013 Three Year\A\Asst Drawings\Region 4\N\King High School\King First Floor.dwg

HOMOGENEOUS AREA: **86**
MATERIAL DESCRIPTION: **12"x12" Green VFT**
MATERIAL LOCATION: **Room 118, Restroom**
MATERIAL QUANTITY: **15** MATERIAL UNITS: **SF**
MATERIAL CATEGORY: **MISC** FRIABLE: **No**
ASBESTOS TYPE: **Assumed**
DISTURBANCE POTENTIAL: **LOW** CONDITION:
AHERA DAMAGE CATEGORY: **6 ACBM with the potential for damage**
ACCESSIBILITY: **Within Reach** DAMAGE REASON:
DAMAGE QUANTITY: **0** DAMAGE REASON:
DAMAGE UNITS: **SF**
COMMENTS:
