ILLINOIS DEPARTMENT OF PUBLIC HEALTH
AHERA THREE YEAR REINSPECTION
ASBESTOS ABATEMENT PROGRAM
SCHOOL INFORMATION FORM

NAME OF SCHOOL DISTRICT: CHICAGO SCHOOL DIST 299
SCHOOL ID NUMBER: 14-016-2990-0531
SCHOOL NAME: Dunbar High School
ADDRESS OF SCHOOL: 3000 S. King Dr.
CITY: Chicago, IL, 60616

K:\CPS 2011\2013 Three Year\A\Gad Drawings\Region 4\13\1303 Dunbar High School\2013 Asbestos Reinspection\2013 Asbestos Reinspection Key Notes

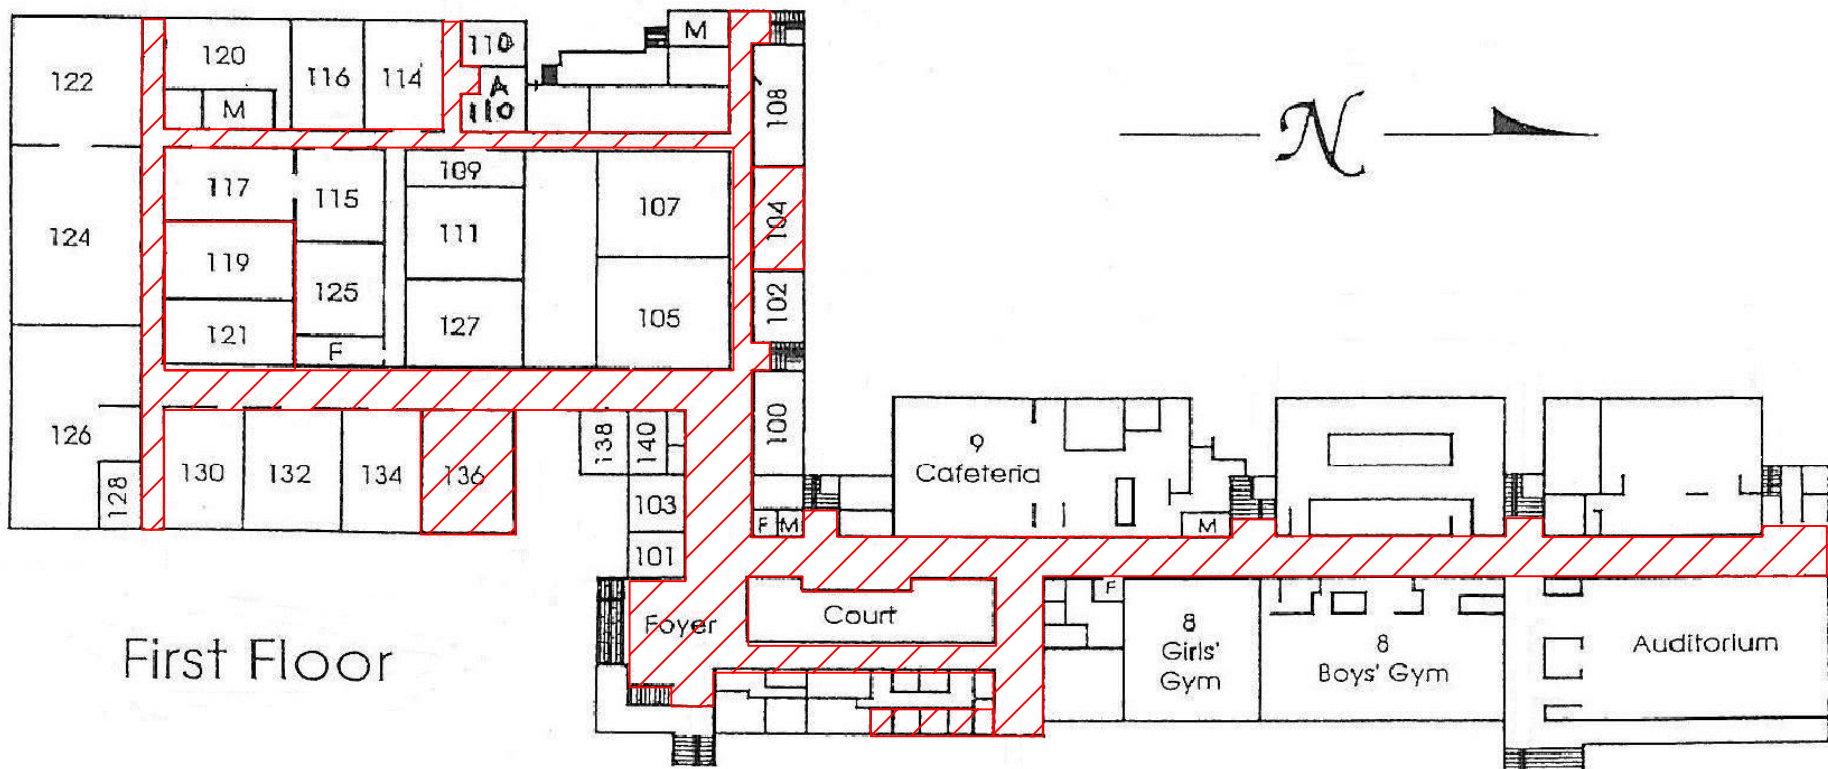
First Floor

HOMOGENEOUS AREA: **87**
MATERIAL DESCRIPTION: **Mastic for HA 85 and 86**
MATERIAL LOCATION: **Throughout Hallways and Various Classrooms**
MATERIAL QUANTITY: **30000** MATERIAL UNITS: **SF**
DAMAGE QUANTITY: **0** DAMAGE UNITS: **SF**

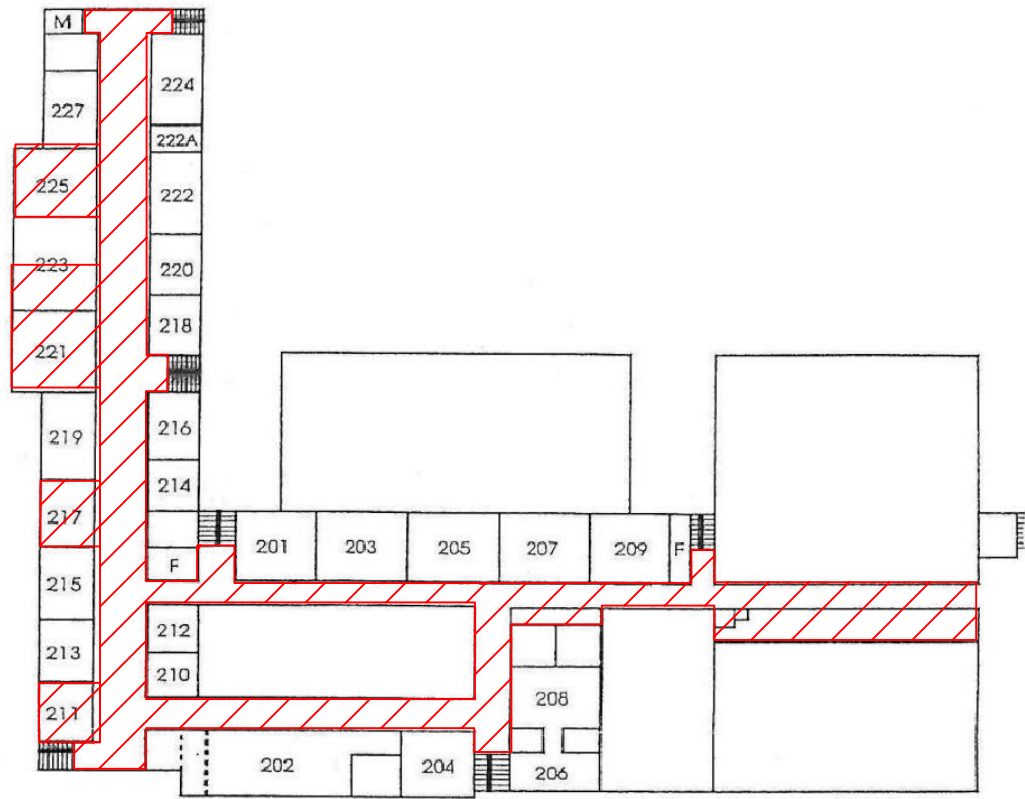
Second Floor

CCA PROJECT NUMBER
A320130001-173
DATE
03/14/2013
SHEET NUMBER
HA-87
