**ILLINOIS DEPARTMENT OF PUBLIC HEALTH
AHERA THREE YEAR REINSPECTION
ASBESTOS ABATEMENT PROGRAM
SCHOOL INFORMATION FORM**

NAME OF SCHOOL DISTRICT: CHICAGO SCHOOL DIST 299
SCHOOL ID NUMBER: 14-016-2990-232C
SCHOOL NAME: Chicago International Charter - West Belden
Campus
ADDRESS OF SCHOOL: 2245 North McVicker Avenue
CITY: Chicago, IL, 60639

DATE REINSPECTION COMPLETED: 4/5/2013 ENROLLMENT 500
IDPH INSPECTOR LICENSE NUMBER: 100-11093
IDPH LICENSED INSPECTOR NAME (Please Print): David Avila
IDPH MP LICENSE NUMBER: 100-07342
IDPH LICENSED MANAGEMENT PLANNER NAME (Please Print): Jigar Shah

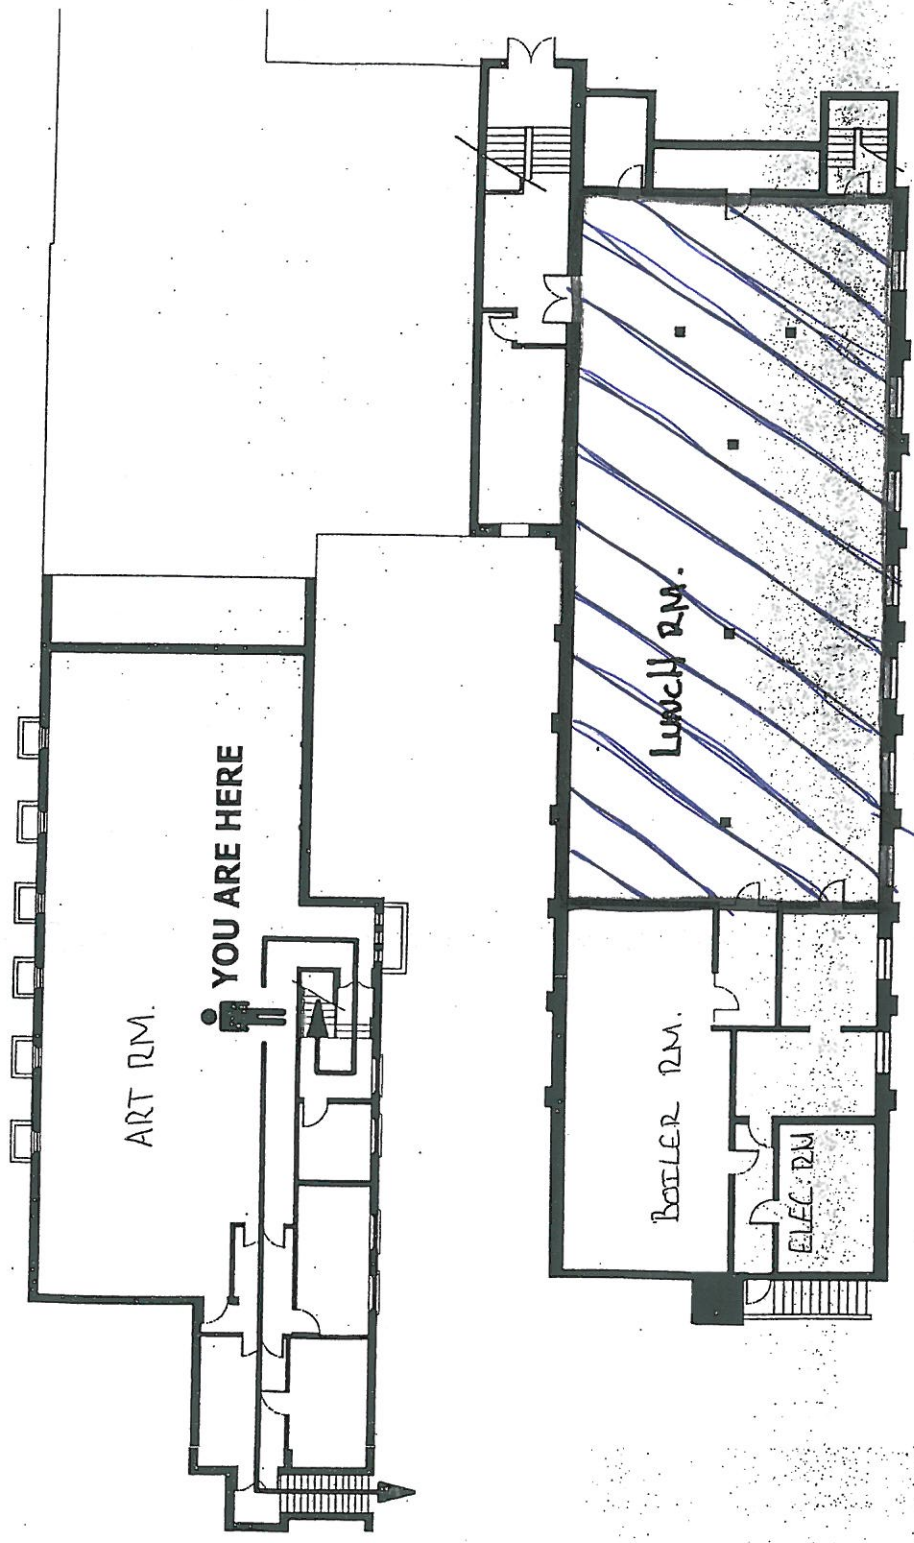
HASO & HASO /
VAT MASTIC

12x12 GRAY w/ LIGHT GRAY SPECKS VAT & MASTIC

HOMOGENEOUS AREA: **51**
MATERIAL DESCRIPTION: **12" X 12" gray with light gray specks, Mastic**
MATERIAL LOCATION: **Lunch Room (1935 Bldg)**
MATERIAL QUANTITY: **2400** MATERIAL UNITS: **SF**
DAMAGE QUANTITY: DAMAGE UNITS: **SF**

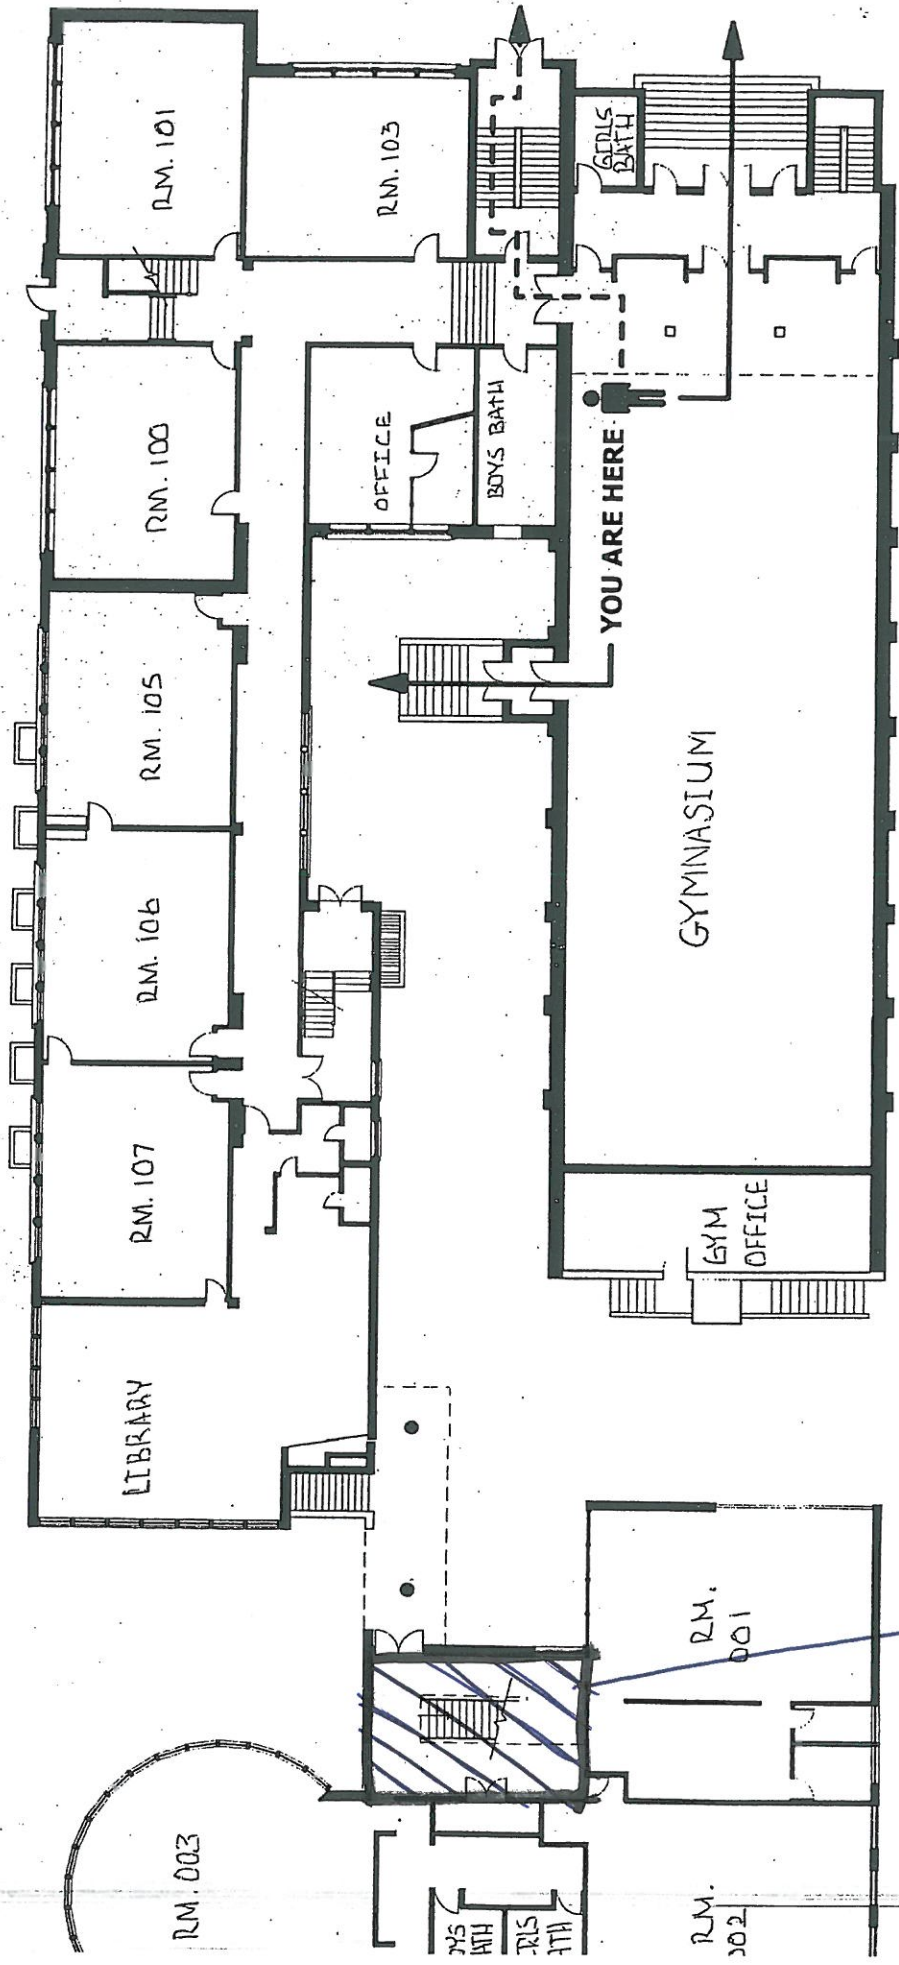
FIRST FLOOR

MAS2 & MAS3
VFT
MASTIC

HOMOGENEOUS AREA: **52**
MATERIAL DESCRIPTION: **12" X 12" white with beige specks, VFT**
MATERIAL LOCATION: **Entrance Corridor, Annex Bldg**
MATERIAL QUANTITY: **400** MATERIAL UNITS: **SF**
MATERIAL CATEGORY: **MISC** FRIABLE: **Yes**
ASBESTOS TYPE: **Assumed**
DISTURBANCE POTENTIAL: **MODERATE** CONDITION:
AHERA DAMAGE CATEGORY: **6 ACBM with the potential for damage**
ACCESSIBILITY: **Within Reach** DAMAGE REASON:
DAMAGE QUANTITY: DAMAGE REASON:
DAMAGE UNITS: **SF**
COMMENTS:

HOMOGENEOUS AREA: **53**
MATERIAL DESCRIPTION: **12" X 12" white with beige specks, Mastic**
MATERIAL LOCATION: **Entrance Corridor, Annex Bldg**
MATERIAL QUANTITY: **400** MATERIAL UNITS: **SF**
MATERIAL CATEGORY: **MISC** FRIABLE: **Yes**
ASBESTOS TYPE: **Assumed**
DISTURBANCE POTENTIAL: **LOW** CONDITION:
AHERA DAMAGE CATEGORY: **6 ACBM with the potential for damage**
ACCESSIBILITY: **Not Reachable** DAMAGE REASON:
DAMAGE QUANTITY: DAMAGE REASON:
DAMAGE UNITS: **SF**
COMMENTS:
