ILLINOIS DEPARTMENT OF PUBLIC HEALTH
AHERA THREE YEAR REINSPECTION
ASBESTOS ABATEMENT PROGRAM
SCHOOL INFORMATION FORM

NAME OF SCHOOL DISTRICT: CHICAGO SCHOOL DIST 299
SCHOOL ID NUMBER: 14-016-2990-2338
SCHOOL NAME: Mayo School
ADDRESS OF SCHOOL: 249 E. 37th St.
CITY: Chicago, IL, 60653

DATE REINSPECTION COMPLETED: 4/2/2013 ENROLLMENT 409
IDPH INSPECTOR LICENSE NUMBER: 100-11460
IDPH LICENSED INSPECTOR NAME (Please Print): Marcus Tsilimos
IDPH MP LICENSE NUMBER: 100-03613
IDPH LICENSED MANAGEMENT PLANNER NAME (Please Print): Daniel Juneau

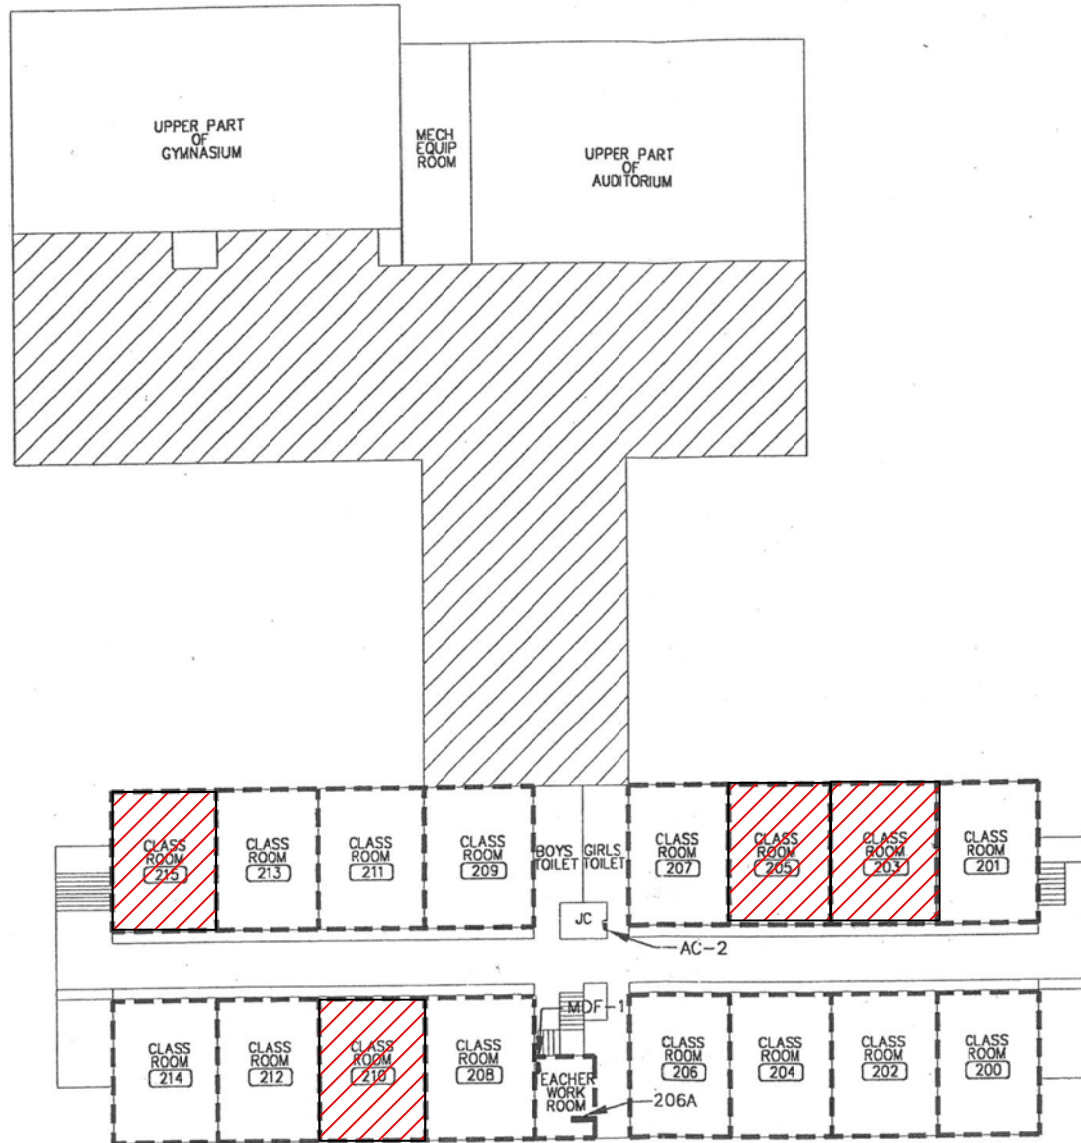
HOMOGENEOUS AREA: **34**
MATERIAL DESCRIPTION: **12"x12" White w/Multicolored Speckles VFT Mastic**
MATERIAL LOCATION: **Room 116,118,203,205,210,215**
MATERIAL QUANTITY: **5400** MATERIAL UNITS: **SF**
DAMAGE QUANTITY: **0** DAMAGE UNITS: **SF**
