**ILLINOIS DEPARTMENT OF PUBLIC HEALTH  
AHERA THREE YEAR REINSPECTION  
ASBESTOS ABATEMENT PROGRAM  
SCHOOL INFORMATION FORM**

NAME OF SCHOOL DISTRICT: CHICAGO SCHOOL DIST 299  
SCHOOL ID NUMBER: 14-016-2990-2184  
SCHOOL NAME: Edison Comprehensive School  
ADDRESS OF SCHOOL: 6220 N Olcott Avenue  
CITY: Chicago, IL, 60631

**THREE-YEAR REINSPECTION**

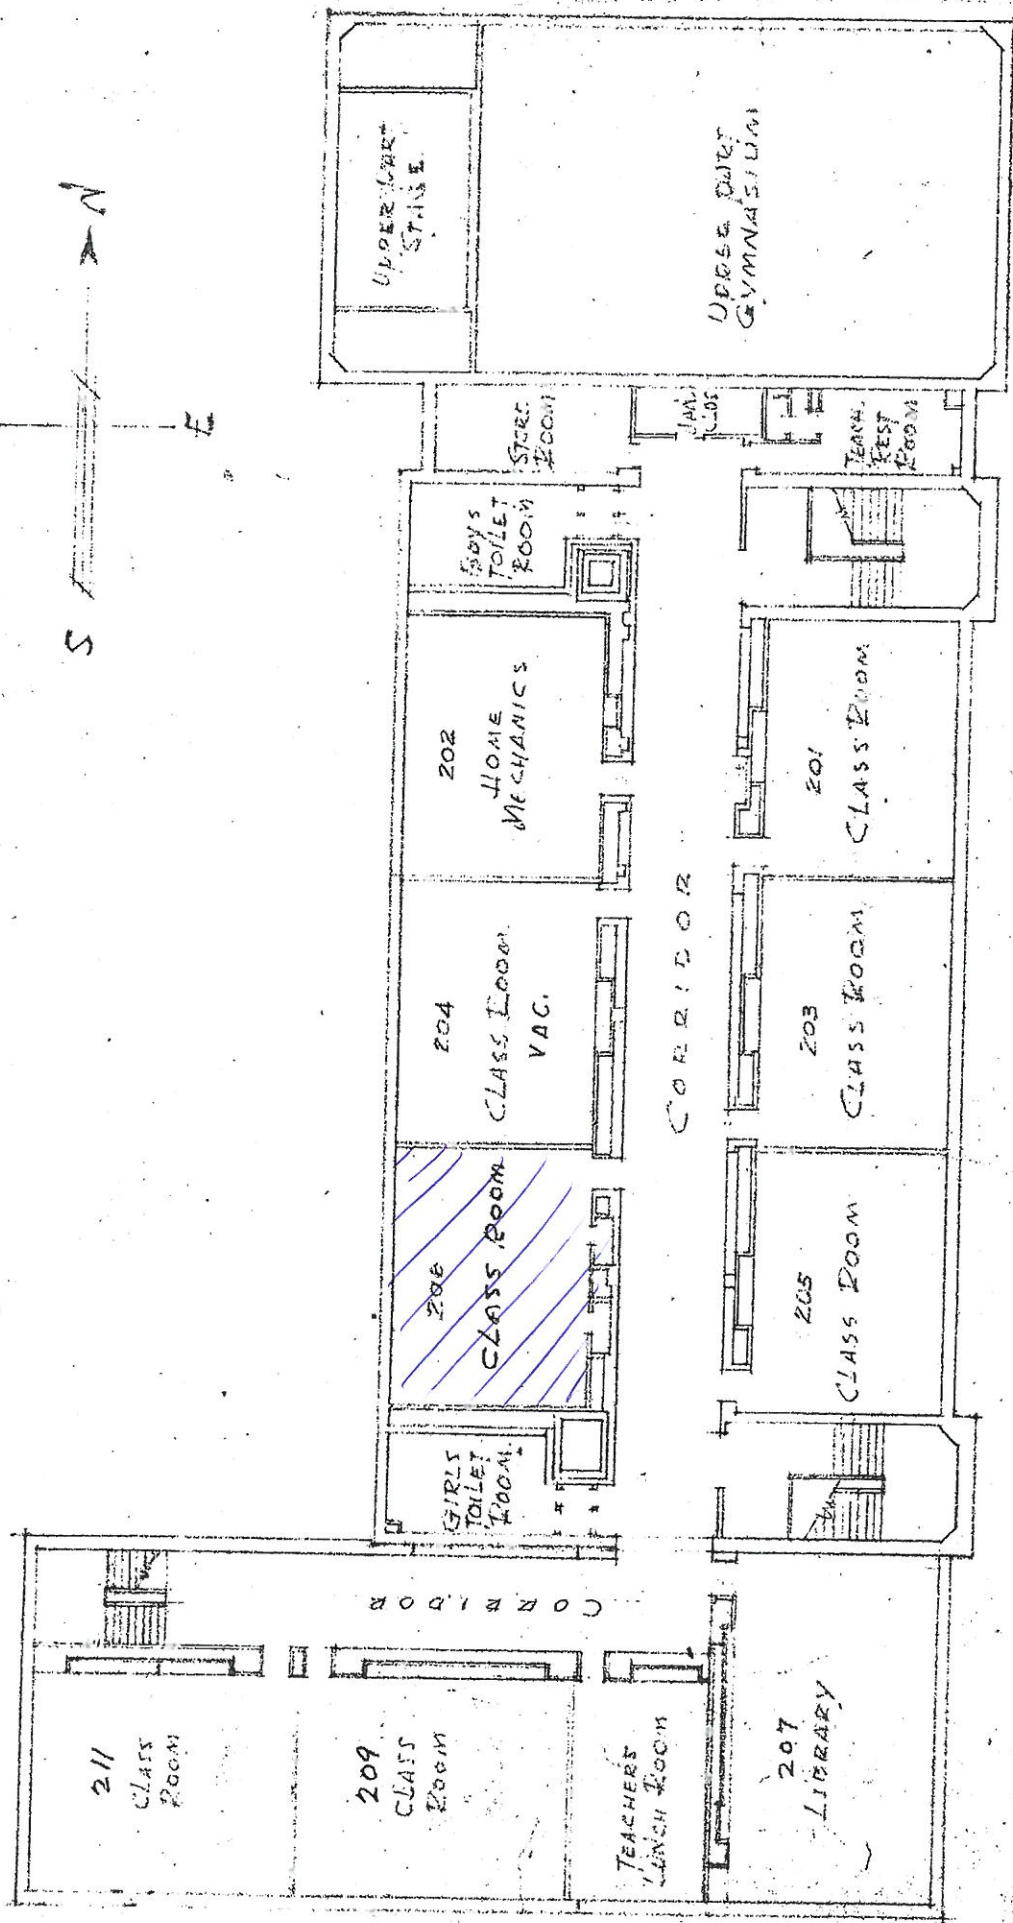
SECOND FLOOR PLAN  
SCALE: 1/20 = 1'-0"

12 FT 12x12" brown white streaks with mastic

HOMOGENEOUS AREA: **55A**  
MATERIAL DESCRIPTION: **12"x12" brown and white VFT MASTIC**  
MATERIAL LOCATION: **Room 206**  
MATERIAL QUANTITY: **800**    MATERIAL UNITS: **SF**  
MATERIAL CATEGORY: **MISC**    FRIABLE: **No**  
ASBESTOS TYPE: **Assumed**  
DISTURBANCE POTENTIAL: **LOW**    CONDITION:  
AHERA DAMAGE CATEGORY: **6 ACBM with the potential for damage**  
ACCESSIBILITY: **Within Reach**    DAMAGE REASON:  
DAMAGE QUANTITY: **0**    DAMAGE REASON:  
DAMAGE UNITS: **SF**  
COMMENTS:

HOMOGENEOUS AREA: **55**  
MATERIAL DESCRIPTION: **12"x12" brown and white VFT**  
MATERIAL LOCATION: **Room 206**  
MATERIAL QUANTITY: **800**    MATERIAL UNITS: **SF**  
MATERIAL CATEGORY: **MISC**    FRIABLE: **No**  
ASBESTOS TYPE: **Assumed**  
DISTURBANCE POTENTIAL: **LOW**    CONDITION:  
AHERA DAMAGE CATEGORY: **6 ACBM with the potential for damage**  
ACCESSIBILITY: **Within Reach**    DAMAGE REASON:  
DAMAGE QUANTITY: **0**    DAMAGE REASON:  
DAMAGE UNITS: **SF**  
COMMENTS:
