ILLINOIS DEPARTMENT OF PUBLIC HEALTH
AHERA THREE YEAR REINSPECTION
ASBESTOS ABATEMENT PROGRAM
SCHOOL INFORMATION FORM

NAME OF SCHOOL DISTRICT: CHICAGO SCHOOL DIST 299
SCHOOL ID NUMBER: 14-016-2990-2208
SCHOOL NAME: Frazier School
ADDRESS OF SCHOOL: 4027 W. Grenshaw
CITY: Chicago, IL, 60624

DATE REINSPECTION COMPLETED: 4/6/2013 ENROLLMENT 0

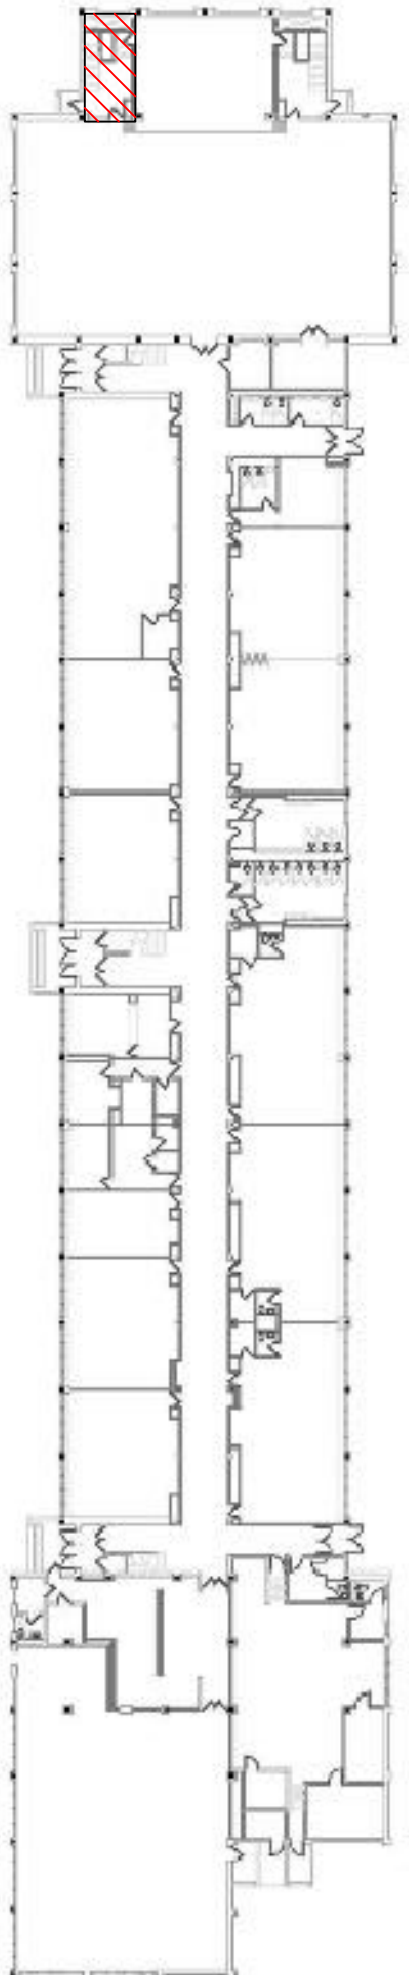
ASBESTOS REINSPECTION KEY NOTES:

HOMOGENEOUS AREA: **65M**
MATERIAL DESCRIPTION: **12"x12" Dark Blue w/Blue Floor Tile Mastic**
MATERIAL LOCATION: **Lunch Room, Stone Room, English Office, 1st Floor East Hallway**
MATERIAL QUANTITY: **3800** MATERIAL UNITS: **SF**
MATERIAL CATEGORY: **MISC** FRIABLE: **No**
ASBESTOS TYPE: **Assumed**
DISTURBANCE POTENTIAL: **LOW** CONDITION:
AHERA DAMAGE CATEGORY: **6 ACBM with the potential for damage**
ACCESSIBILITY: **Not Reachable** DAMAGE REASON:
DAMAGE QUANTITY: **0** DAMAGE REASON:
DAMAGE UNITS: **SF**
COMMENTS:

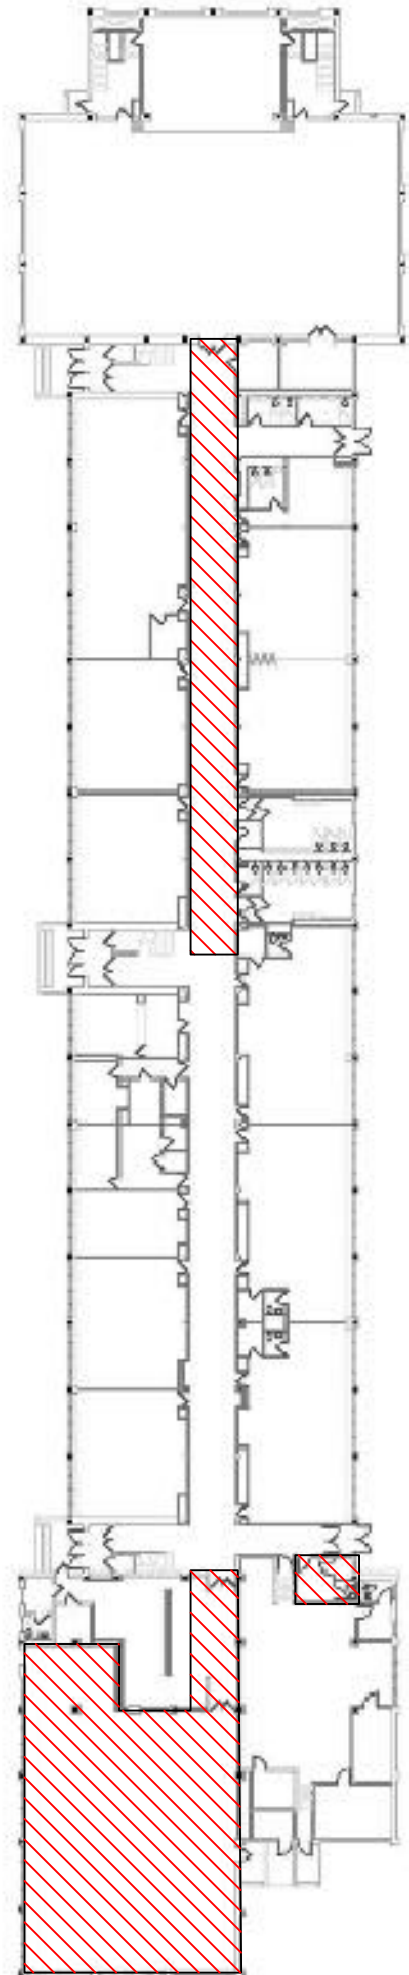
ASBESTOS REINSPECTION KEY NOTES:

HOMOGENEOUS AREA: **68M**
MATERIAL DESCRIPTION: **12"x12" White w/Multi Color Floor Tile Mastic**
MATERIAL LOCATION: **1st Floor West Hallway**
MATERIAL QUANTITY: **2190** MATERIAL UNITS: **SF**
MATERIAL CATEGORY: **MISC** FRIABLE: **No**
ASBESTOS TYPE: **Assumed**
DISTURBANCE POTENTIAL: **LOW** CONDITION:
AHERA DAMAGE CATEGORY: **6 ACBM with the potential for damage**
ACCESSIBILITY: **Not Reachable** DAMAGE REASON:
DAMAGE QUANTITY: **0** DAMAGE REASON:
DAMAGE UNITS: **SF**
COMMENTS:

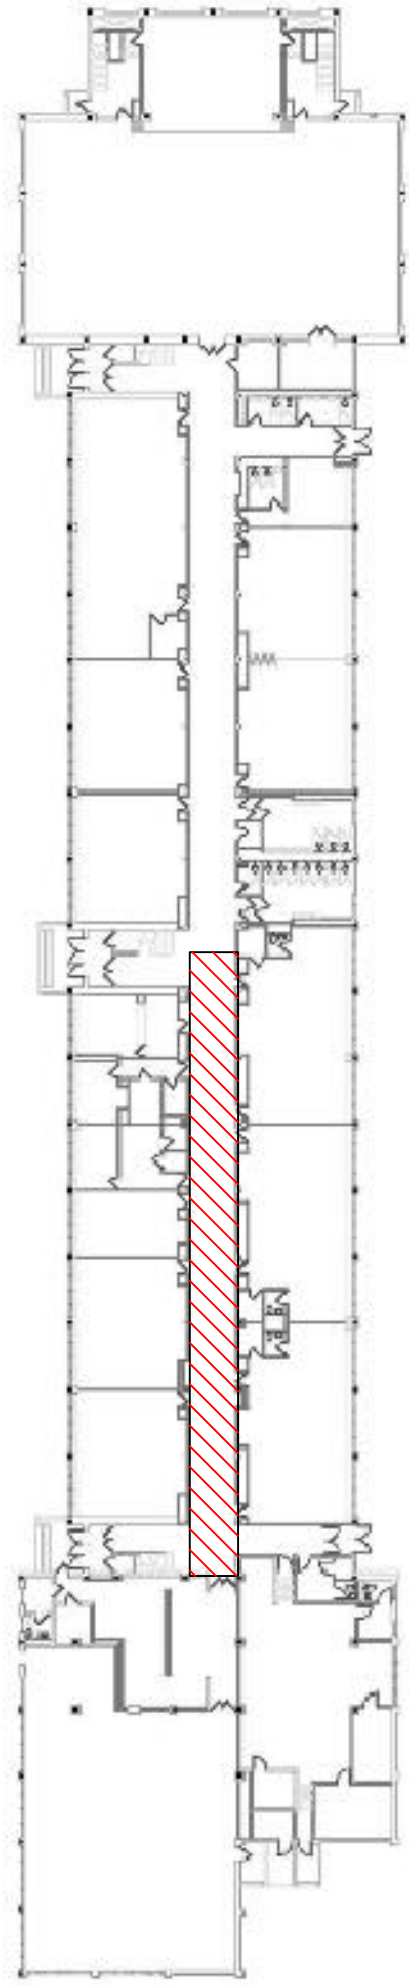
ASBESTOS REINSPECTION KEY NOTES:

HOMOGENEOUS AREA: **65**
MATERIAL DESCRIPTION: **12"x12" Dark Blue w/Blue Floor Tile**
MATERIAL LOCATION: **Lunch Room, Stone Room, English Office, 1st Floor East Hallway**
MATERIAL QUANTITY: **3800** MATERIAL UNITS: **SF**
MATERIAL CATEGORY: **MISC** FRIABLE: **No**
ASBESTOS TYPE: **Assumed**
DISTURBANCE POTENTIAL: **LOW** CONDITION:
AHERA DAMAGE CATEGORY: **6 ACBM with the potential for damage**
ACCESSIBILITY: **Within Reach** DAMAGE REASON:
DAMAGE QUANTITY: **0** DAMAGE REASON:
DAMAGE UNITS: **SF**
COMMENTS:
