ILLINOIS DEPARTMENT OF PUBLIC HEALTH
AHERA THREE YEAR REINSPECTION
ASBESTOS ABATEMENT PROGRAM
SCHOOL INFORMATION FORM

NAME OF SCHOOL DISTRICT: CHICAGO SCHOOL DIST 299
SCHOOL ID NUMBER: 14-016-2990-0009
SCHOOL NAME: DuSable Campus
ADDRESS OF SCHOOL: 4934 S. Wabash
CITY: Chicago, IL, 60615

DATE REINSPECTION COMPLETED: 4/18/2013 ENROLLMENT 0

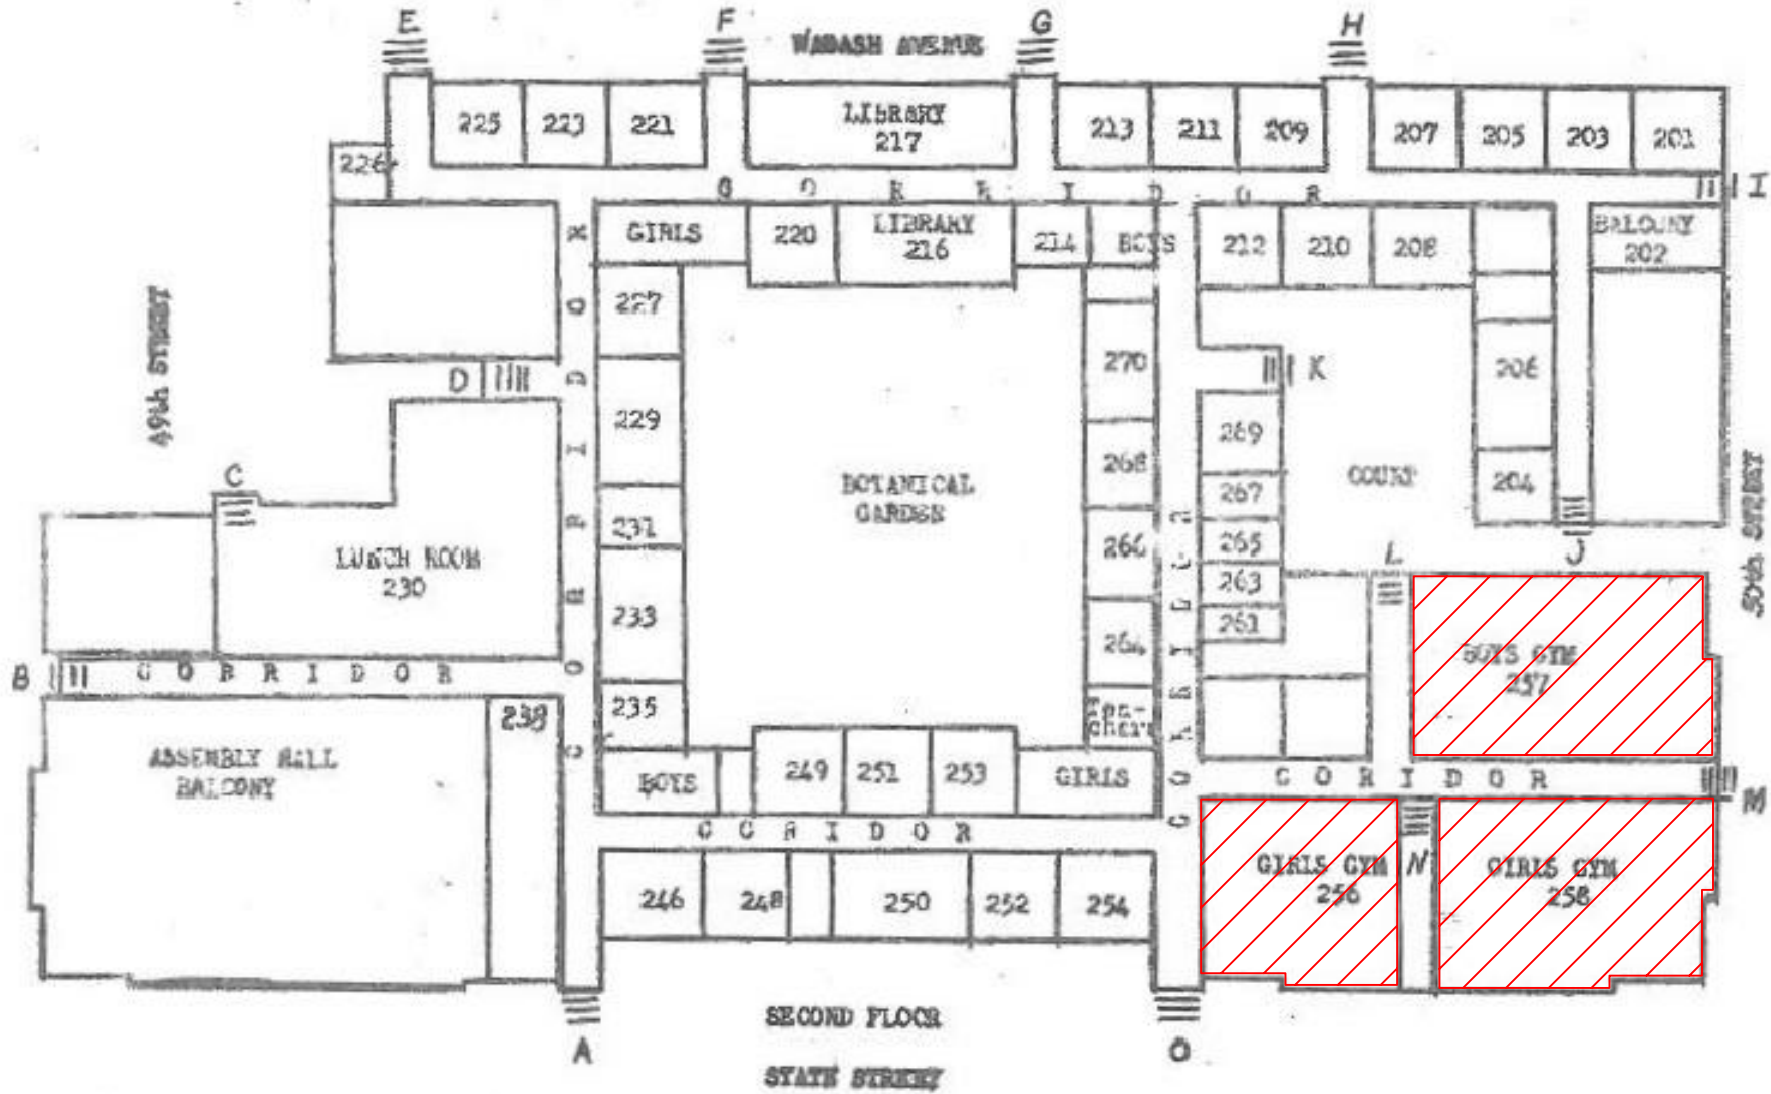
HOMOGENEOUS AREA: **166**
MATERIAL DESCRIPTION: **1'x1' White Ceiling Tile**
MATERIAL LOCATION: **Gymnasiums 256, 257, and 258**
MATERIAL QUANTITY: **17500** MATERIAL UNITS: **SF**
DAMAGE QUANTITY: **0** DAMAGE UNITS: **SF**

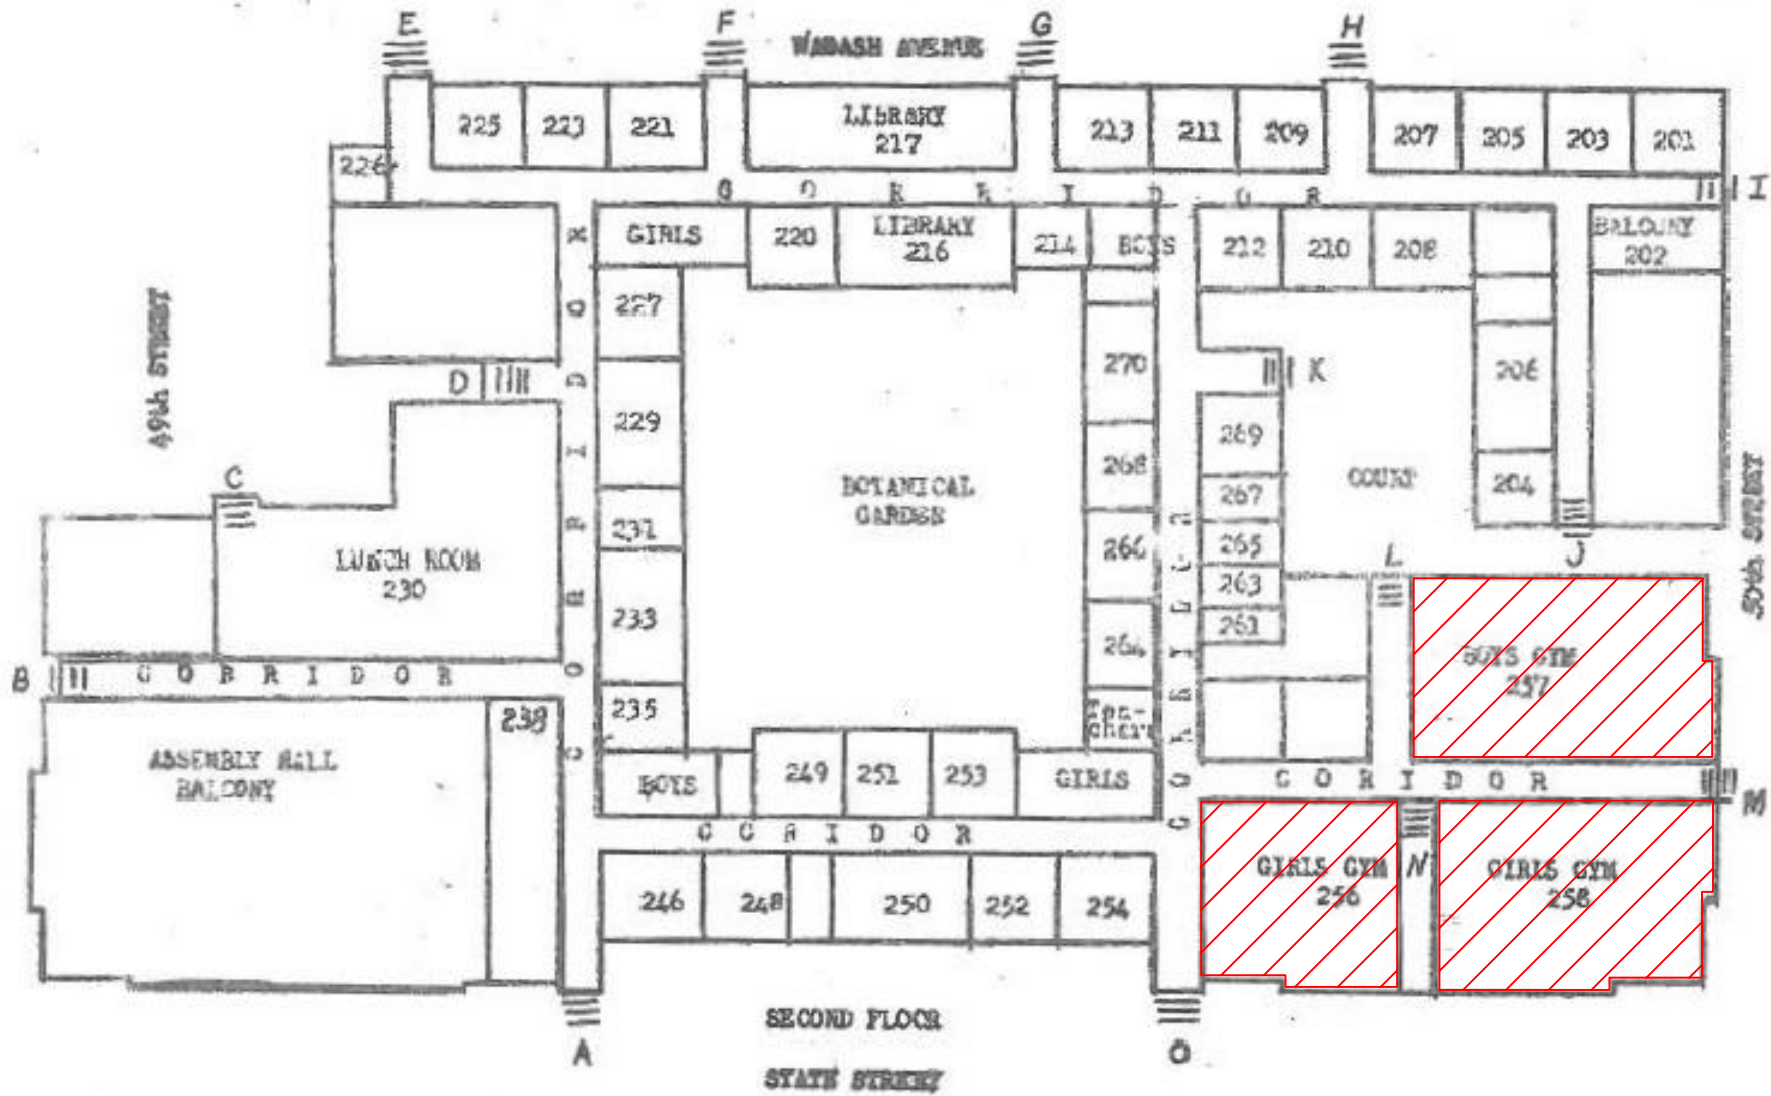
HOMOGENEOUS AREA: **167**
MATERIAL DESCRIPTION: **1'x1' White Ceiling Tile Adhesive**
MATERIAL LOCATION: **Gymnasiums 256, 257 and 258**
MATERIAL QUANTITY: **17500** MATERIAL UNITS: **SF**
DAMAGE QUANTITY: **0** DAMAGE UNITS: **SF**
