**ILLINOIS DEPARTMENT OF PUBLIC HEALTH  
AHERA THREE YEAR REINSPECTION  
ASBESTOS ABATEMENT PROGRAM  
SCHOOL INFORMATION FORM**

NAME OF SCHOOL DISTRICT: CHICAGO SCHOOL DIST 299  
SCHOOL ID NUMBER: 14-016-2990-002C  
SCHOOL NAME: Chicago International Charter - Bucktown School  
ADDRESS OF SCHOOL: 2235 N. Hamilton (2132W) 47  
CITY: Chicago, IL, 606473360

DATE REINSPECTION COMPLETED: 3/26/2013 ENROLLMENT 655

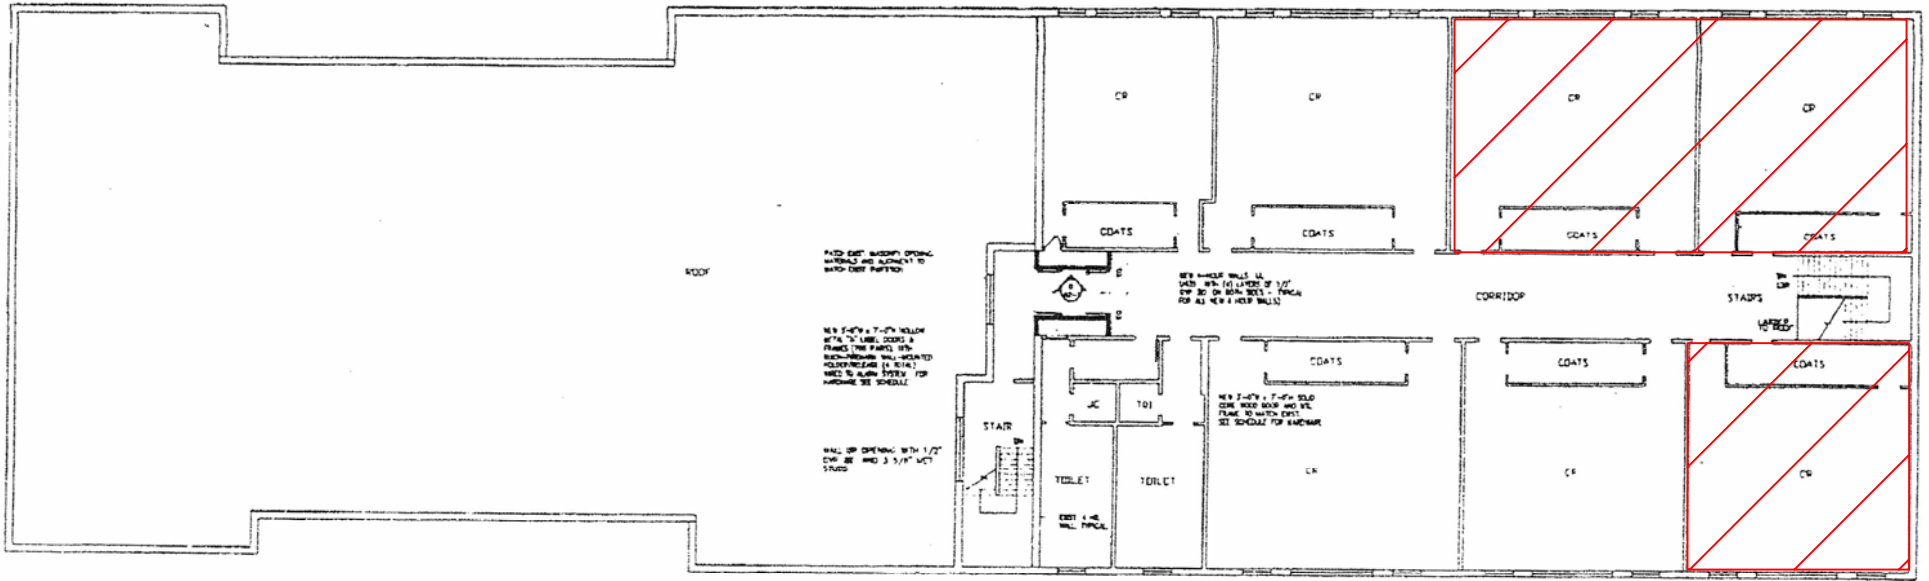
MCPD 08112013 Three Year's Good Drawings/Region 3/0/Chicago International Charter - Bucktown Third Floor

**ASBESTOS REINSPECTION KEY NOTES:**
