ILLINOIS DEPARTMENT OF PUBLIC HEALTH
AHERA THREE YEAR REINSPECTION
ASBESTOS ABATEMENT PROGRAM
SCHOOL INFORMATION FORM

NAME OF SCHOOL DISTRICT: CHICAGO SCHOOL DIST 299
SCHOOL ID NUMBER: 14-016-2990-2274
SCHOOL NAME: North Lawndale College Prep/Catalyst
CharterSchool
ADDRESS OF SCHOOL: 1616 S. Spaulding
CITY: Chicago, IL, 60623

DATE REINSPECTION COMPLETED: 4/2/2013 ENROLLMENT 0
IDPH INSPECTOR LICENSE NUMBER: 100-09725
IDPH LICENSED INSPECTOR NAME (Please Print): Patrick Hrycyk
IDPH MP LICENSE NUMBER: 100-03613
IDPH LICENSED MANAGEMENT PLANNER NAME (Please Print): Daniel Juneau

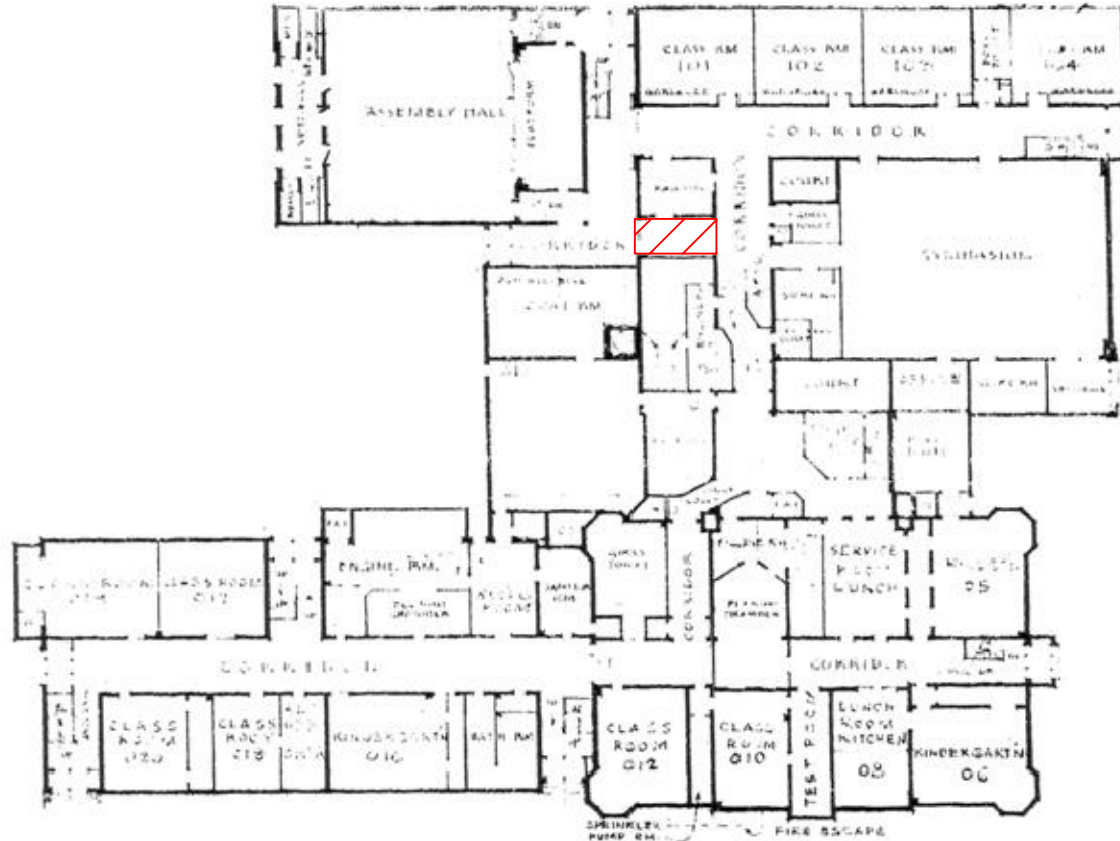
K:\CPS 2011\2013 Three Year\A\Gad Drawings\Region 3\N\North Lawndale College Prep -Catalyst Charter School\North Lawndale College Prep (Howland) Basement.dwg

HOMOGENEOUS AREA: **86M**
MATERIAL DESCRIPTION: **2 X 2 Tan W/White & Grey Floor Tile Mastic**
MATERIAL LOCATION: **Room 117 of 1912 Bldg**
MATERIAL QUANTITY: **1200** MATERIAL UNITS: **SF**
MATERIAL CATEGORY: **MISC** FRIABLE: **No**
ASBESTOS TYPE: **Assumed**
DISTURBANCE POTENTIAL: **LOW** CONDITION:
AHERA DAMAGE CATEGORY: **6 ACBM with the potential for damage**
ACCESSIBILITY: **Not Reachable** DAMAGE REASON:
DAMAGE QUANTITY: **0** DAMAGE REASON:
DAMAGE UNITS: **SF**
COMMENTS:

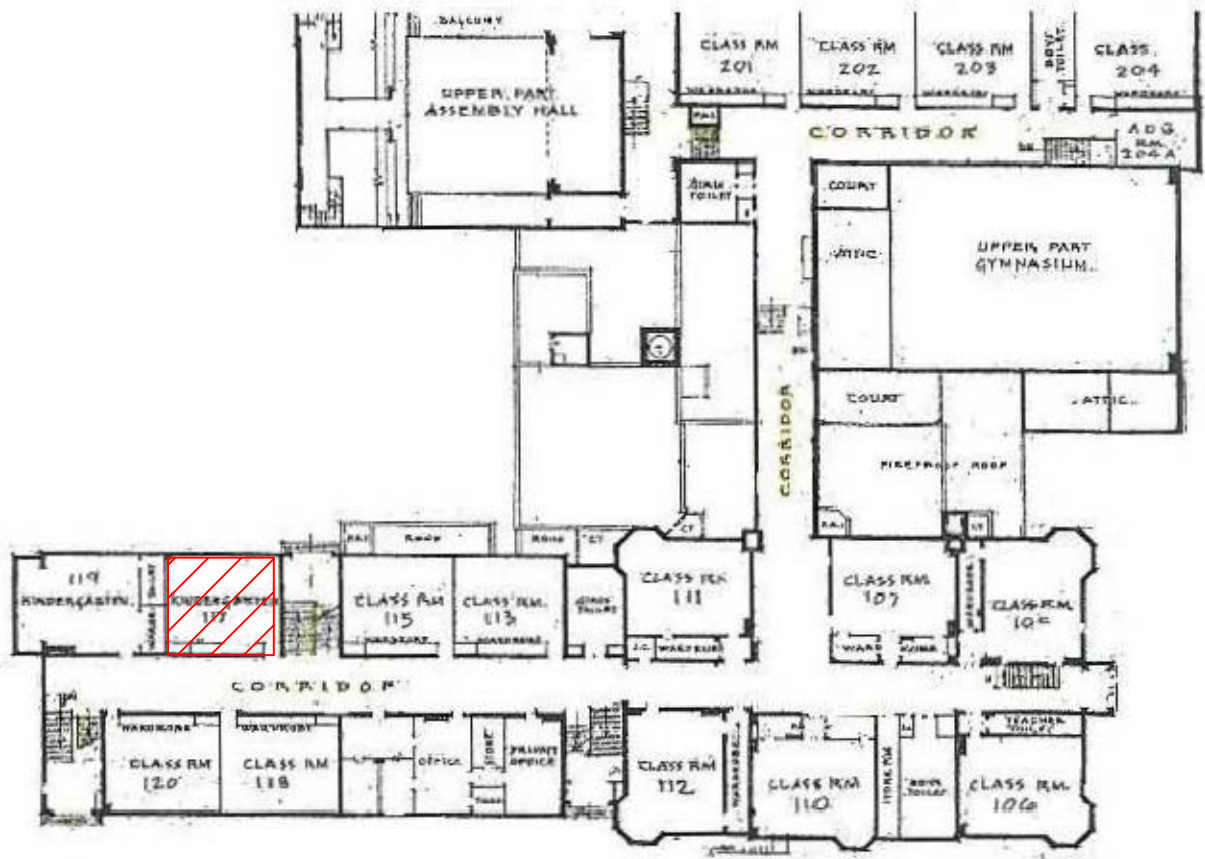
KCPSS 2011.0303 Three Year's Good Inaugural Region 3/N/North Lamdale College Prep -Catalyst Charter School/Howland First Floor.dwg

HOMOGENEOUS AREA: **86**
MATERIAL DESCRIPTION: **2 X 2 Tan W/White & Grey Floor Tile**
MATERIAL LOCATION: **Room 117 of 1912 Bldg**
MATERIAL QUANTITY: **1200** MATERIAL UNITS: **SF**
MATERIAL CATEGORY: **MISC** FRIABLE: **No**
ASBESTOS TYPE: **Assumed**
DISTURBANCE POTENTIAL: **LOW** CONDITION:
AHERA DAMAGE CATEGORY: **6 ACBM with the potential for damage**
ACCESSIBILITY: **Within Reach** DAMAGE REASON:
DAMAGE QUANTITY: **0** DAMAGE REASON:
DAMAGE UNITS: **SF**
COMMENTS:
