ILLINOIS DEPARTMENT OF PUBLIC HEALTH  
AHERA THREE YEAR REINSPECTION  
ASBESTOS ABATEMENT PROGRAM  
SCHOOL INFORMATION FORM

**THREE-YEAR REINSPECTION**

**Pulaski Academy**

Wednesday, May 15, 2013

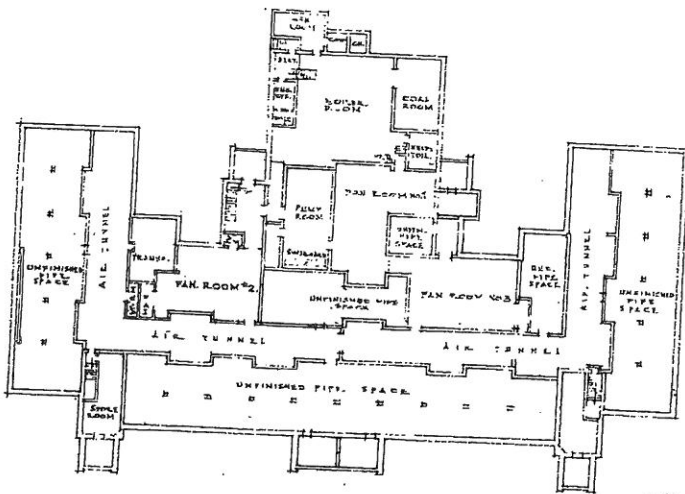
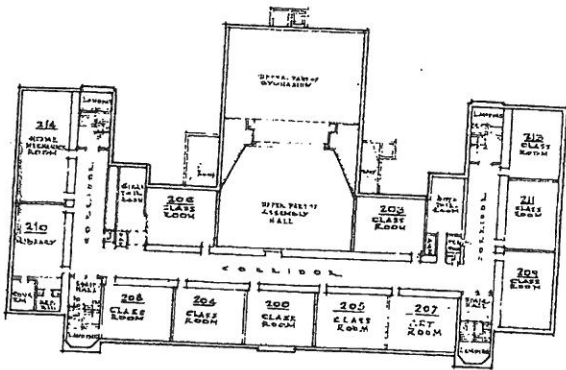
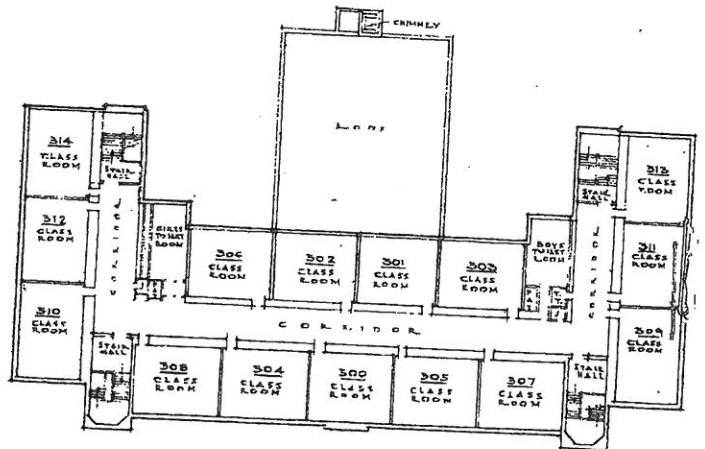
PULASKI SCHOOL  
NEW H A # 112 VET + # 113 ASSOCIATED  
MASTIC

Description: 12" x 12" BLUE WITH GRAY STREAKS  
Location: # 108  
Quantity: 800 S.F.

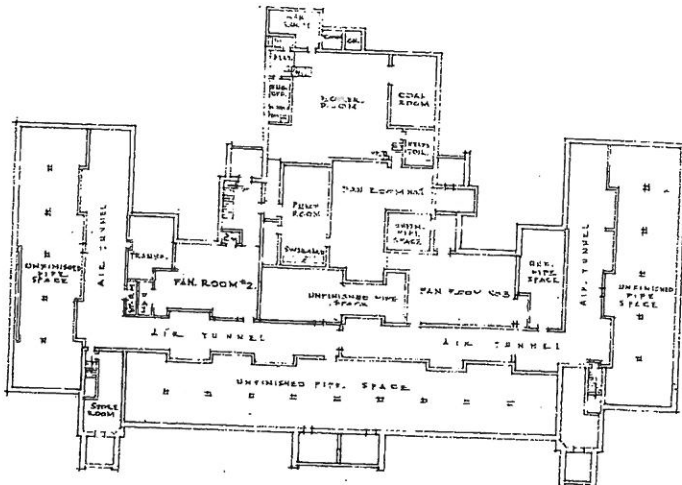
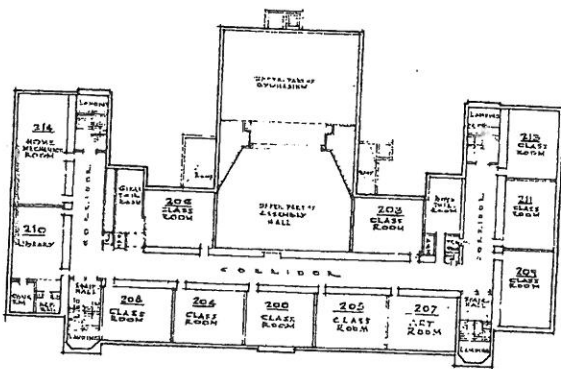
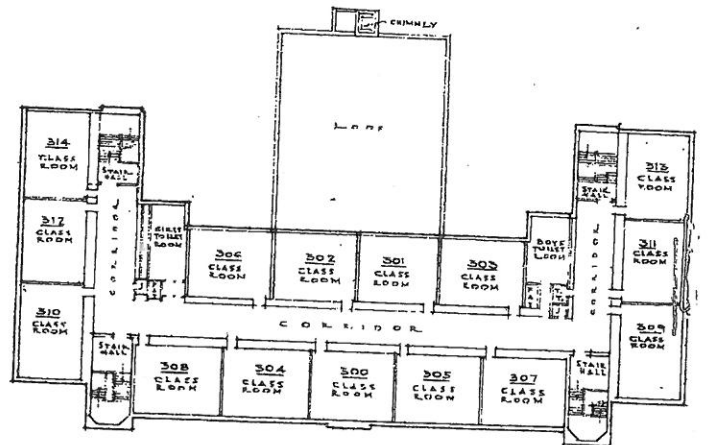
## NEW H A #112 VFT + #113 ASSOCIATED MASTIC

Description: 12" x 12" BLUE WITH GRAY STREAKS  
Location: #108  
Quantity: 800 S.F.

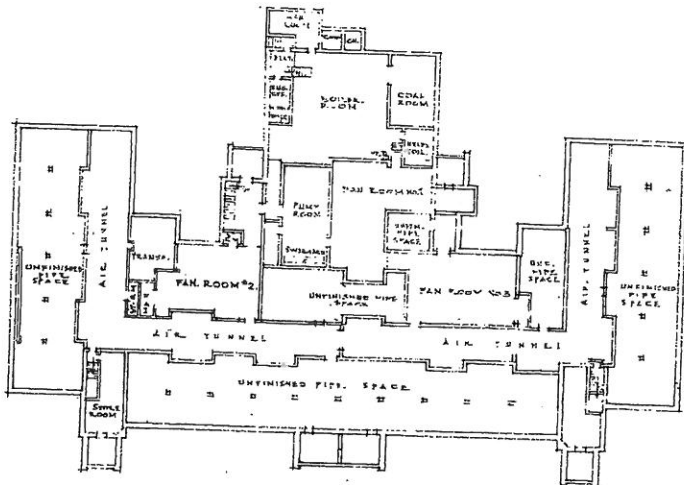
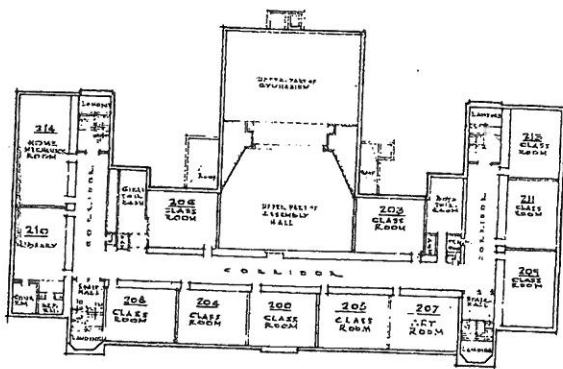
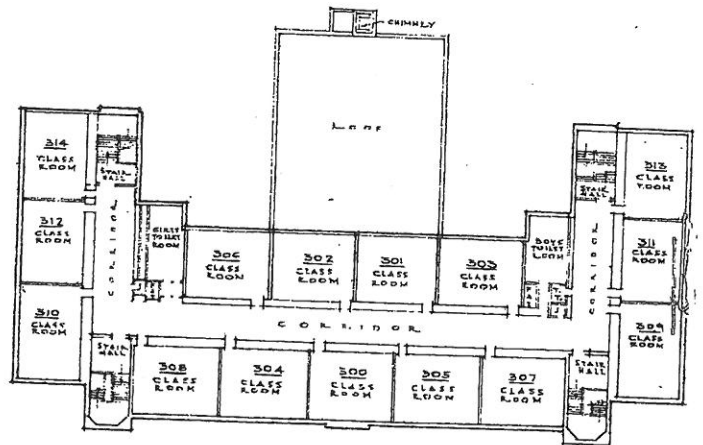
Location: NEW LUNCHROOM (OLD CLASSROOMS) # 110

Quantity: 3800 S.F.

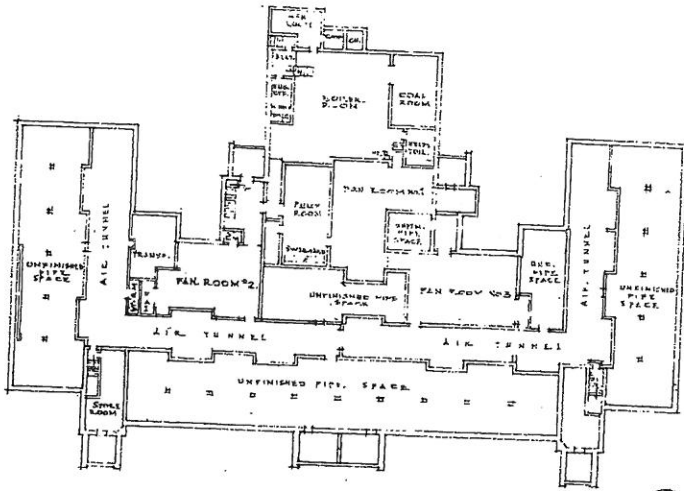
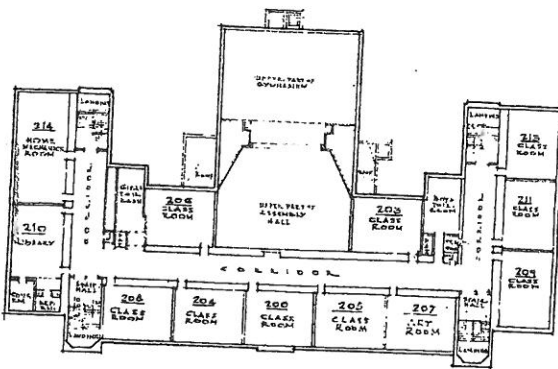
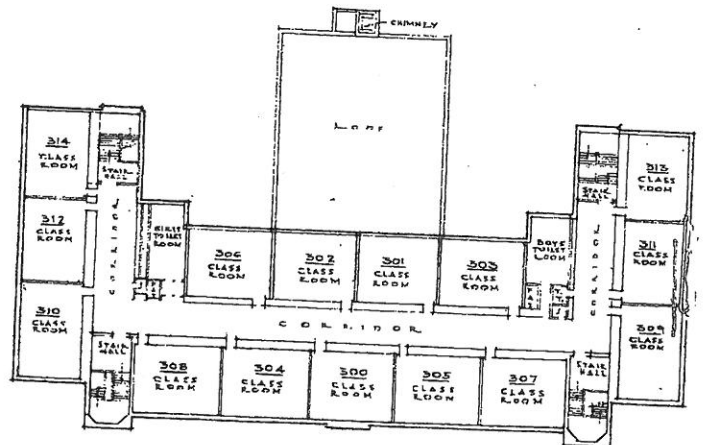
1949 BLDG

Description: 12" x 12" GREEN WITH LIGHT GREEN STREAKS  
Location: MUSIC ROOM, + # 110  
Quantity: 800 S.F.

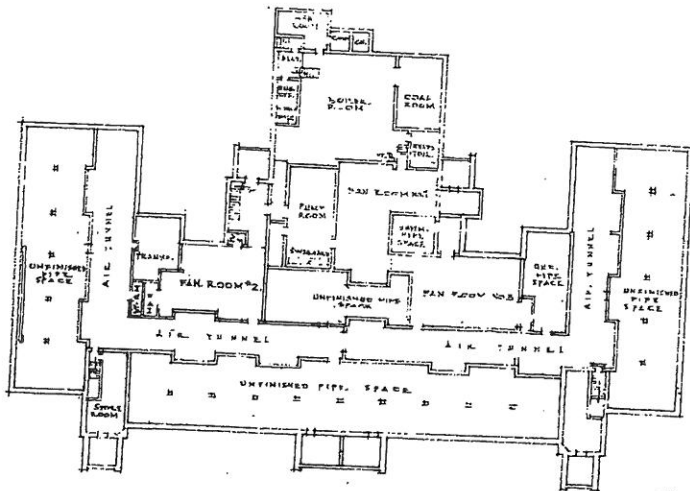
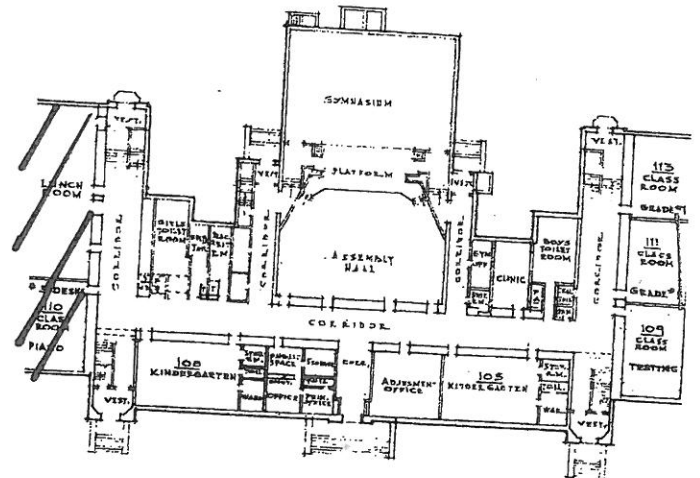
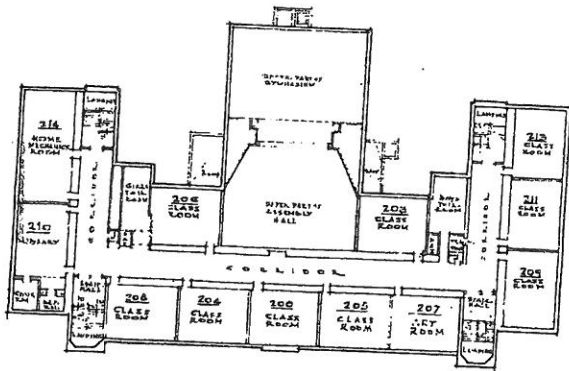
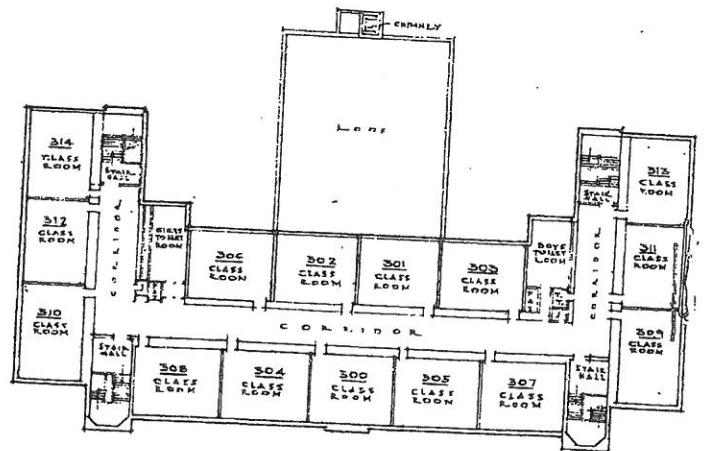
1949 BLDG

Description: 12" x 12" GREEN WITH LIGHT GREEN STREAKS  
Location: MUSIC ROOM, + # 110  
Quantity: 800 SF

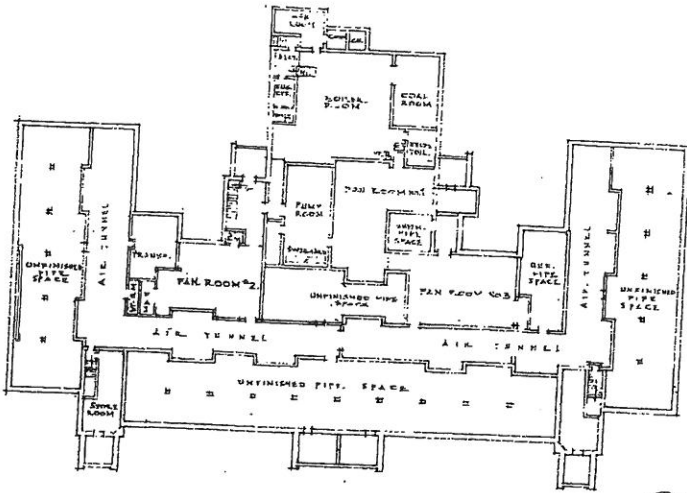
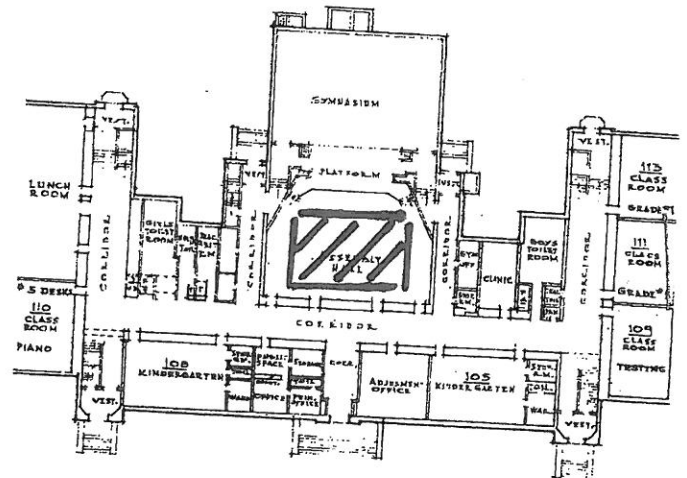
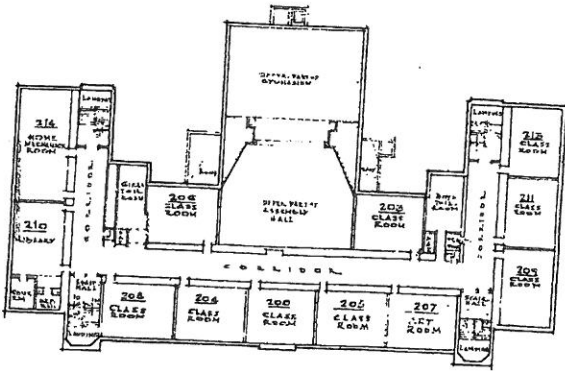
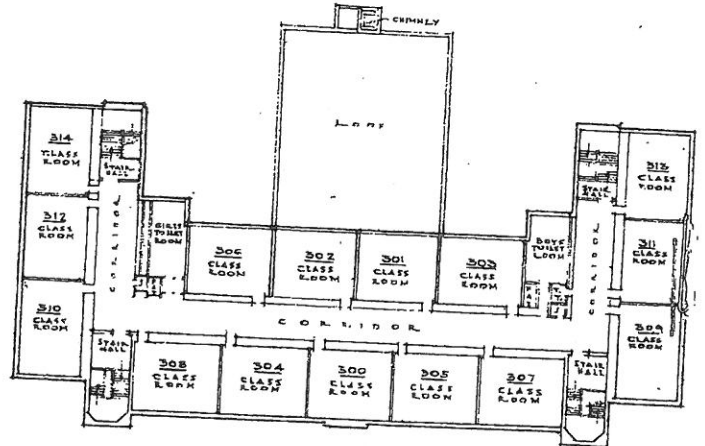
1949

Quantity: ASSEMBLY HALL - SEATING AREA  
1500 S.F.

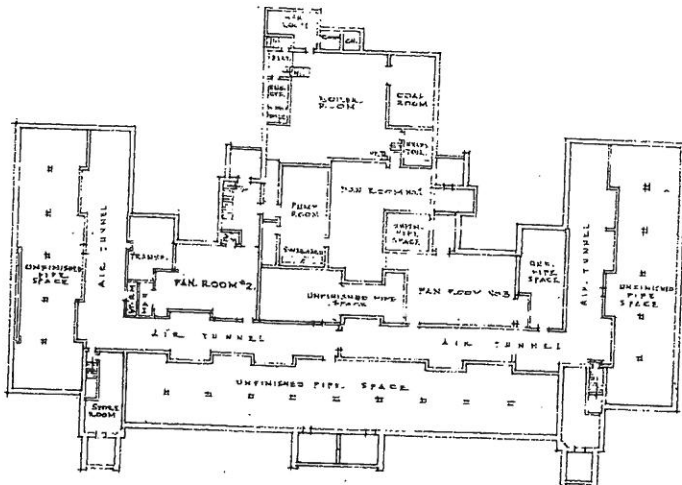
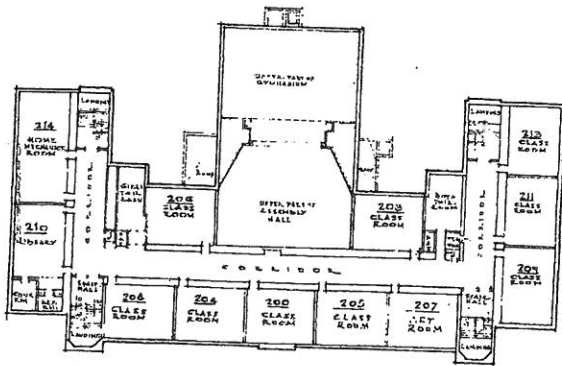
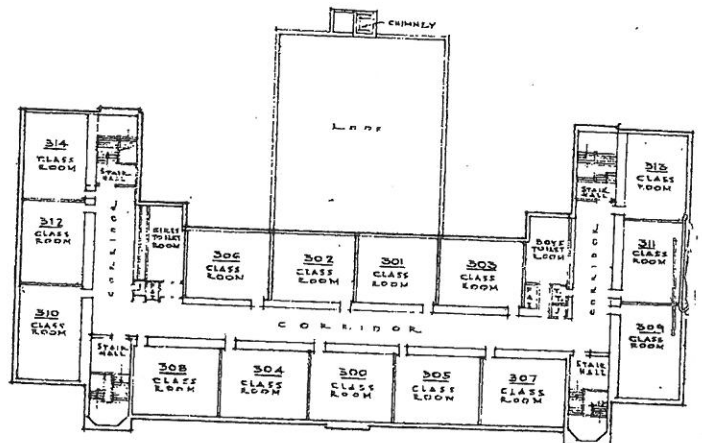
# PULASKI SCHOOL NEW H A # 122

Description: DRYWALL SYSTEM  
Location: #110 MUSIC ROOM  
Quantity: 200 S.F.

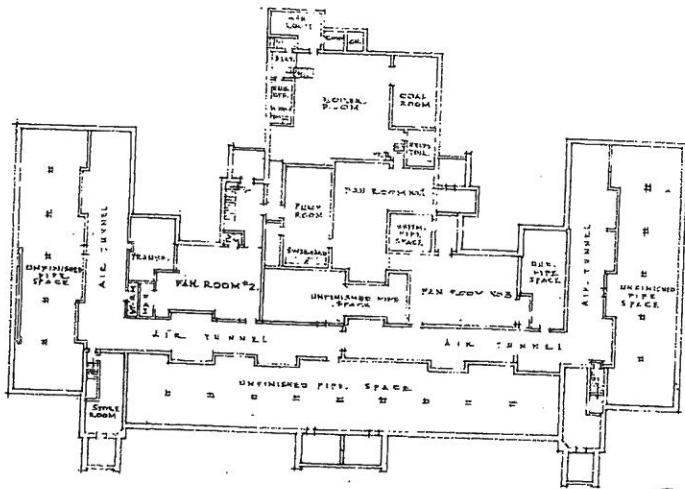
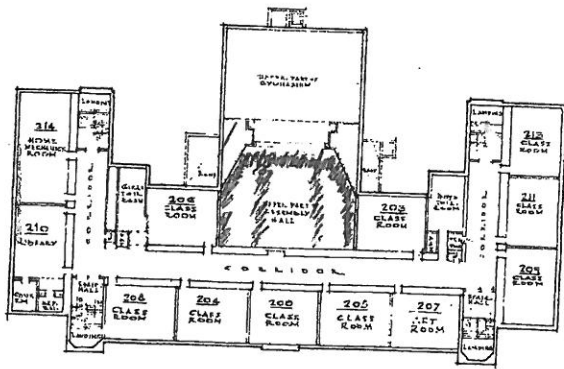
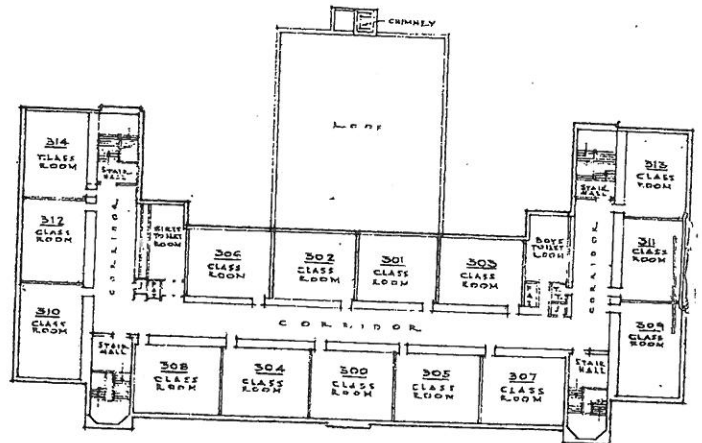
Location: ASSEMBLY HALL - AISLES

Quantity: 1500 S.F.

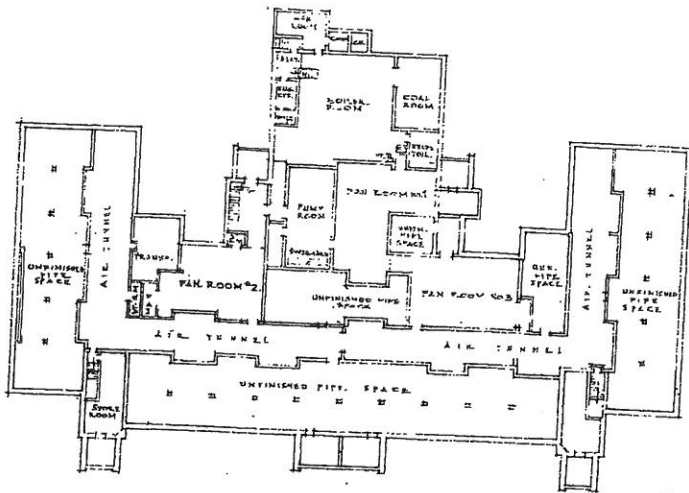
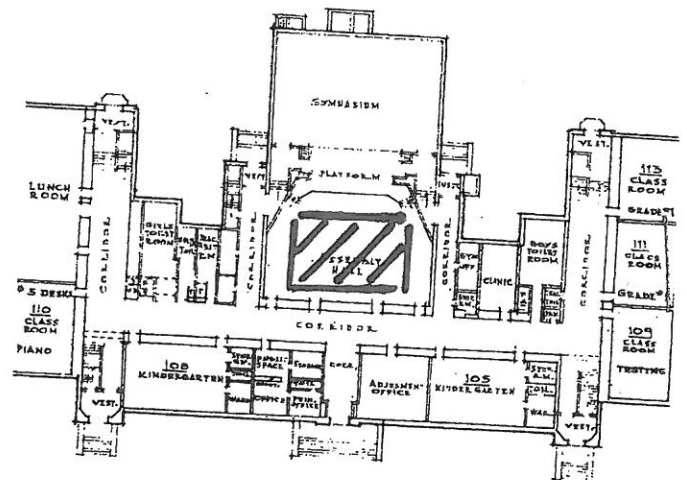
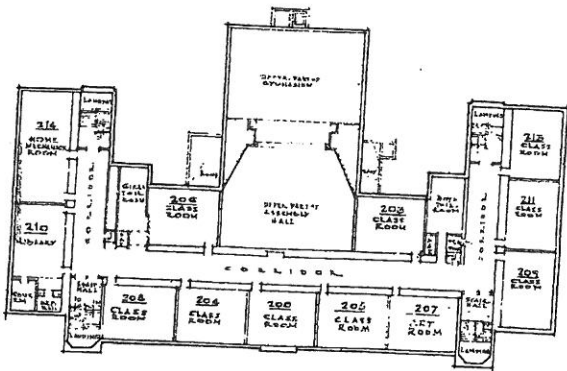
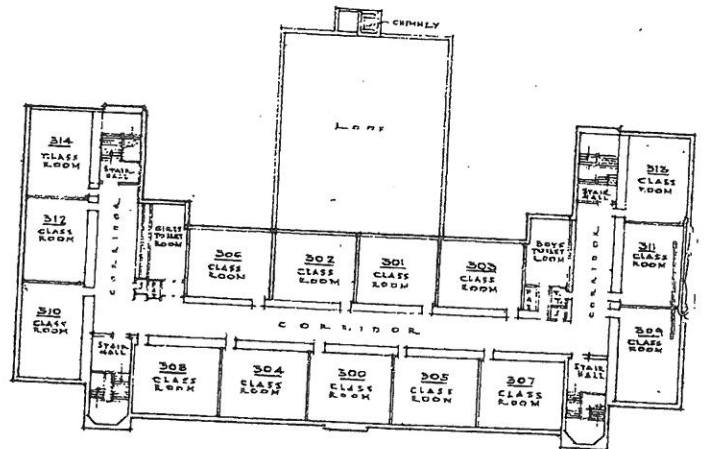
1949

Quantity: ASSEMBLY HALL - SEATING AREA  
1500 S.F.

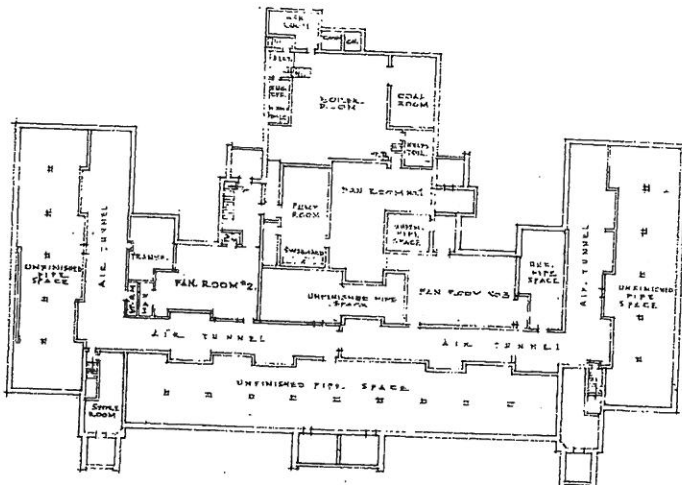
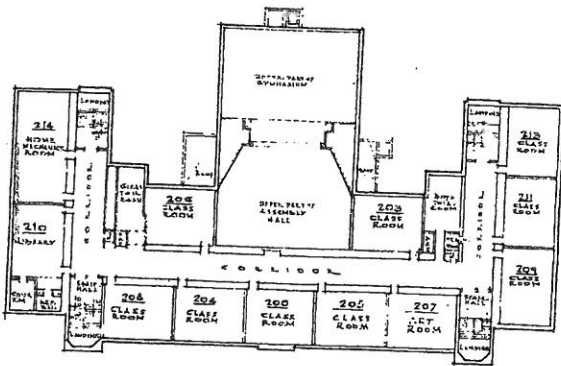
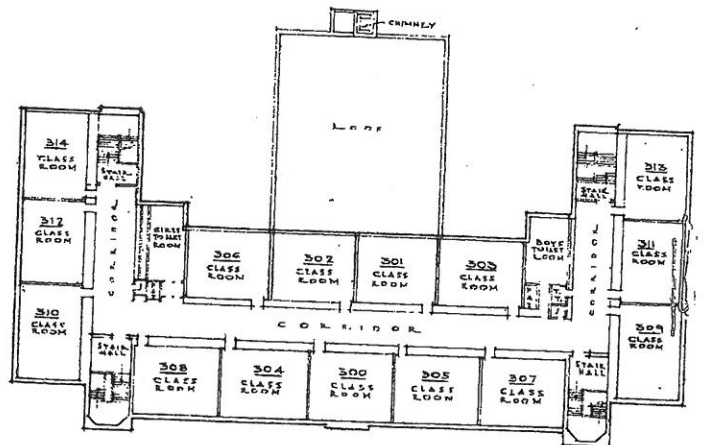
Description: ASSOCIATED WITH NEW H A # 118 -  
Location: LUNCH ROOM  
Quantity: 3000 S.F.

12" x 12"  
GRAY WITH DARK  
GRAY VFT

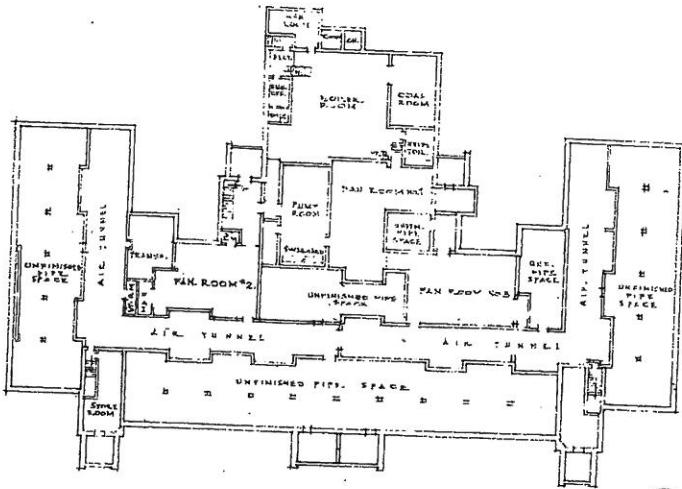
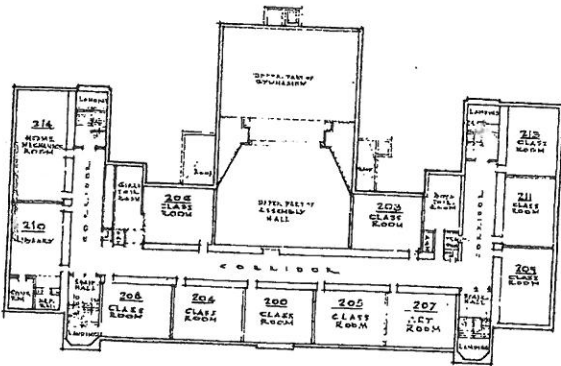
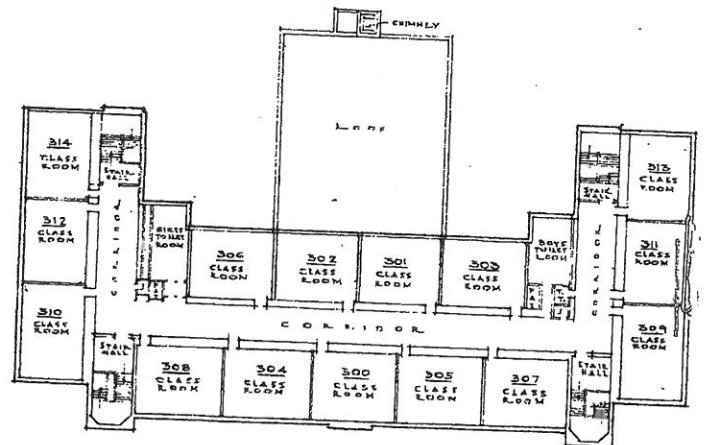
# PULASKI SCHOOL NEW H A # 118 VFT

Description: **12" x 12" GRAY W/ DARK GRAY STREAKS**  
Location: **NEW LUNCH ROOM**  
Quantity: **3000 S.F.**

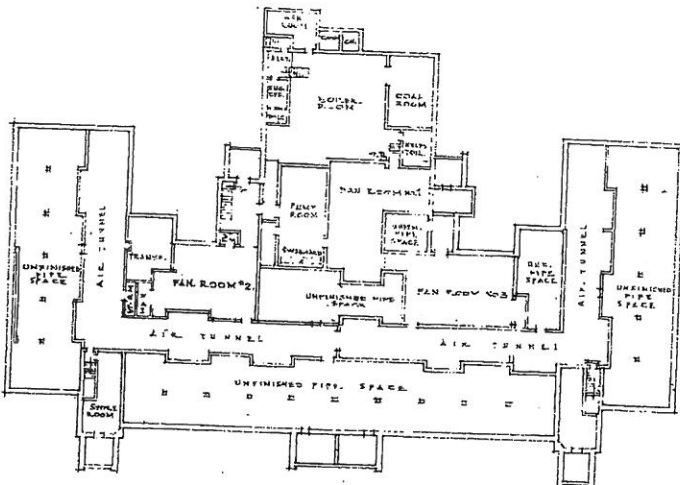
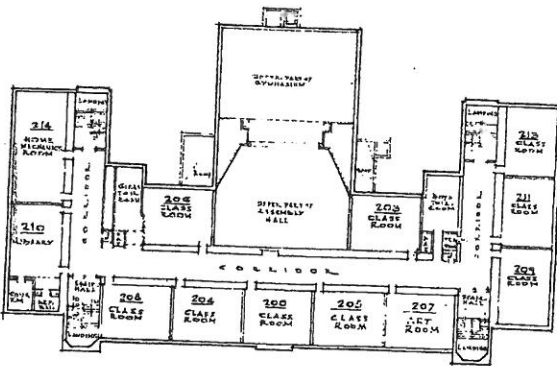
Description: ASSOCIATED WITH NEW HA # 118 -  
Location: LUNCH ROOM  
Quantity: 3000 S.F.

12" x 12"  
GRAY WITH DARK  
GRAY VFT
